**National Highway
Traffic Safety
Administration**

NEF-140ns
DP15-006

Docket No. NHTSA-2016-XXXX

Denial of Motor Vehicle Defect Petition

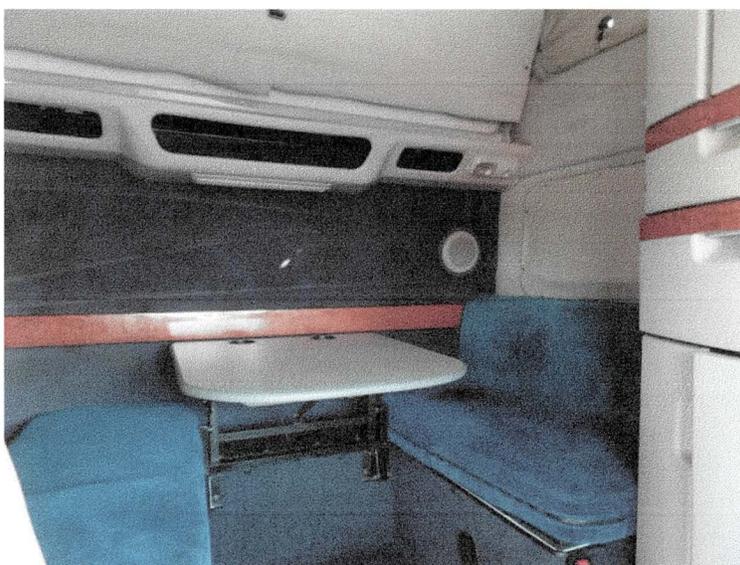
Figure 5: Volvo work station

One petitioner claims an injury was sustained when the cab bottomed out. ODI understands that the petitioner was seated at the work station (table) in the sleeper berth while the vehicle was in transit. Petitioners did not provide, in their petition or during their meeting with the investigator, enough details about the event for ODI to determine whether the injury was related to the alleged defect. Volvo has not designated this as a seating position. The seating area for the work station does not provide back support for a seated individual and is not equipped with seatbelts. Volvo does not intend for it to be used while the vehicle is in transit.

While ODI believes that it may be foreseeable that vehicle occupants may use the work station during transit, ODI does not believe that the alleged defect creates an unreasonable risk to motor vehicle safety. Volvo reported three (3) complaints and three (3) field reports for the cab bottoming out. One of the field reports described an incident in which a mounting bolt had punctured the air bag, which caused the failure. Volvo did not report any warranty claims related to bottoming out. Volvo also received three (3) reports of the cab hitting or striking the vehicle's aerodynamic flaring. Volvo has not received any reports of injury related to bottoming out.

It is ODI's contention—based on currently available information—that the incidence in the petition is isolated and is not related to a larger defect trend. There are several factors that could cause the sleeper cab to bottom out including traveling on a rough road surface, an incidence of heavy swaying, or an incident such as the one described in the field report. Furthermore, if the vehicle had a defect that caused the cab to bottom out ODI would expect to see more complaints, warranty claims, and field reports regarding the issue.

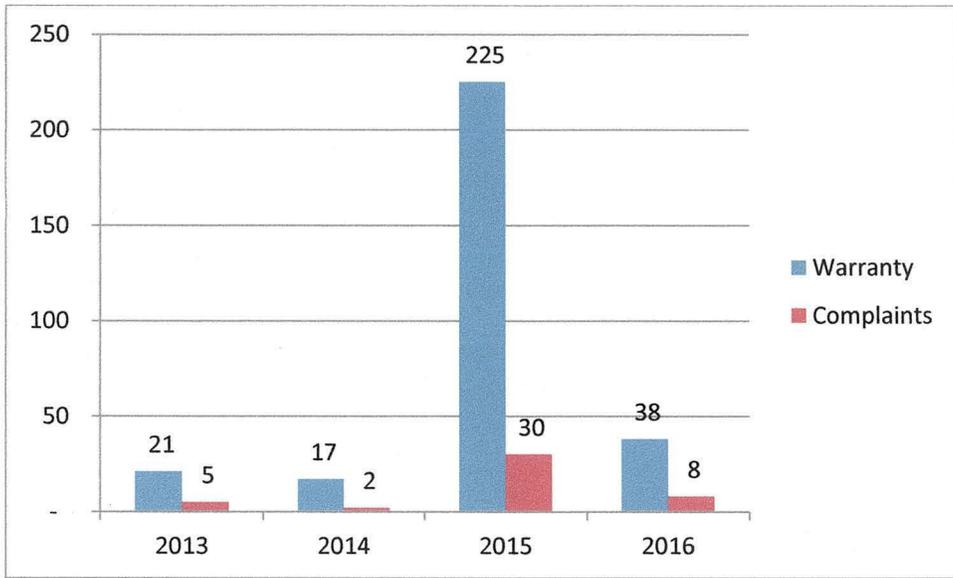
Figure 5 - Number of Volvo Reports by Vehicle Model Year

The final concern raised by the petitioners was cab misalignment/bottoming out. They stated that the cab has come out of alignment multiple times and it can then bottom out, forcefully striking the frame. Volvo reported forty-three (43) complaints and field reports and 292 warranty claims for cab misalignment. When sorted by MY, the 2015 MY stood out, with twenty-nine (29) complaints and field reports and 222 warranty claims. This equates to a 0.47%

warranty rate on the subject vehicles and a 1.24% warranty rate specifically for the 2015 MY. This significant shift indicated to ODI that there is a defect with the cab mounting components beginning in or about the 2015 MY; however a safety risk has not been identified because none of the complaints, field reports, or warranty claims received by Volvo report injuries.
