Repair Instructions

Campaign 15V-510

060-1650 Motor Home Entrance Door Hardware

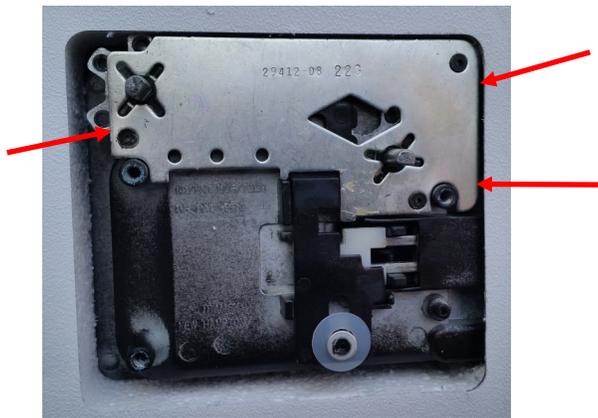
2. Check the dead bolt retaining plate for tightness by gently pulling up on it in the areas shown below with a straight slot screw driver.

If the plate is tight—go to step 3. If the plate appears to be loose, continue to step 5.

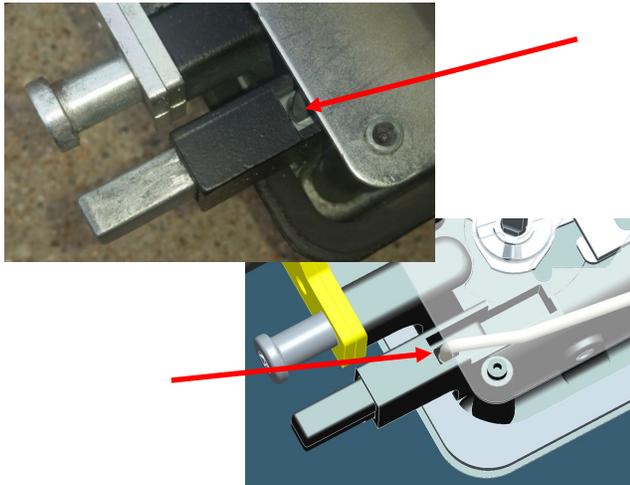
6. Check to see that the deadbolt rod and deadbolt are properly aligned and functional using the key to extend and retract the deadbolt.

If the deadbolt rod and deadbolt are disconnected, you must lift the plate and reinsert the formed end deadbolt rod into the deadbolt slot before you can proceed to step 7.
