Michael A. Berardi
Director
Service Engineering Operations
Ford Customer Service Division

May 5, 2016

SUBJECT: DEMONSTRATION / DELIVERY HOLD - Safety Recall 16S13
Certain 2015-2016 Model Year Transit Wagon Vehicles with Low Roof
Side Curtain Airbag Inspection and Adjustment

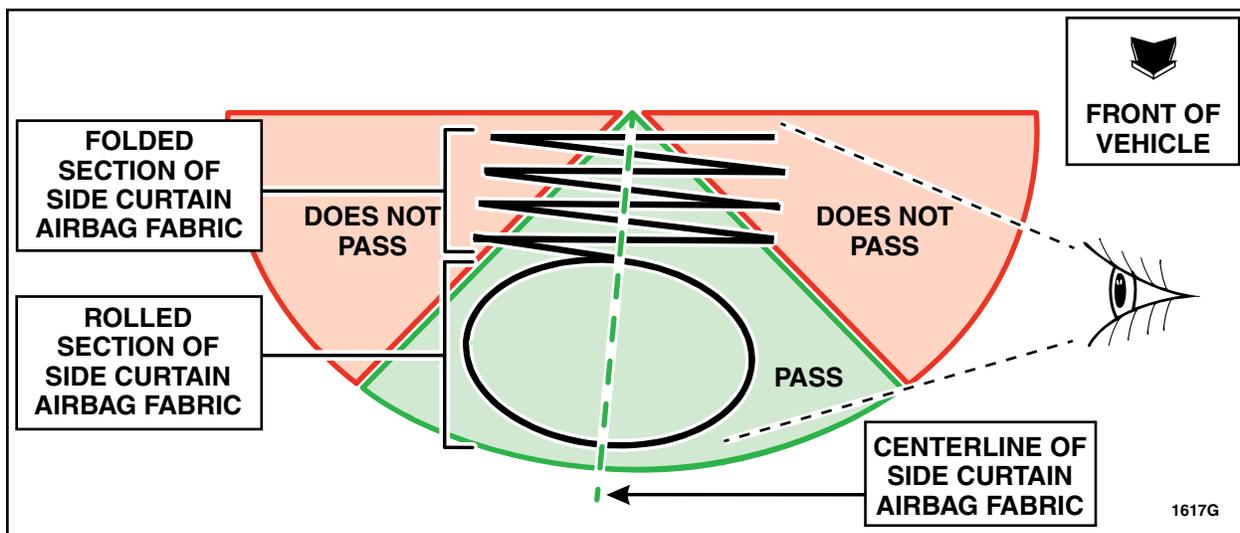
FIGURE 1

2. Inspect the driver and passenger side curtain airbag fold orientation starting at the B-pillar and ending at the rear of the vehicle. When properly positioned, the centerline of each side curtain airbag will have a rolled section of side curtain airbag fabric that should be positioned below the folded section. The side curtain airbag fabric orientation may be positioned anywhere within the acceptable (**PASS**) range illustrated in Figure 1.

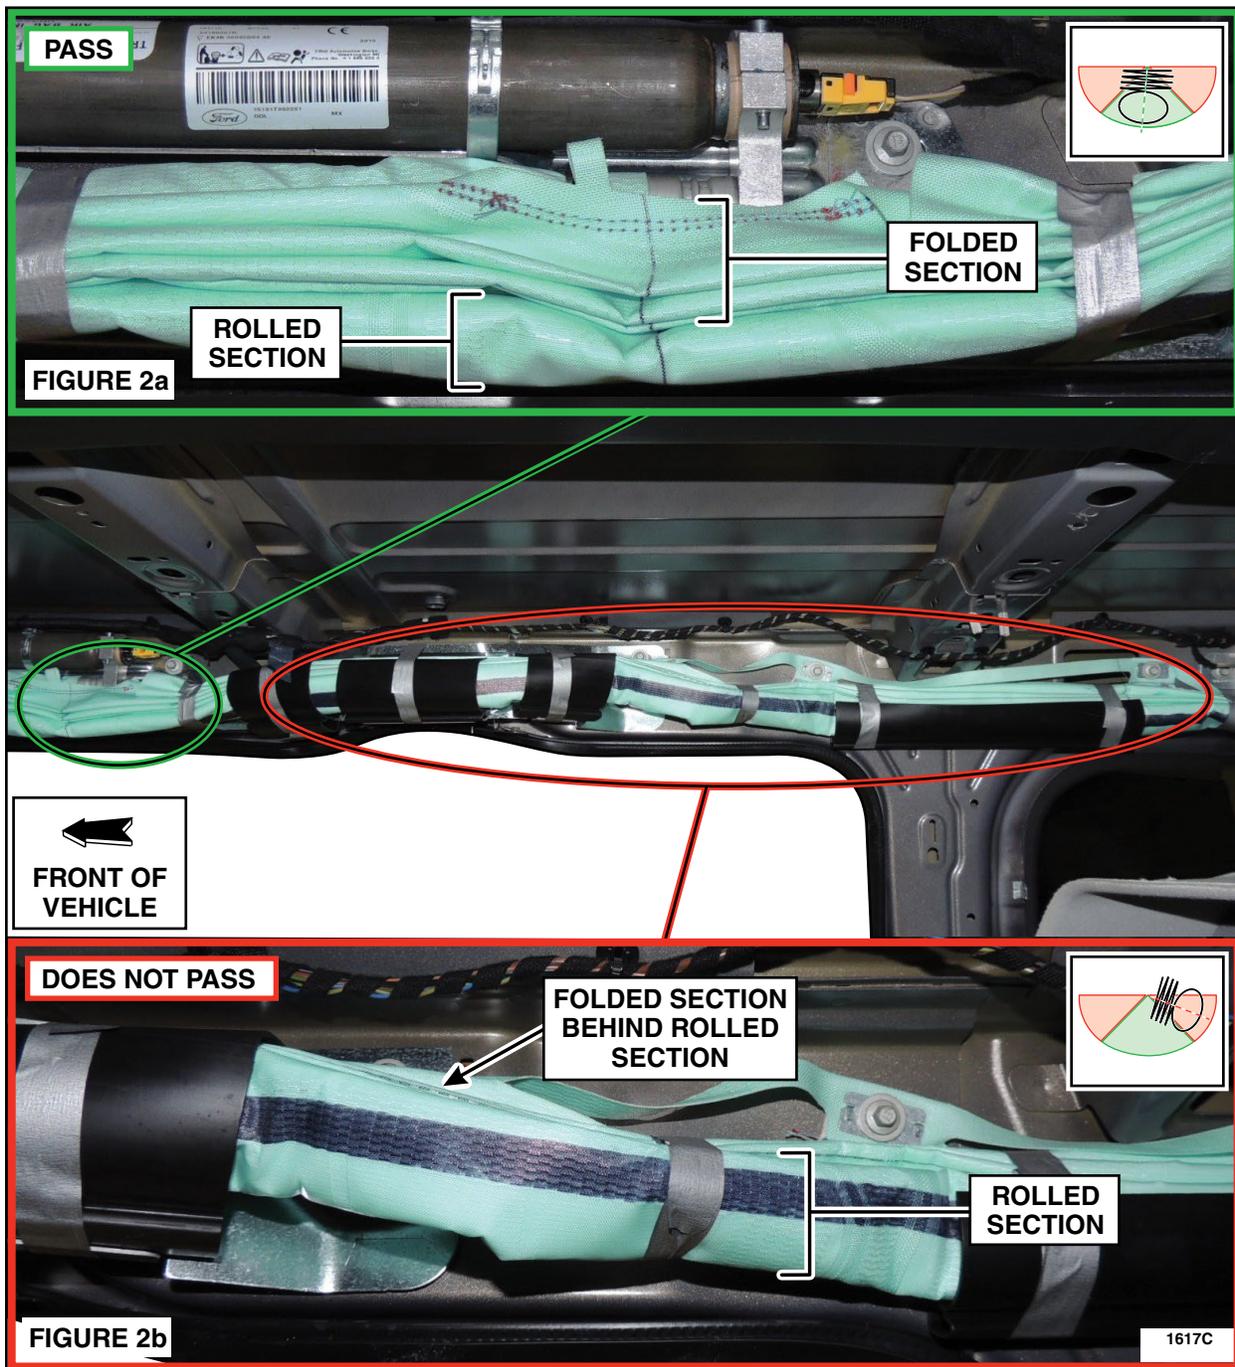
FIGURE 2

The side curtain airbag **PASSES** inspection if the centerline of the rolled and folded sections is within the acceptable (**PASS**) range. See Figure 1 and 2a. If both the driver and passenger side curtain airbags pass inspection, the repair is complete. Install the rear headliner sections. Please follow the WSM procedures in Section 501-05 (rear headliner).

The side curtain airbag **DOES NOT PASS** inspection if the centerline of the rolled and folded sections is **not** within the acceptable (**PASS**) range at any point rearward of the B-pillar. See Figure 1 and 2b. If the side curtain airbag does not pass inspection at any point rearward of the B-pillar, proceed to the Side Curtain Airbag Adjustment Procedure on Page 3.
