Cummins ECM Water Intrusion Issue @ Jamestown Engine Plant (JEP)

05/23/2016

Problem Statement

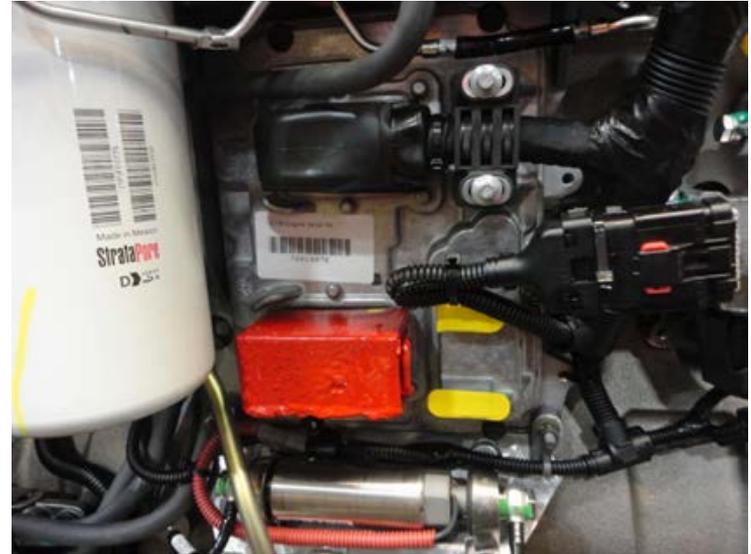
Failed ECM resulting in burned 30 amp fuse

¿ Why did it happen ?	Corrective Action	Responsible	Date
Specific Problem	1.- WHY ?	Blown 30 amp Fuse caused the ECM to short and fail	[Redacted]	[Redacted]	4/12/2016
	2.- WHY ?	Water ingress via engine wash process through the connector ports resulting in corrosion			
	3.- WHY ?	[Redacted]			
	4.- WHY ?	[Redacted]			
	5.- WHY ?	[Redacted]

- Replaced masking covers with verified/certified covers, the covers were vacuum tested to ensure proper sealing
- An additional cover was added prior to engine wash, as shown in picture
