# NISSAN BULLETIN

## Engine Room Harness Voluntary Safety Recall Campaign

Reference: PM658  
Date: June 29, 2016

## Sentra (B17) EGI Harness Repair

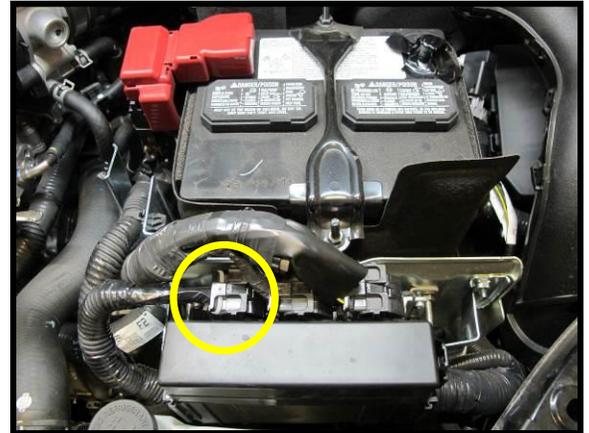
The repairs will be completed on the **LEFT** side connector (gray color) identified in Figure 1

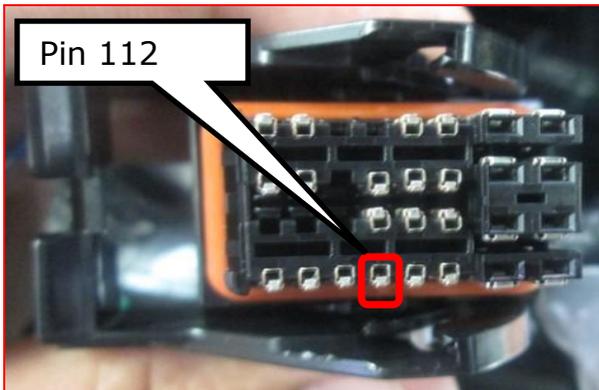
Figure 12

11. Locate terminal and corresponding wire (Figures 11, 12, 13).

- Pin: 112
- Wire Color: Solid Orange
