GROUP BOD	MODEL 2015MY Optima (QF)
	NUMBER 115	DATE September 2015
<b>TECHNICAL SERVICE BULLETIN</b>		
SUBJECT: SERVICE ACTION: EXTERIOR DOOR HANDLE TRIM CAP REPLACEMENT (SA198)

**SUBJECT: SERVICE ACTION: EXTERIOR DOOR HANDLE TRIM CAP REPLACEMENT (SA198)**

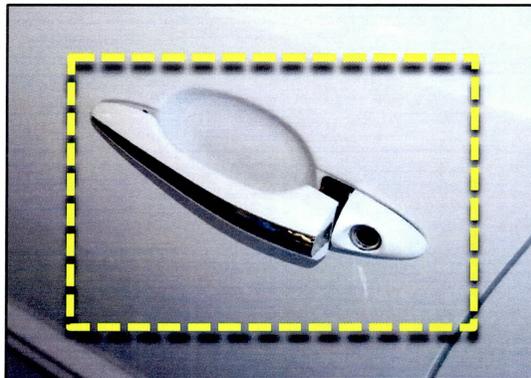
This bulletin provides the procedure to replace the exterior door handle trim cap of some 2015MY Optima (QF) vehicles, produced from September 2, 2014 through August 24, 2015, which may experience an inoperative driver's side exterior door handle. Kia is requesting the completion of this Service Action on all affected vehicles, including dealer stock, prior to delivery. Before conducting the procedure, verify the vehicle is included in the list of affected VINs.
