# Bendix SR-5 Trailer Spring Brake Relay Valve Recall

July 2016

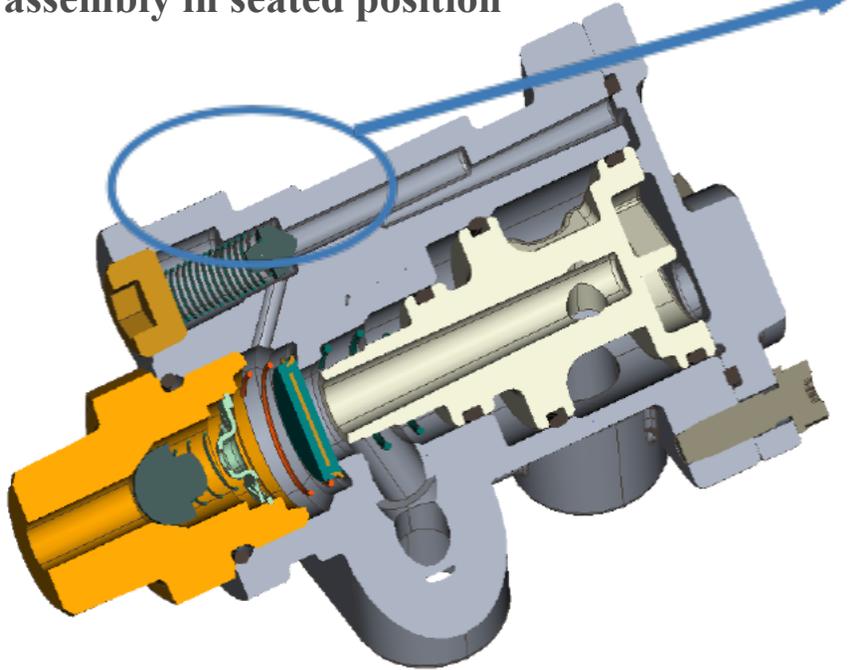
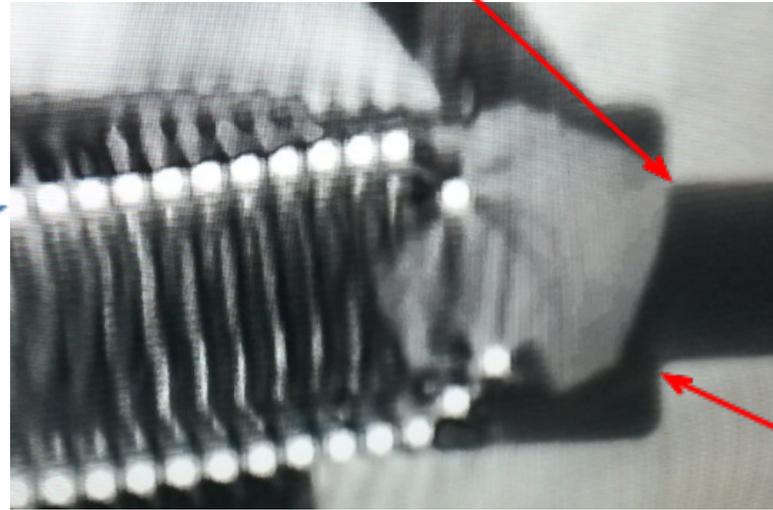
Sectional view of check valve assembly in seated position

When combined with certain field conditions – causes misalignment of internal Check Valve

**Caught on Sharp Edge**

## Production Remedy - Re-introduce Radius on Valve Body (Began on Mar 4, 2016)

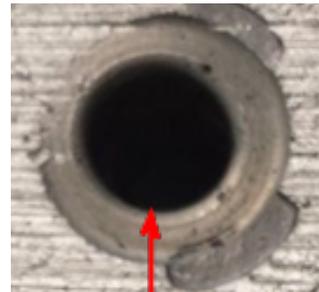
**Missing Radius on Valve Body**

**Check Valve seat**  
(Radius Present / Radius Not Present)

**If Valve becomes Misaligned, Leakage can be Large enough to cause 'Slow to Park'**

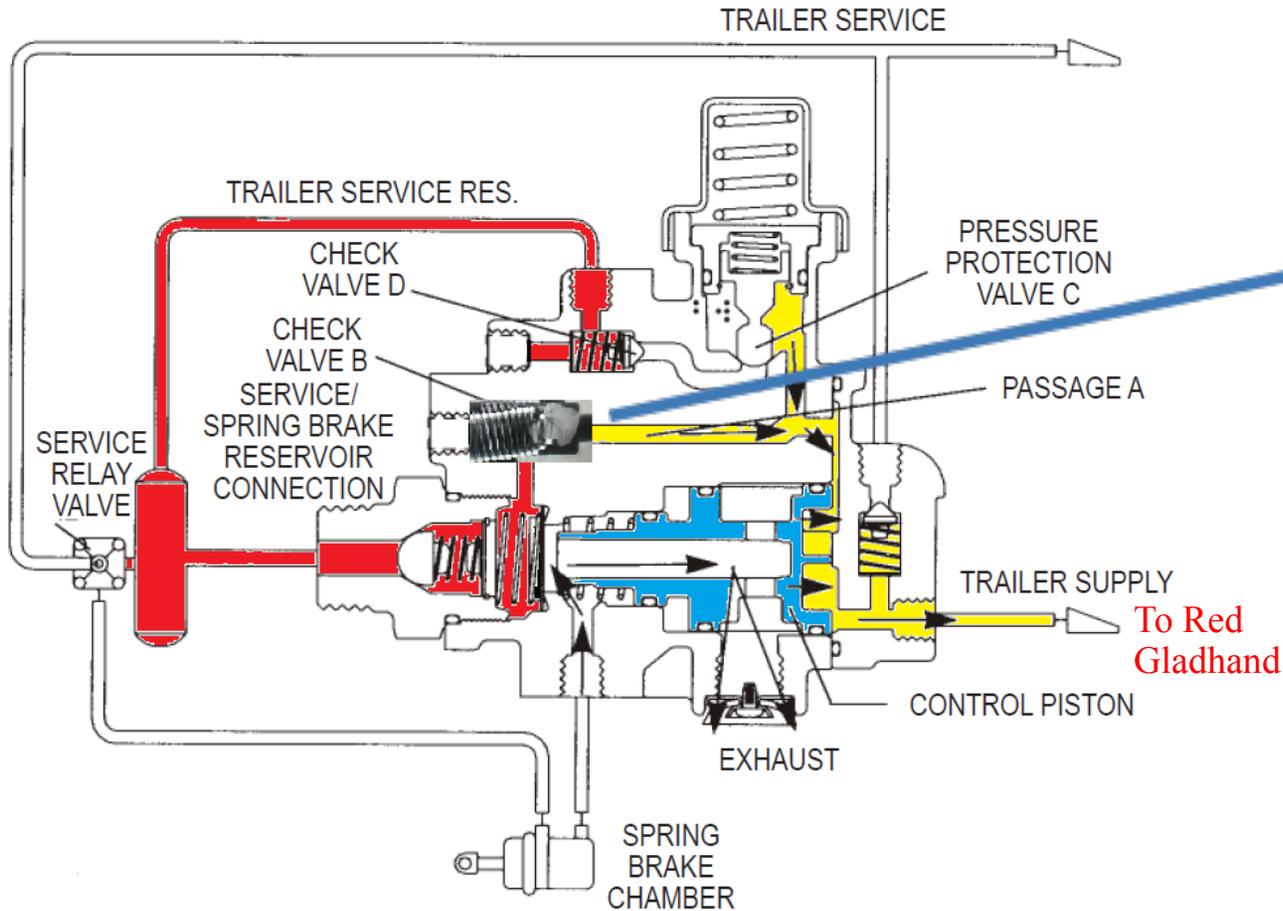
If Leakage is present (& large enough), the leaking air provides enough back pressure on the main control piston (**BLUE**) to prevent normal movement.

If the main piston does not move, immediate exhaust (<3 seconds) cannot happen.

This is how the leakage from the check valve is causing the 'slow to park' condition.

Once leakage fully exhausts tank pressure, the backpressure drops, the main piston moves & the trailer parks.

Missing Radius (combined with other conditions) can cause leakage – preventing immediate parking
