Recall Bulletin

PRODUCT SAFETY RECALL

SUBJECT: Heated Windshield Washer Module Short Circuit – Add Wire Harness

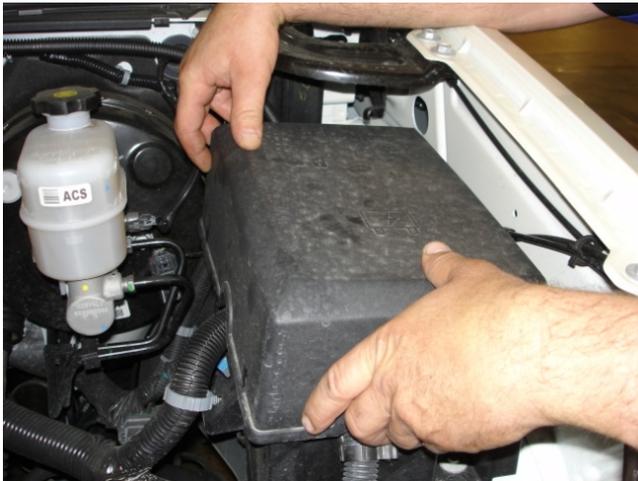
2182449

2. Locate the underhood busseled electrical center (UBEC).

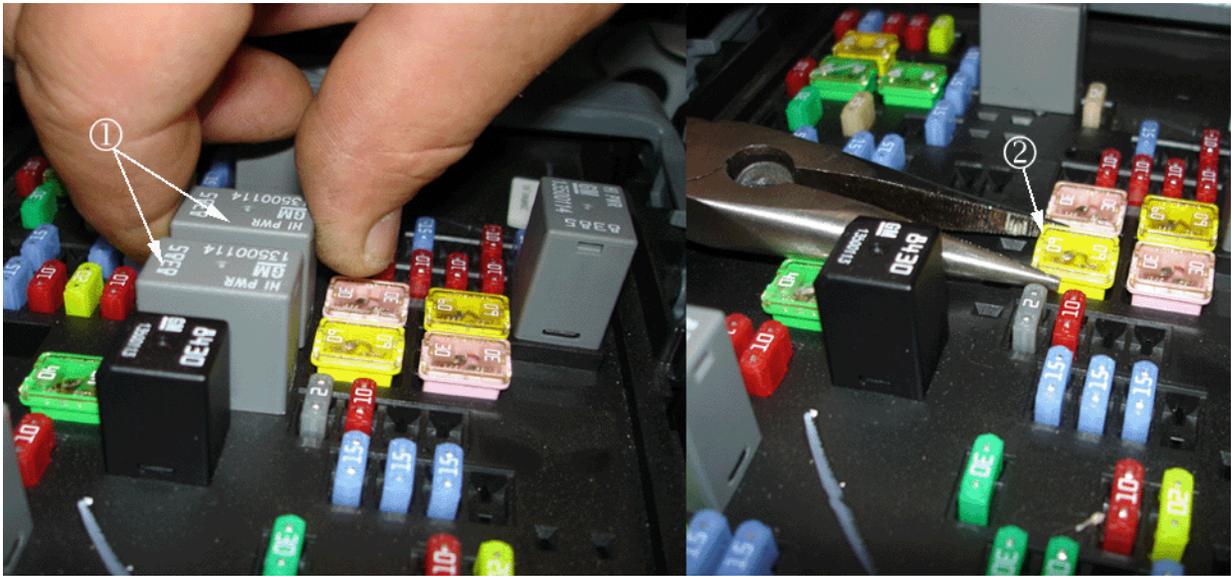
2182450

3. Remove the UBEC cover and locate the 60 amp heated windshield washer fuse.

Important: Remove the two relays (1) next to the fuse to gain access to the fuse.

4. Remove the 60 amp heated windshield washer fuse (2) using needle-nose pliers.
5. Store the 60 amp heated windshield washer fuse in the glove compartment.
6. Install the two relays (1) removed in Step 4.
7. Connect the negative battery cable. Refer to *Battery Negative Cable Disconnection and Connection* in SI.
8. Test the operation of the windshield wiper system.
 - 8.1 Ensure the wiper system functions in low and high positions.
 - 8.2 Verify that the windshield wiper/washer switch functions. The windshield wiper system should provide wiper fluid to the windshield.
 - 8.3 Ensure that the heated windshield washer fluid system has been disabled.
 - Verify that the heated windshield washer switch does NOT flash.
9. Secure the UBEC cover on the UBEC.
10. Close the hood.

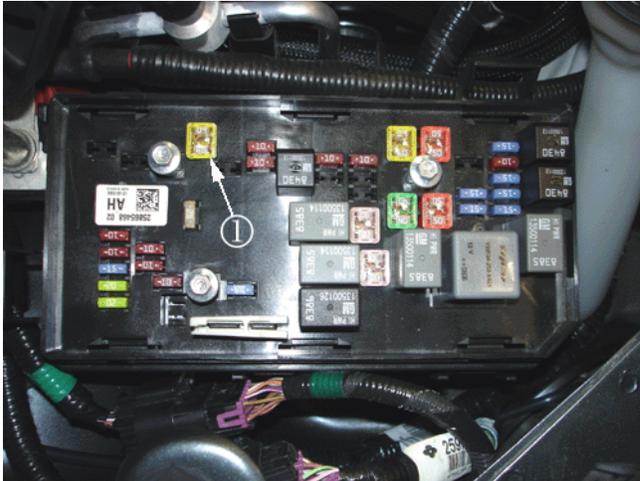
2182455

2. Locate the underhood bussed electrical center (UBEC) (1).

3. Remove the UBEC cover and locate the 60 amp heated windshield washer fuse (1).
4. Remove the 60 amp heated windshield washer fuse using needle-nose pliers.
5. Store the 60 amp heated windshield washer fuse in the glove compartment.
6. Connect the negative battery cable. Refer to *Battery Negative Cable Disconnection and Connection* in SI.
7. Test the operation of the windshield wiper system.
 - 7.1 Ensure the wiper system functions in low and high positions.
 - 7.2 Verify that the windshield wiper/washer switch functions. The windshield wiper system should provide wiper fluid to the windshield.
 - 7.3 Ensure that the heated windshield washer fluid system has been disabled.
 - Verify that the DIC does not display the following message, “HEATING WASH FLUID WASH WIPES PENDING”.
8. Secure the UBEC cover on the UBEC.
9. Close the hood.

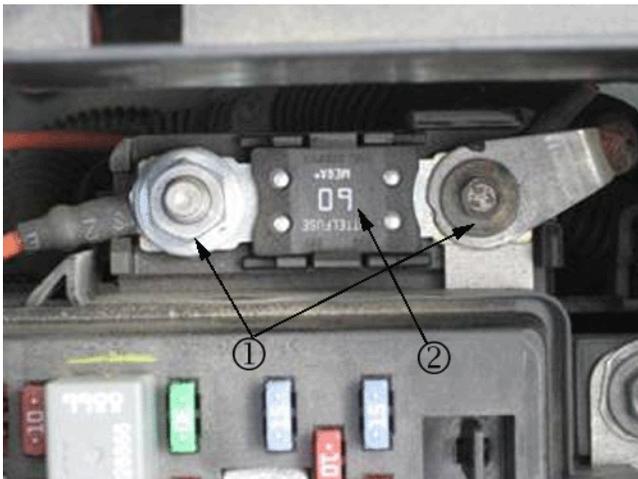
2182535

2. Locate the under-hood bussed electrical center (UBEC).
3. Remove the UBEC cover and locate the 60 amp heated windshield washer Mega fuse.

4. Remove the two nuts (1) for the Mega fuse (2). Refer to the picture.
5. Remove the 60 amp heated windshield washer Mega fuse.
6. Store the 60 amp heated windshield washer Mega fuse in the glove compartment.
7. Install the two nuts back into the two studs.
8. Connect the negative battery cable. Refer to *Battery Negative Cable Disconnection and Connection* in SI.

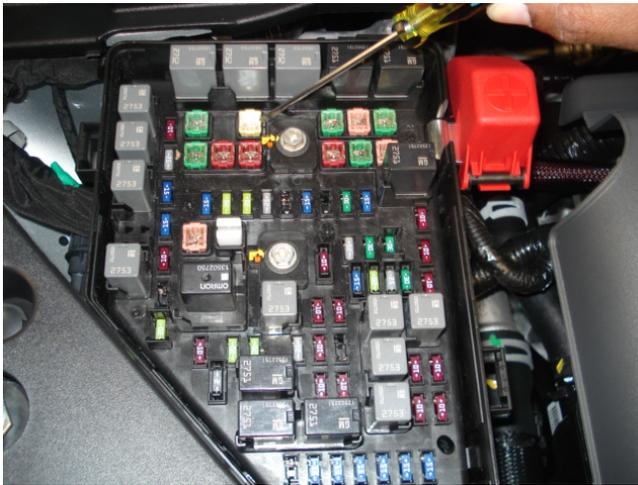
2182447

2. Locate the underhood bussed electrical center (UBEC).

3. Remove the UBEC cover and locate the 60 amp heated windshield washer fuse.
Important: Remove the two relays next to the fuse to gain access to the fuse.

4. Remove the 60 amp heated windshield washer fuse using needle-nose pliers.
5. Store the 60 amp heated windshield washer fuse in the glove compartment.
