# RECALL CAMPAIGN BULLETIN

NTB03-070d

August 20, 2008

## VOLUNTARY RECALL CAMPAIGN ALTIMA AND SENTRA QR25DE ENGINE EXHAUST PIPE HANGER PIN AND PRE-CATALYST

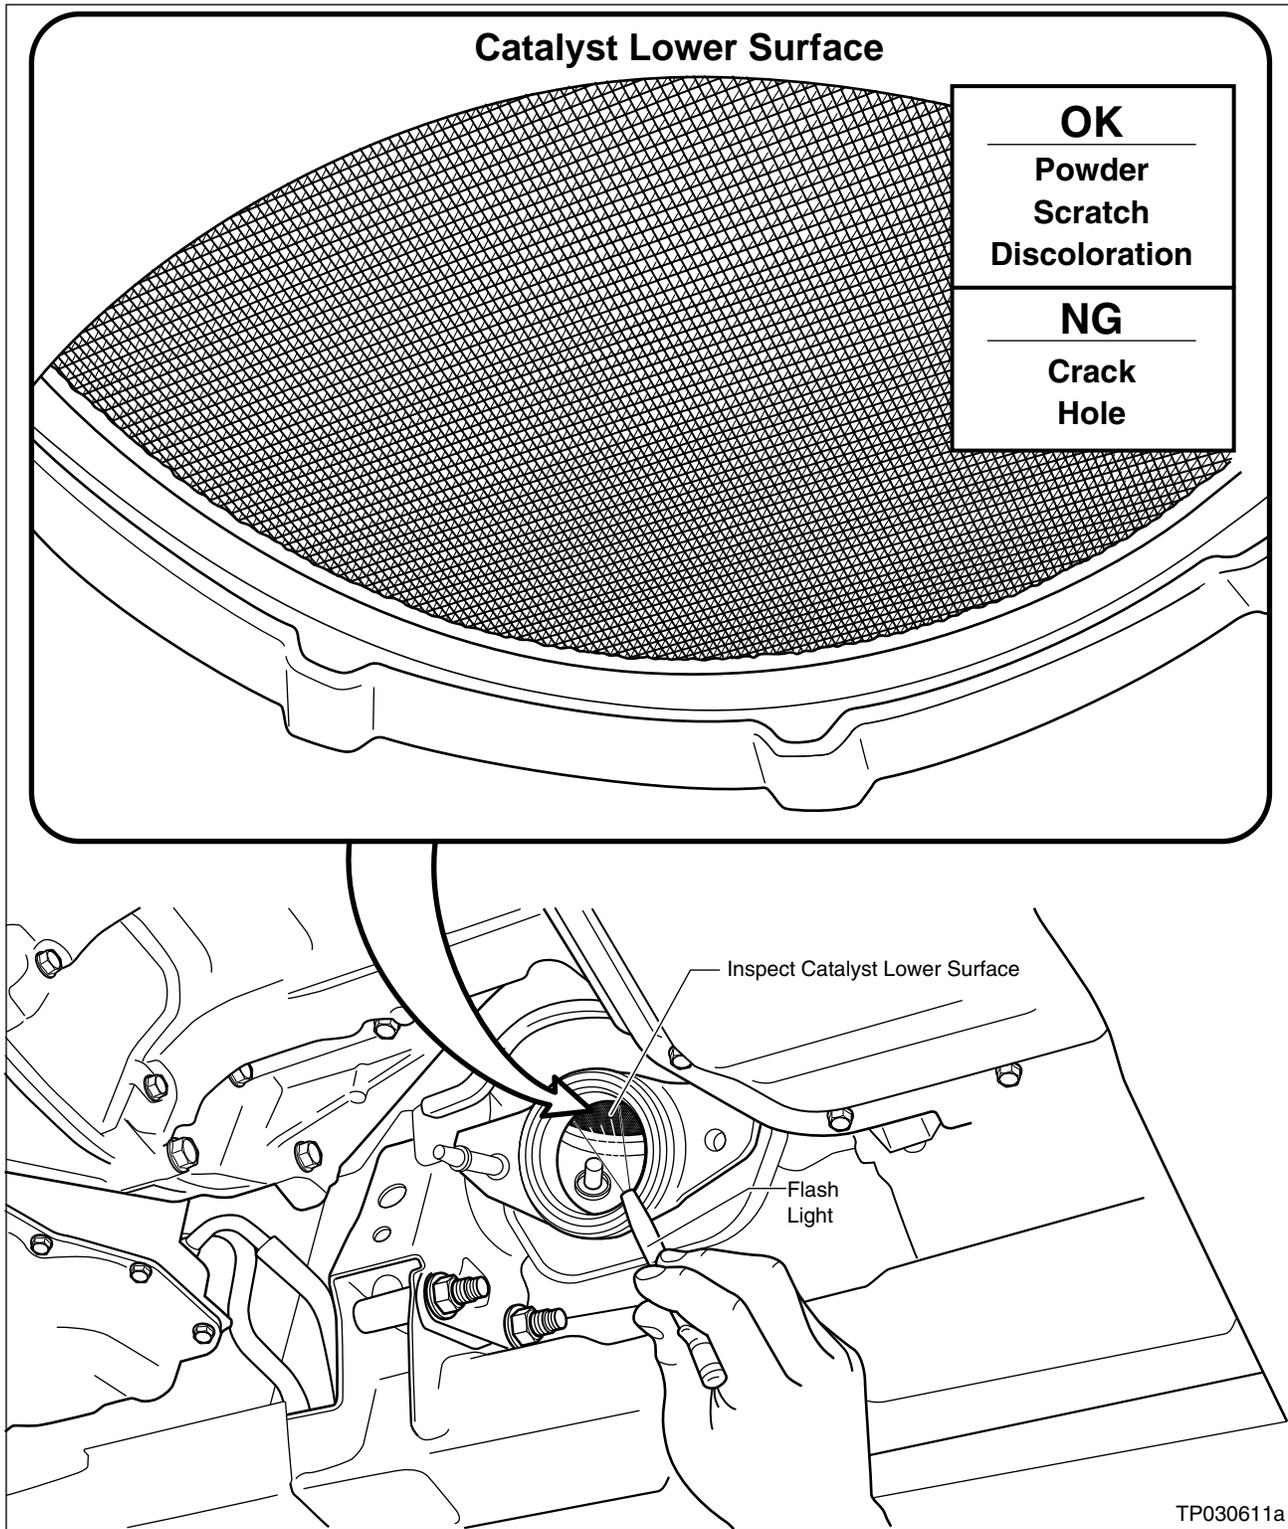
Figure D4

5. Inspect the entire catalyst lower surface condition as shown in Figure D4.

**IMPORTANT:** Make sure you inspect the entire lower surface. You are looking for cracks or holes in the lower surface.

6. Return to the Repair Flow Chart (page 4) for further instructions.

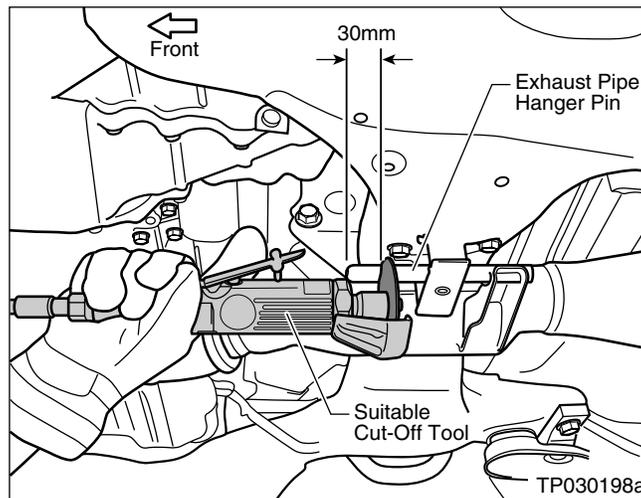
**NOTE:** If it looks like the pin has already been trimmed, skip step 3 here and move on to the next appropriate step in the Repair Flow Chart (page 4).

3. Use a 3" (or equivalent) air-powered cut-off wheel to cut the pin as shown in Figure F1 below.
