Defect Information Report

Maserati SpA ("Maserati") has determined that a defect that relates to motor vehicle safety exists in certain Model Year Maserati GranTurismo, Quattroporte and Alfa Romeo 8C Competizione vehicles. Maserati is providing this notification to your office in accordance with 49 C.F.R. Part 573.

RECALL CAMPAIGN INSTRUCTIONS & INFORMATION BULLETIN

SUBJECT: Recall 183, Front/Rear Upper & Lower Ball Joint Nut Tightening

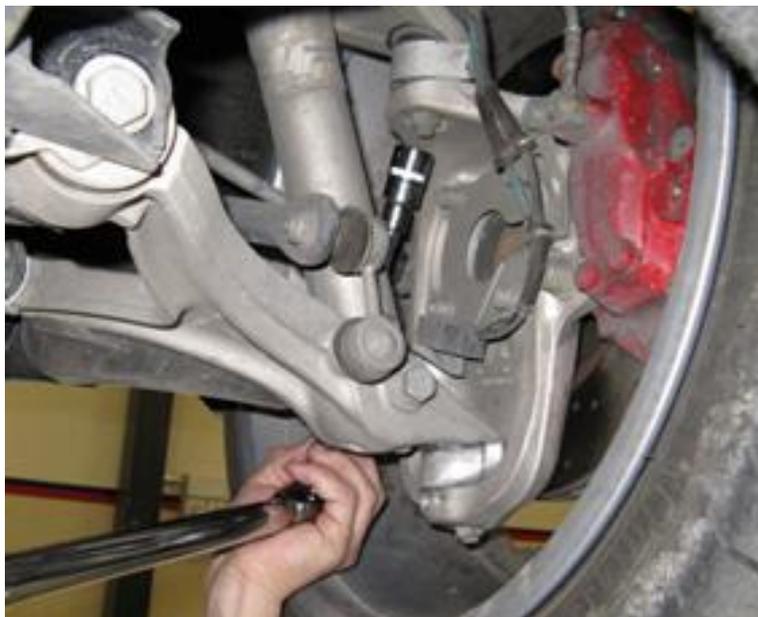
Figure 1 – Front upper levers

To check tightness of the pin fastening nuts of the front right and left upper levers (see Figure 1), the front right and left lower levers (see Figure 2) and the rear right and left upper levers (see Figure 3), proceed as follows:

- Calibrate the torque wrench to **25 Nm**.
- With reference to the corresponding figure, check that the torque wrench immediately locks without turning when you try to tighten the nut. This means that the nuts are correctly tightened.

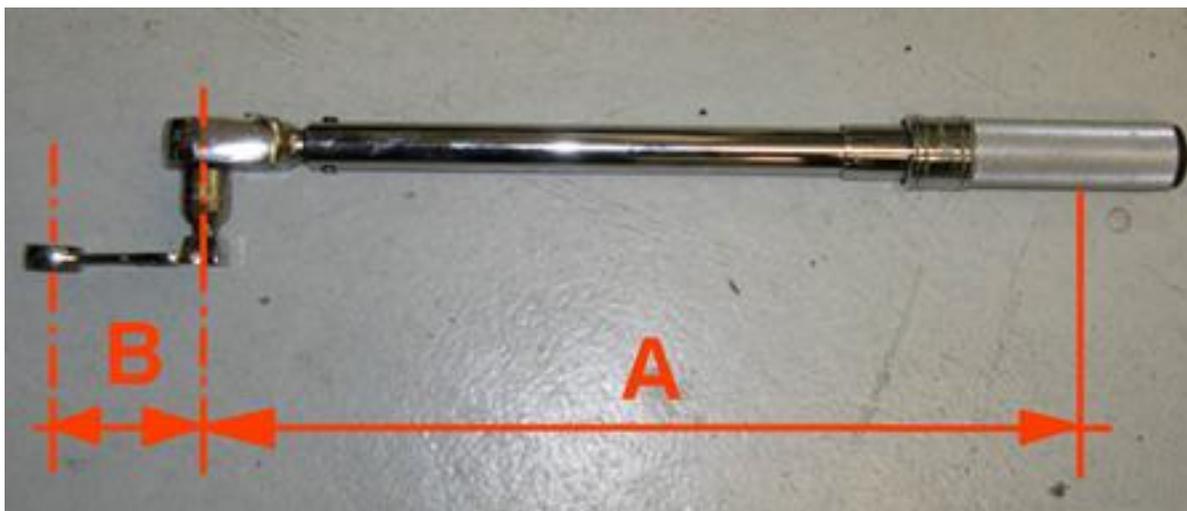
Figure 4 – Length of the torque wrench and the special tool

- A is the length of your torque wrench expressed in metres and measured as shown in **Figure 4**
- B is the length of the tool “Tightening torque adapter” (length = 0.07 m).

- In this case, to access the nut, you need to use the special tool “**Tightening torque adapter**” (part number **900027696**).
- As you need to check that the nut is tightened to a torque of **25 Nm**, the torque to which the torque wrench must be calibrated is given by the following formula:

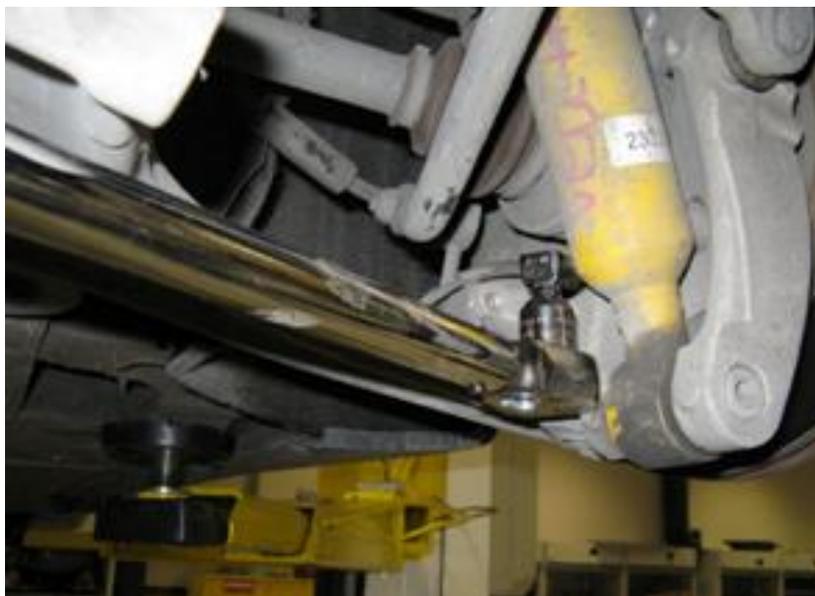
Figure 5 – Rear lower levers

To check tightness of the pin fastening nuts of the rear right and left lower levers, proceed as follows:

- Calibrate the torque wrench to the torque as determined above.
- With reference to Figure 5, check that the nut is tightened correctly, i.e. that the torque wrench locks immediately without turning when you try to tighten the nut. This means that the nuts are correctly tightened.
