## TRW Drag Link

VNL, VNM

### RVXX1003, TRW Drag Link

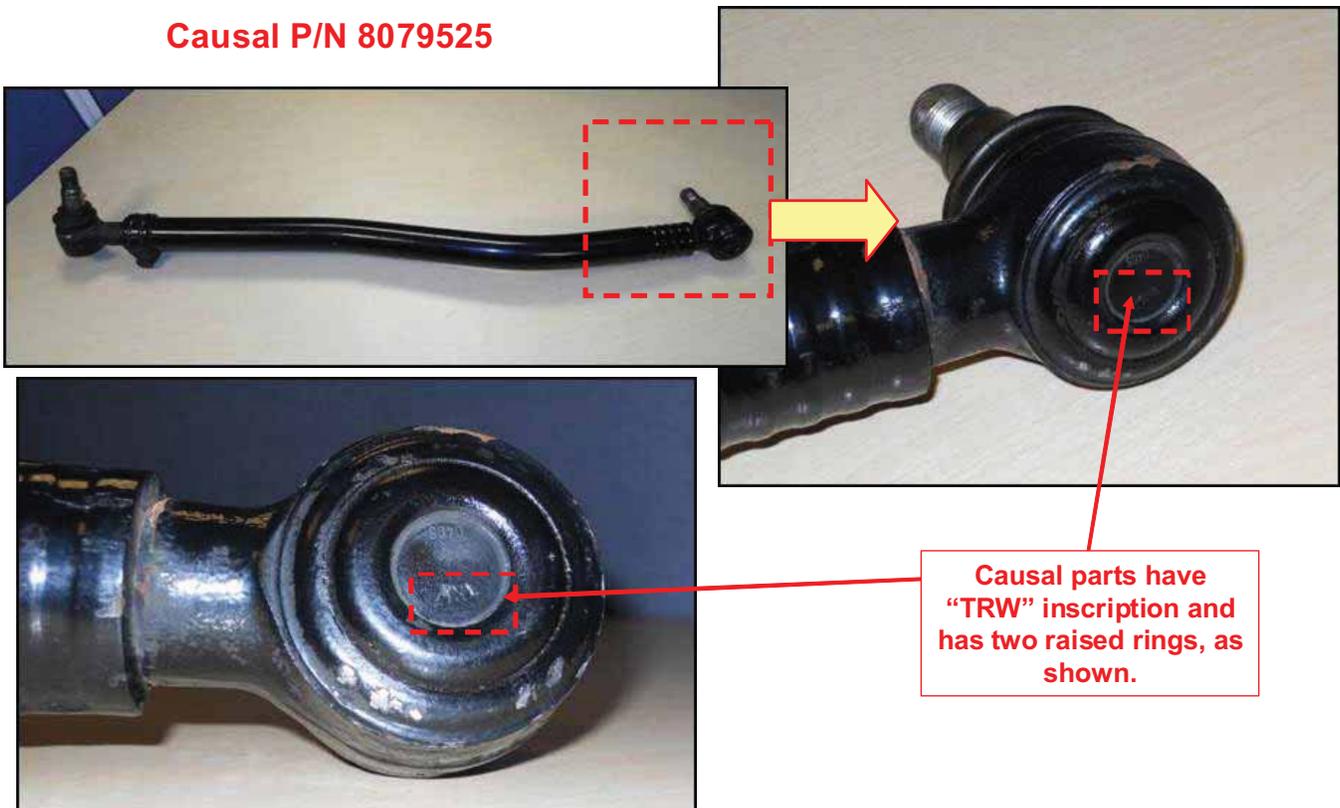
#### Causal P/N 8079525

On certain model year 2001 through 2006 trucks equipped with a TRW sealed (i.e. non-greasable) drag link, certain factors can exist, which if left untreated may result in a ball socket separation. Ball socket separation at the drag link results in complete loss of steering and therefore can result in a vehicle crash.

Causal parts have  
"TRW" inscription and  
has two raised rings, as  
shown.

Repair will involve inspection of the drag link to determine if a TRW brand sealed type (TRW is stamped in the bottom of the ball socket) and replacement are required. If a TRW sealed drag link is found, the part will be replaced with a greasable drag link, part number 85128559. If the drag link is not TRW type, a free inspection will be provided, however owner would be responsible for any replacement expenses.
