**Re: Defect Information Report (FL-480), NHTSA 06V-387, Supplemental Report No.: 1,
ArvinMeritor RPL20 Interaxle Drivelines**

Subject: ArvinMeritor RPL20 Interaxle Driveline Snap Rings

Models Affected: Specific Freightliner Columbia vehicles manufactured between July 11, 2006, and August 31, 2006, with Arvin-Meritor RPL20 high angle interaxle drivelines.

November 2006
 FL480A-C
 NHTSA #06V-387

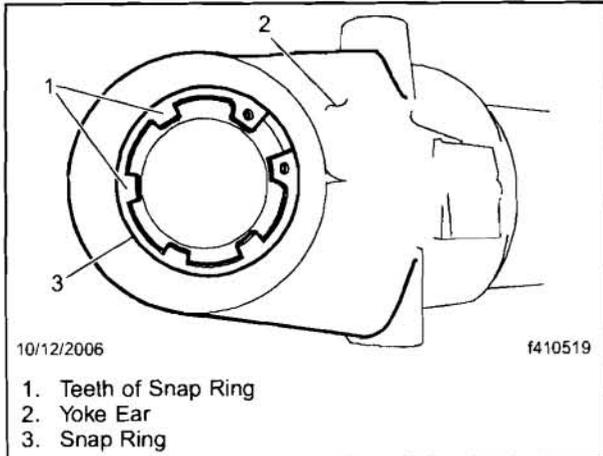
Fig. 1, Interaxle-Driveshaft Yoke (side view)

3. Raise the rear of the vehicle so the tires are off the ground, and support it with safety stands.
4. Underneath the vehicle, find the yokes on the interaxle driveshaft that have snap rings. See **Fig. 1**. Make sure all the snap rings are present. There should be a total of four (two at each end of the driveshaft).

If any snap rings are missing, replace the driveshaft. Go to "Interaxle Driveline Replacement."

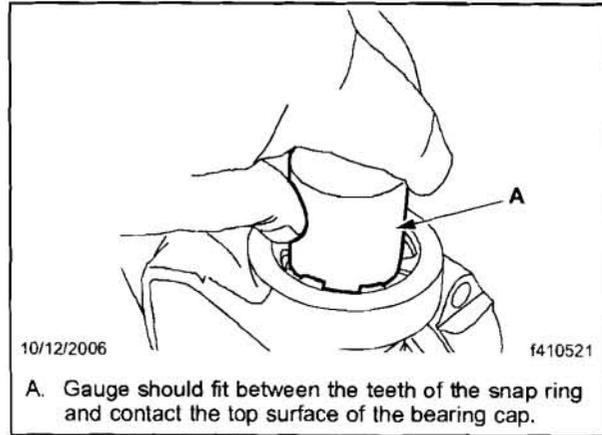
Fig. 2, Checking the Snap Ring Seating

5. Using the gage from the kit, check that all snap rings at both ends of the interaxle driveshaft are correctly seated in the yoke ears. The gage should fit between the teeth of the snap ring, and contact the top surface of the U-joint bearing. See **Fig. 2**.

If any snap ring is missing or incorrectly seated, replace the interaxle driveshaft. Go to "Interaxle Driveline Replacement."
