**Re: Defect Information Report – Supplemental Report No. 1
12V-074, 12C2(FL-622), HDEP EPA07/EPA10 High Pressure Fuel Line Pump to Rail
Dealer and Owner Notification**

SAFETY RECALL BULLETIN

Subject: **Safety Recall 12C2**
EPA07/10 DD Platform High Pressure Fuel Feed Lines

**18SP685 – EPA07/10 DD15/16 High Pressure
Fuel Feed Lines, Mounting Bracket, Vibration
Dampers and P-clips Service Kit
(P/N: A4720707032)**

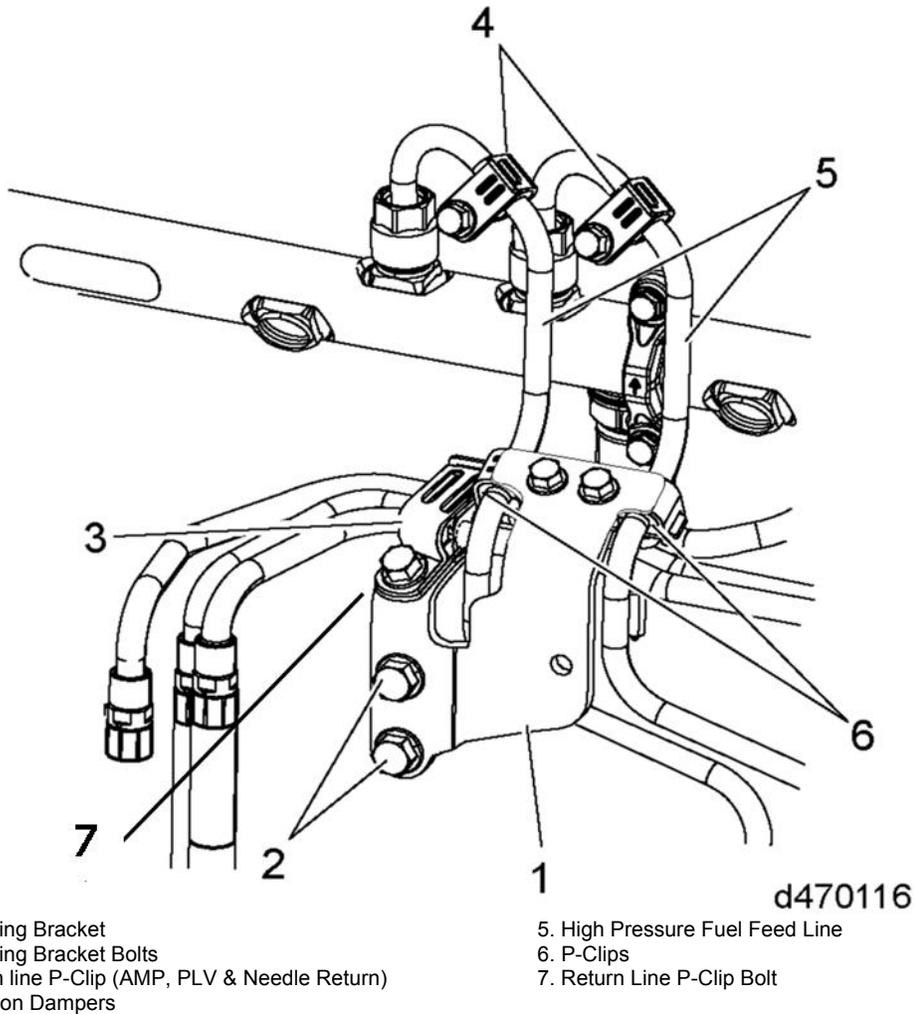
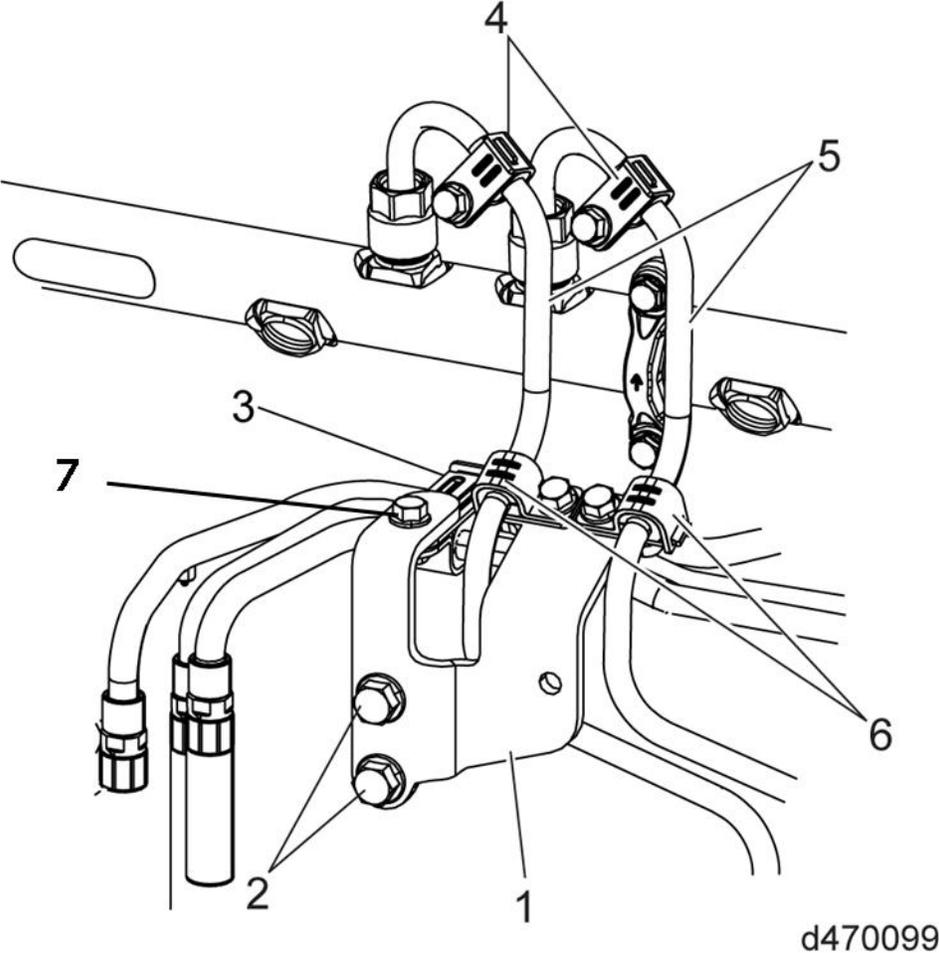
Figure 2 – DD15/16 Engines Before Engine Serial Number 472901S0012796

3. Perform a **VISUAL** inspection to check for missing parts or evidence of fuel leaks. Inspect the High Pressure Fuel Feed Line Mounting Bracket and its attaching bolts, the two P-Clips for the High Pressure Fuel Feed Lines, the two High Pressure Fuel Feed Line Vibration Dampers, and the two High Pressure Fuel Feed Lines. Do not attempt to loosen, tighten or otherwise disturb any of the parts at this time. See Figures 2 and 3.

4. Visual inspection results:
 - a. If the Return Line P-clip bolt (7) is missing, replace with bolt P/N: N910105006023.
 - b. If the Return Line P-clip (3) itself is missing, replace with:

- For DD13, replace with P/N: A4720780341.
 - For DD15/16 engines built before serial number 472901S0012796, replace with P/N: A4720780341.
 - For DD15/16 engines built after serial number 472901S0012796, replace with P/N: A4720780041.

- c. If any of the bolts holding the High Pressure Fuel Feed Line Vibration Dampers (4), High Pressure Fuel Feed Line P-clips (6), or High Pressure Fuel Feed Line Mounting Bracket (2) are missing or damaged, proceed to step 11.

- d. If any part of the High Pressure Fuel Feed Line Vibration Dampers (4) or High Pressure Fuel Feed Line P-clips (6) are missing or damaged, proceed to step 11.
