RECALL CAMPAIGN BULLETIN

NTB13-035

VOLUNTARY SAFETY RECALL CAMPAIGN 2013 PATHFINDER OCS SENSORS

APPLIED VEHICLES: 2013 Pathfinder (R52)

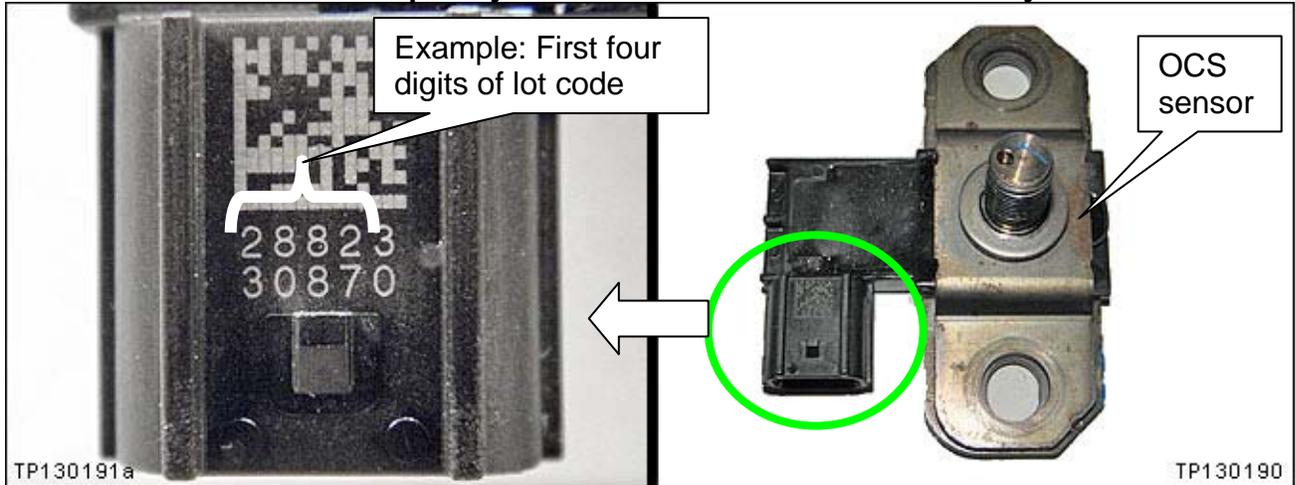
Figure 16

OCS sensor lot code example – your vehicles lot code numbers may be different.

NG: Lot code is in this range - 2472 to 3102; replace the sensor

- If the first four digits of the lot code are 2472 to 3102, replace the sensor.

- If the first four digits of the lot code are not in the range above, reinstall the original sensor.

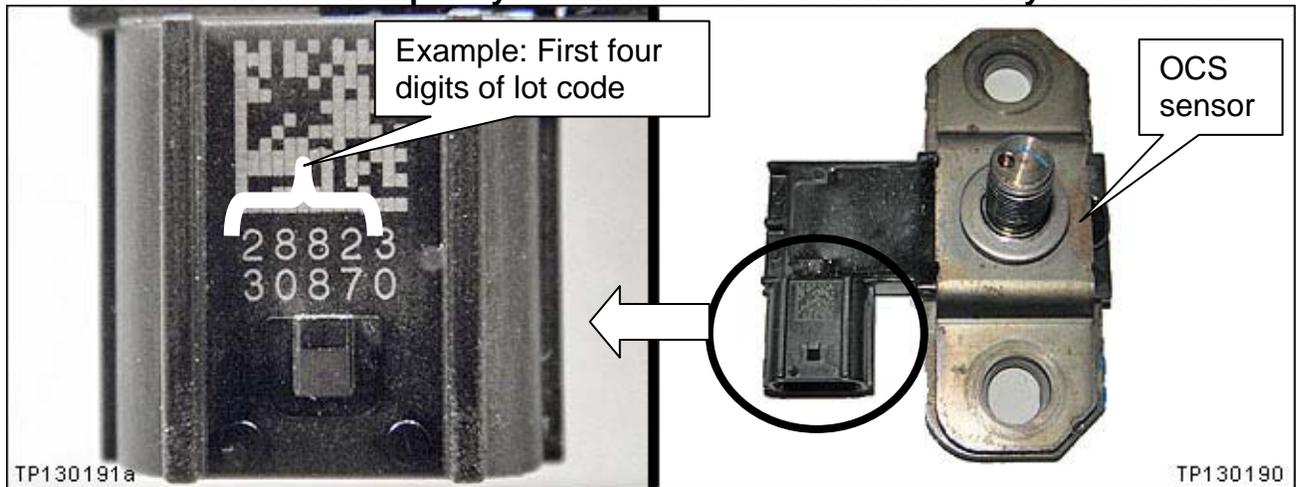
Figure 20

OCS sensor lot code example – your vehicles lot code numbers may be different.

NG: Lot code is in this range - 2472 to 3102; replace the sensor

- If the first four digits of the lot code are 2472 to 3102, replace the sensor.

- If the first four digits of the lot code are not in the range above, reinstall the original sensor.
