SUBJECT: SAFETY RECALL: BELLOWS PIPE ON 2012 - 2013 MCI D SERIES COACHES WITH CUMMINS 2010 ISX ENGINE

Ref.: **NHTSA # 13V-142**
Transport Canada # 2013-121
MCI Service Bulletin 397

Service Bulletin No. 397

<i>MODEL</i> D Series Coaches	<i>TYPE</i> Field Change Program	<i>SECTION/GROUP</i> 8-Engine	<i>DATE</i> April 25, 2013
<i>SUBJECT</i> EXHAUST SYSTEM BELLOWS PIPE			
<i>CONDITIONS</i>

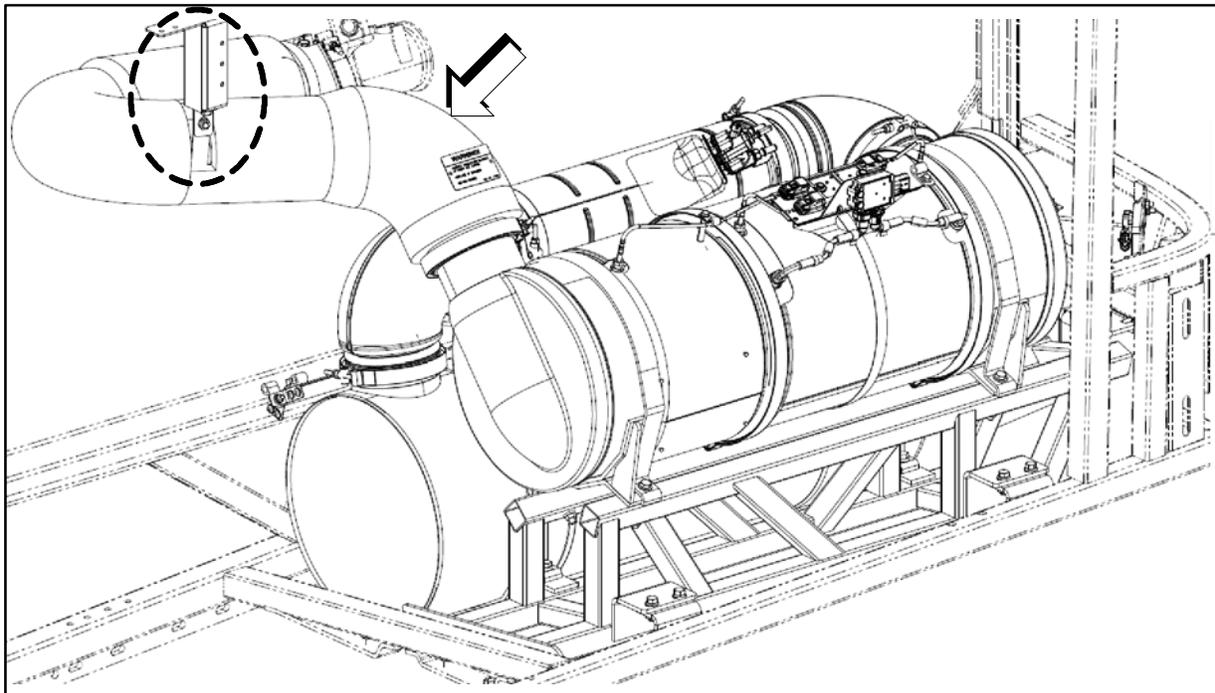
Figure 1.

1. Turn the main battery disconnect switch to the OFF position.
2. Chock both sides of the tires.
3. Open the engine compartment doors and locate the exhaust system bellows pipe (refer to Figure 1).

4. Remove and retain the blanket on the turbo side of the installation, and place the blanket on a workbench.
5. Locate and remove the existing two (2) capscrews and locknuts from the pipe assembly bracket where it attaches to the coach frame (refer to Figure 1). Remove and retain the mounting hardware to be re-installed at a later step in this procedure. Discard the existing pipe assembly bracket.
6. On the turbo and exhaust side of the installation, untighten the clamps from the exhaust pipe.
7. Remove the bellows pipe and place on a workbench.

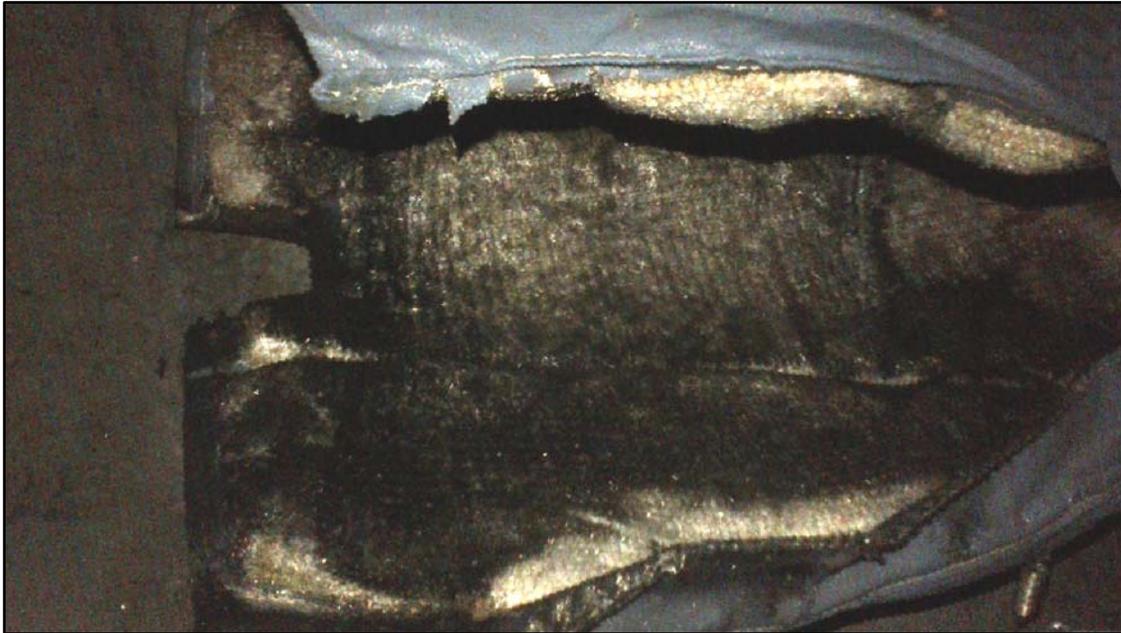
Figure 2.

Replacement of the existing bellows pipe is required if any one (1) of the following three (3) failures is exhibited upon visual inspection: (a photo of the failure is required for claim submittal)

1. the interior jacket of the blanket has evidence of smoke leaks and soot (refer to Figure 2); or

If any one (1) of the above three (3) conditions exists, a new bellows pipe, p/n 08-20-1786, is required to be installed in Step 8. of this procedure.

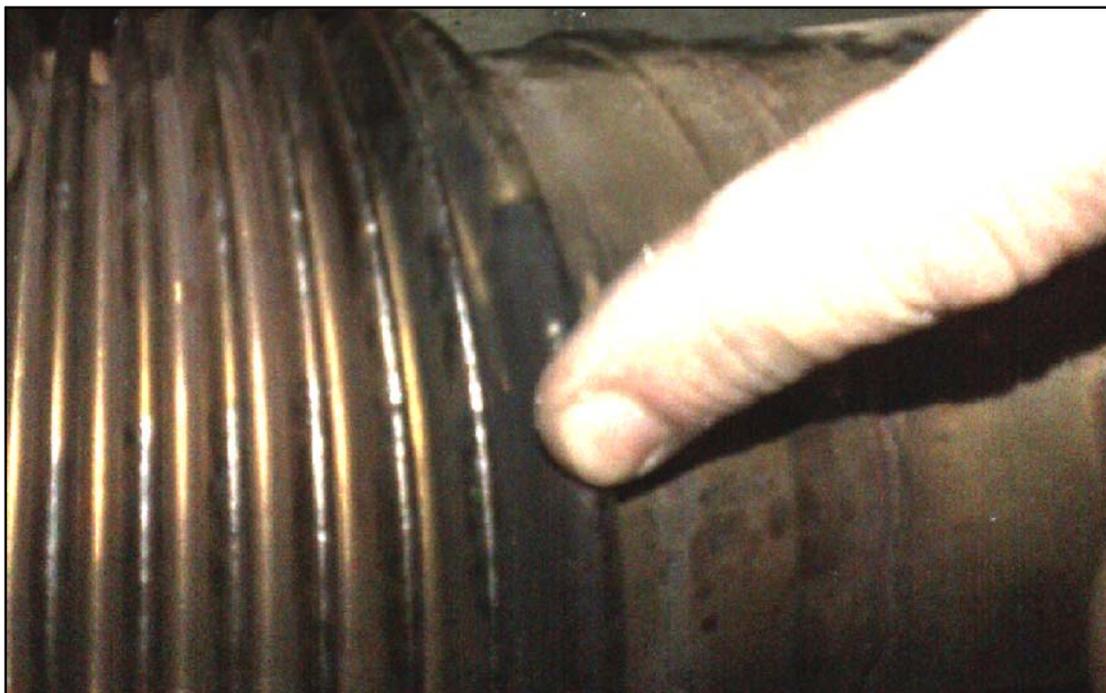
Figure 3.

2. the bellows pipe has a crack or evidence of breakage (refer to Figure 3); or

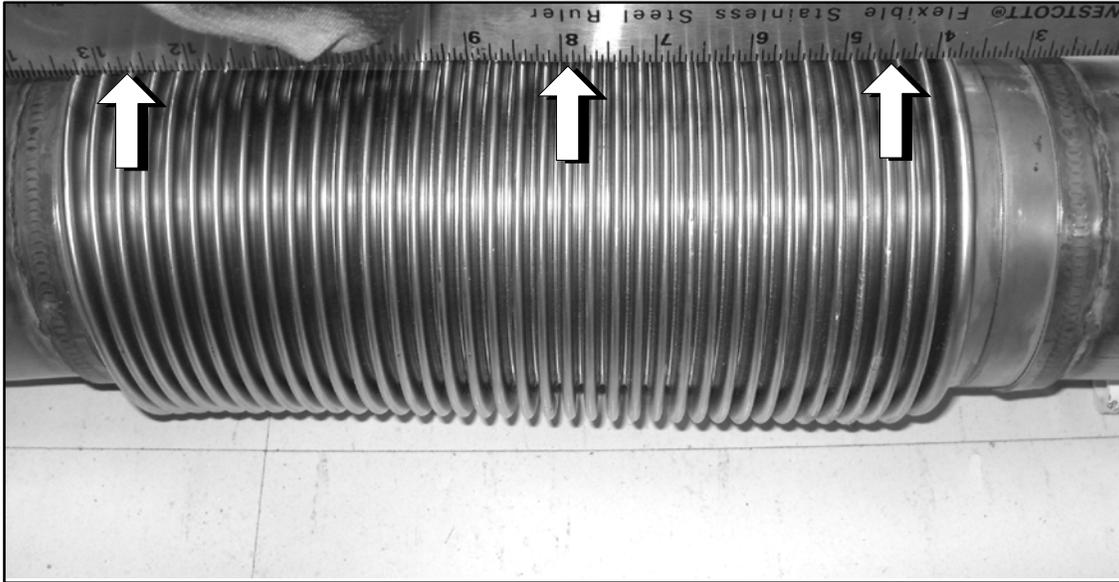
Figure 4.

3. *the bellows pipe has a gap of more than 0.250 inch between a straight edge and the bellows due to permanent deformation, when a straight edge is positioned over the bellows at multiple positions around the circumference (refer to Figure 4).*
