13V-308
(4 pages)

Subject: Noncompliance Information Report (Revision 1)
Navistar Campaign 13512

- Navistar, Inc. on behalf of IC Bus, LLC, a wholly owned subsidiary.

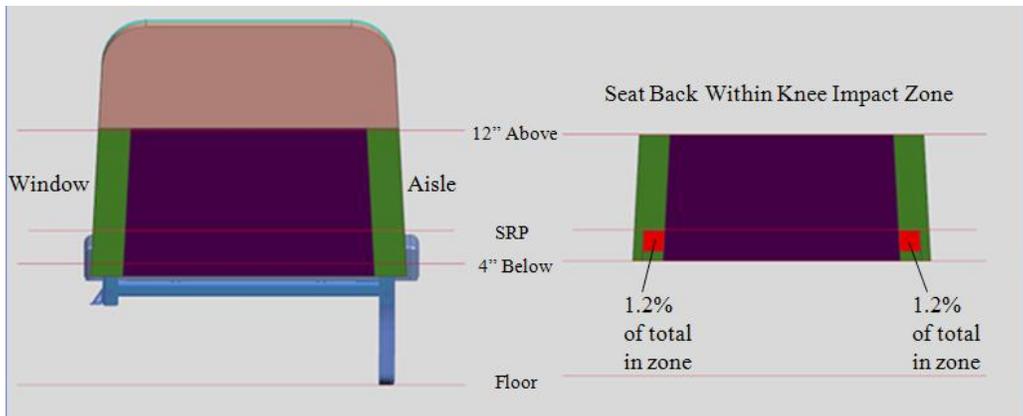
- Certain school bus passenger seats do not meet the full requirements of FMVSS 222 as prescribed in paragraph S5.3.2.2 which states when any point on the rear surface of that part of a seat back or restraining barrier within any zone specified in S5.3.2.1 is impacted from any direction at 4.9 m/s (11MPH) by the knee form specified in S6.7, the resisting force of the impacted material shall not exceed 2,669 N (600 lbs.) and the contact area on the knee form surface shall not be less than 1,935 mm² (3 in²).
- The resisting force of the impacted material did exceed 2,669 N (600 lbs.) in two small areas on the outside lower corner of the knee impact zone). Navistar and third party test results of exemplar seats are shown in the exhibit and table below:

Window Impact Loads (lbs)			Aisle Impact Loads (lbs)		
Navistar	3rd party	MGA	Navistar	3rd party	MGA
644	655	767	543	322	587
652	658	819	567	370	657
771	707	970	573	400	827
813	828	1174	575	450	836

855		1244		576	465	933
876		1326		623	487	968
948				655	505	
957				662	508	
986				680	526	
994				729	532	
1069				788

- 05/28/2013 – IC Bus visits MGA test lab to review test results and compliance testing reports and verify test methods.
- 06/14/2013 – IC Bus initially performs FMVSS 222 knee impact force testing in effort to duplicate the MGA test. The resisting force of the impacted material when tested measured 4759.5 N (1070 LBS) and begins investigation into root cause. It was determined that the foam in the lower corner was not built to print dimensions on the suspect seats.

- 06/18/2013 – Navistar contained the issue by having the supplier change their manufacturing process to build the seat foam to print dimensions.
- 06/24/2013 – Completed testing of several seats at a third party test labs. Of the seats tested, some were below the maximum force requirement and some exceeded the maximum requirement in the lower corners of the knee impact zone, reference chart above.

- 07/02/2013 – Navistar meets to review test results and determines that non-compliance to FMVSS 222, paragraph S5.3.2 exists in certain passenger seats.

- The remedy will involve installation of polystyrene blocks in the lower outside corners of each seat.
