# SERVICE BULLETIN

Number: 13-002

Date: 8/22/2013

## Ford 5.4L / 6.8L Mount Kit Safety Recall

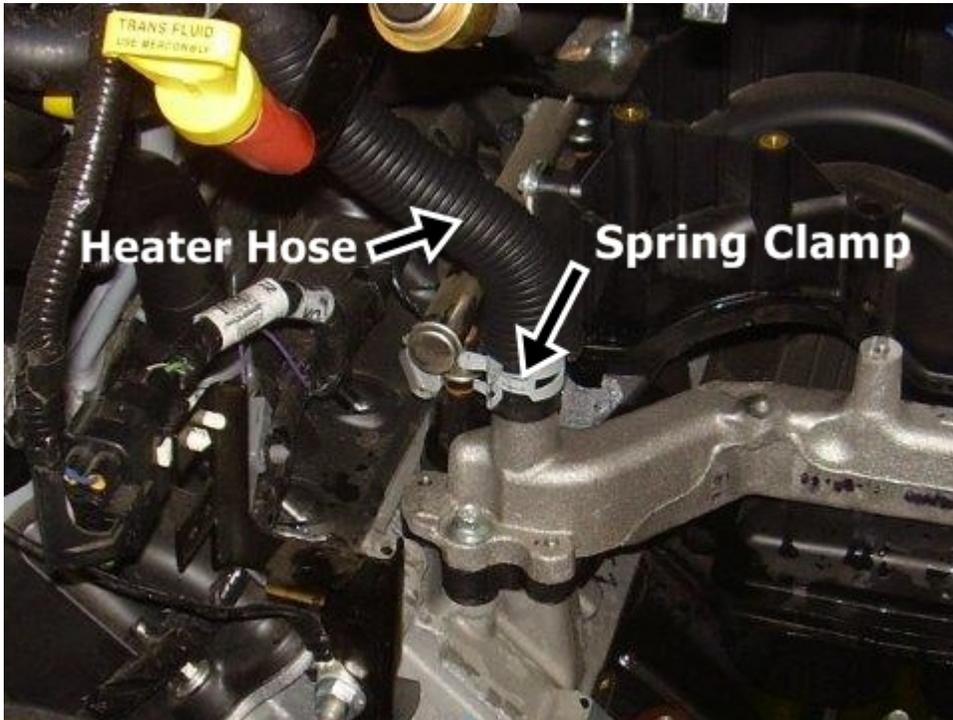
If the tab from the heater hose spring clamp is not oriented properly, (toward the rear of the engine) it could possibly pinch the alternator cable against the compressor mount plate.

**View from front of engine with the tangs improperly located to the front of the engine (without mount, compressor, or alternator)**

If the harness is pinched, move harness to a location that is clear of spring clamp and rotate the tangs of the clamp to the rear of the engine (See pictures below)

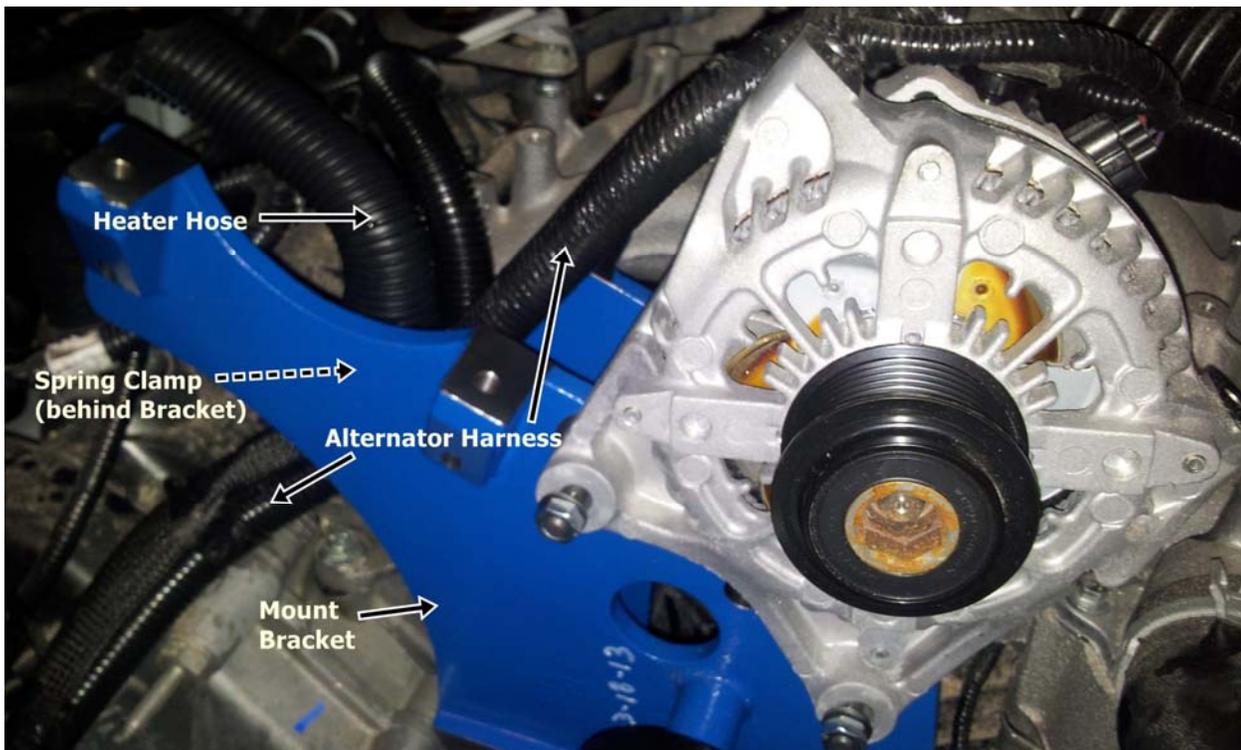
**View from front of engine (without compressor)**

1. Reach behind the compressor and move the alternator cable up and down
2. If it moves without binding and you have verified that spring clamp tangs are oriented properly, to the rear of the engine, the vehicle is OK.

3. If the harness does not move, feel to see which way the spring clamp tangs are oriented. If the tangs are oriented properly, vehicle is OK.
4. Submit warranty claim to Trans/Air Mfg. for this inspection using MK-10-A flat rate code.

5. If the harness does not move, and if the tangs are not oriented properly, follow instructions below:
  - a) Remove compressor belt
  - b) Loosen the compressor from the mount bracket

- c) Lay the compressor to the left side of the bracket
  - d) Loosen the mount bracket enough to free the harness
  - e) Rotate the spring clamp on the heater hose, until the tangs are facing the rear of the bus

- f) Inspect harness for damage and repair if necessary
  - g) Contact Trans/Air Warranty for authorization if repair is necessary
  - h) Tighten the mount bracket

- i) Re-check to make sure the harness is not binding or pinched
  - j) Mount the compressor back into the bracket
  - k) Re-install belt
  - l) Submit warranty claim to Trans/Air Mfg. for this inspection using MK-45-A flat rate code
