Spartan Motors Chassis, Inc.

SERVICE BULLETIN

RSB13-250-005

SUBJECT: Loose steering linkage fasteners.

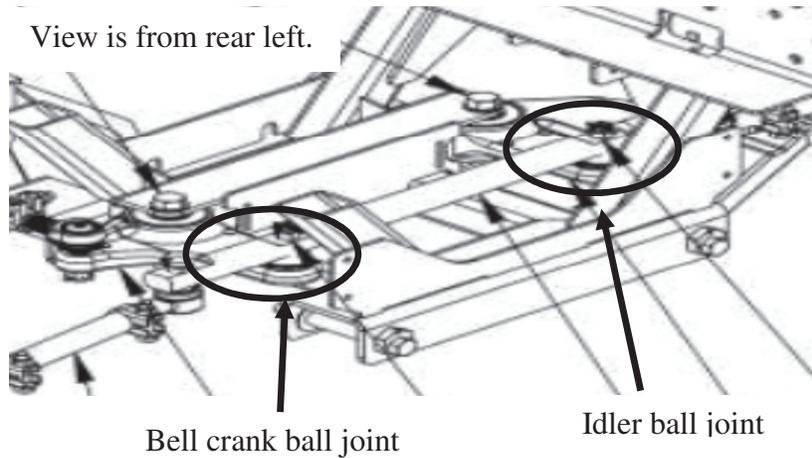
FIG. 2-1

1. Follow normal maintenance and safety procedures to gain access to the bell crank and idler. Refer to FIG. 2-1.

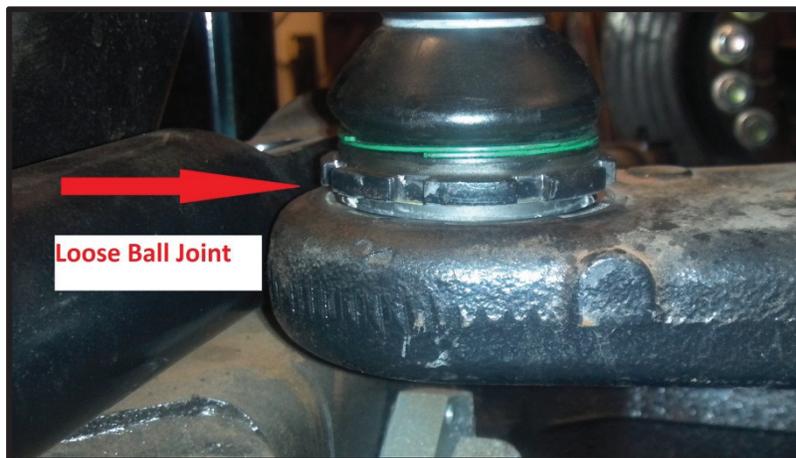
2. Visually inspect the ball joint located in both the bell crank (driver's side) and idler arm (passenger side). The ball joint shall be fully engaged with the notched flange in contact with the surface of the bell crank of the idler arm. If it is not, please proceed to the repair procedure. Refer to FIG. 2-2 and 3-1.
