Reference: NHTSA Identification Number 13V-528

December 2013

Safety Recall N62 / NHTSA 13V-528 Left Outer Tie Rod Assembly

A Mopar service parts steering linkage may have been installed on some of the 705,000 of the above vehicles during a prior service appointment. The left tie rod ball stud on the Mopar service parts steering linkage may fracture under certain driving conditions. This could cause a loss of directional control and/or a crash without warning.

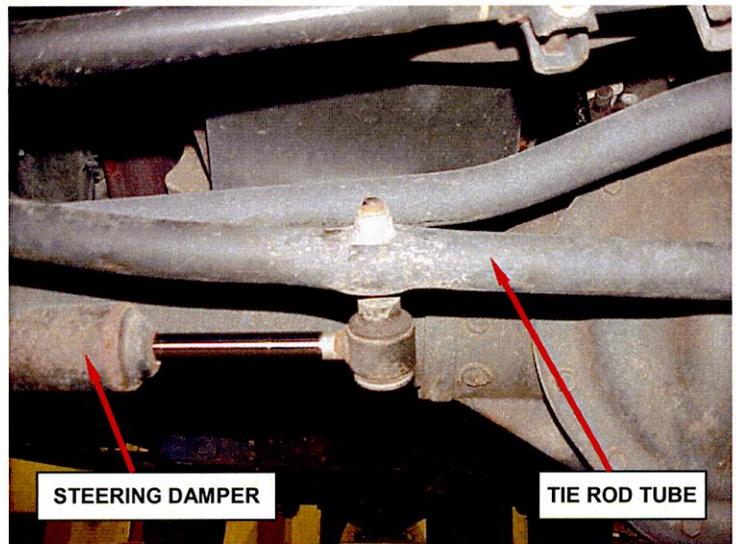
Figure 1 – Steering Linkage

- If the steering damper mounts to the tie rod tube as shown in Figure 1, the steering linkage does not require replacement. Return the vehicle to the customer.

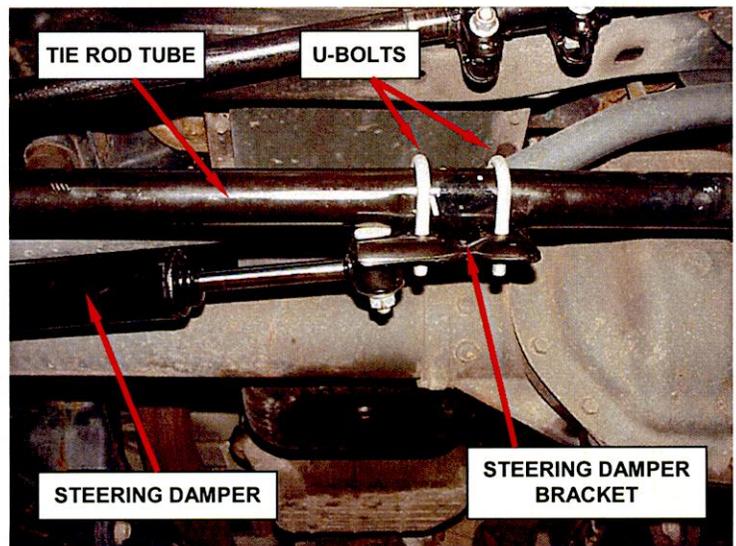
Figure 2 – Steering Linkage

- If the steering damper mounts to the tie rod tube as shown in Figure 2, the steering linkage must be replaced. Continue with **Section B. Replace Steering Linkage.**

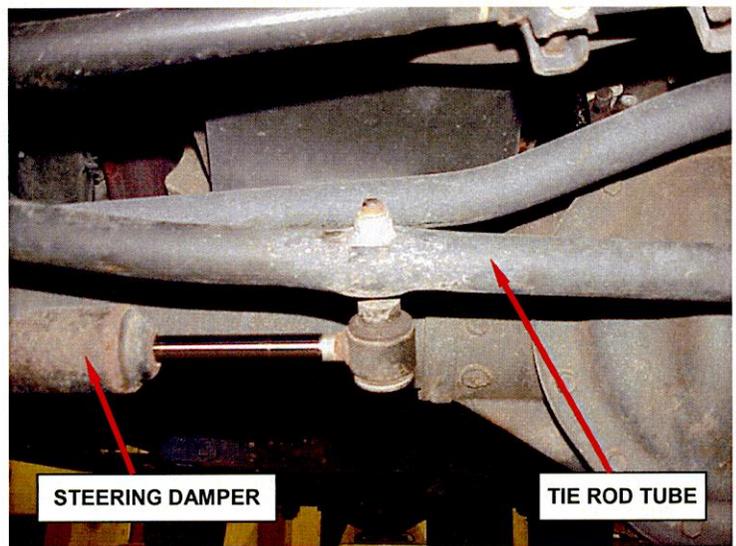
Figure 1 – Steering Linkage

1. Look under the front of the vehicle and inspect the steering linkage at the steering damper mounting point:
 - If the steering damper mounts to the tie rod tube as shown in Figure 1, the steering linkage does not require replacement. Return the vehicle to the customer.

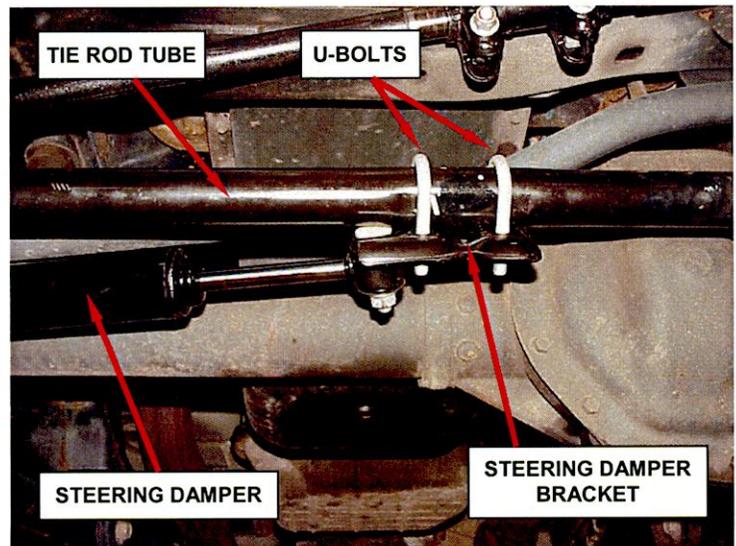
Figure 2 – Steering Linkage

- If the steering damper mounts to the tie rod tube as shown in Figure 2, the steering linkage must be replaced. Continue with **Section B. Replace Steering Linkage.**
