Safety Recall 12E-017 – ProLo Hatch

Description of Non-compliance

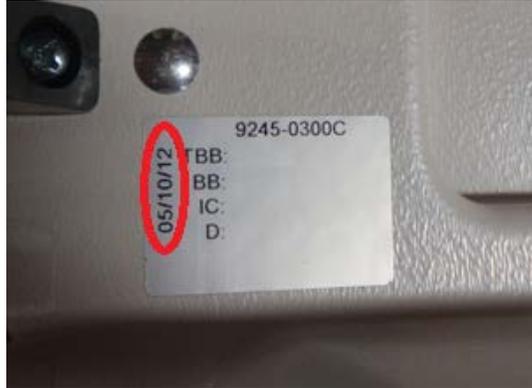
1. Check the label just to the right of the handle on the hatch lid for the build date to determine if the hatch was manufactured during the period from April 1, 2011 through March 25, 2012. Units built within this date range are subject to the campaign.

2. Replace the suspect components as described below in the Remedy Program.

Replacing the 008956 Nylon Receiver on the ProLo hatch using the **009493 ProLo Repair Service Kit** will resolve the noncompliance. This kit includes (1) 008956 Nylon Receiver, (2) anti-rattle springs, (4) Phillips head screws and detailed work instructions (enclosed).
