**RE: Defect Information Report – Supplemental Report No. 4  
12V-242, FL-628, Bosch Hydraulic Brake Calipers  
Dealer Notice and Important Campaign Letter**

## Subject: Bosch Hydraulic Brake Calipers

**Models Affected: Specific Freightliner Custom Chassis motor-home chassis manufactured March 28, 2005, through July 19, 2011, with certain Bosch hydraulic brake calipers.**

November 2012  
FL628AB  
NHTSA #12V-242

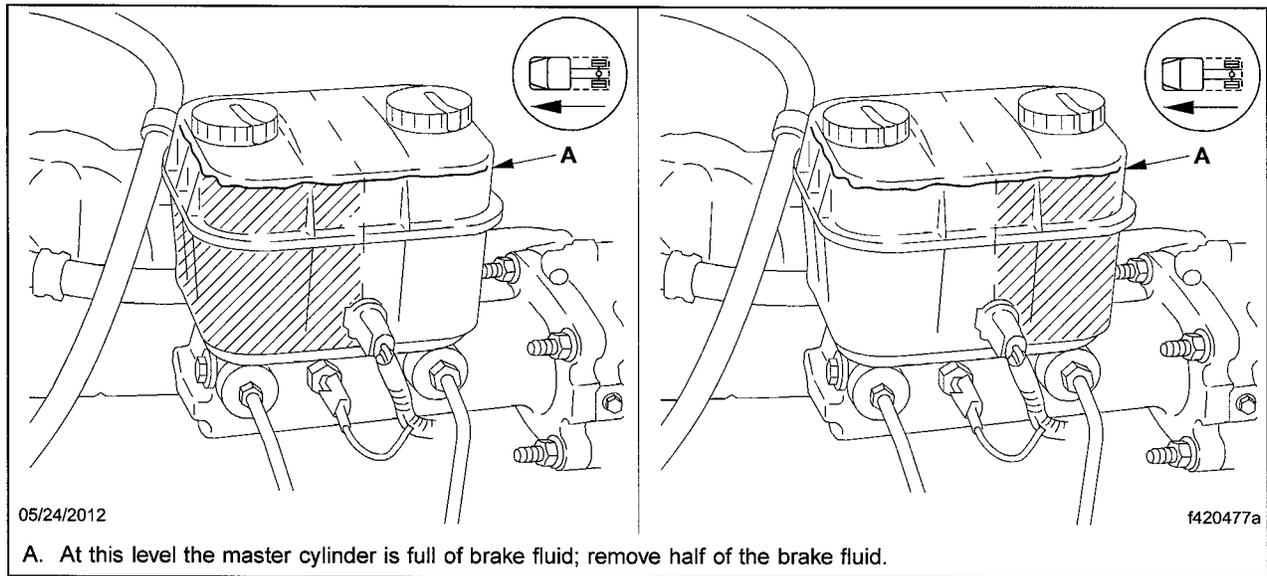
Fig. 2, Master Cylinder Reservoir

1. Open the engine access panel.
2. If removing the rear wheel caliper(s), remove half the fluid from the rear section of the master cylinder reservoir. See Fig. 2. If removing the front wheel caliper(s), remove half the fluid from the front section. Removing the fluid from the reservoir keeps the reservoir from overflowing when retracting pistons into the caliper.

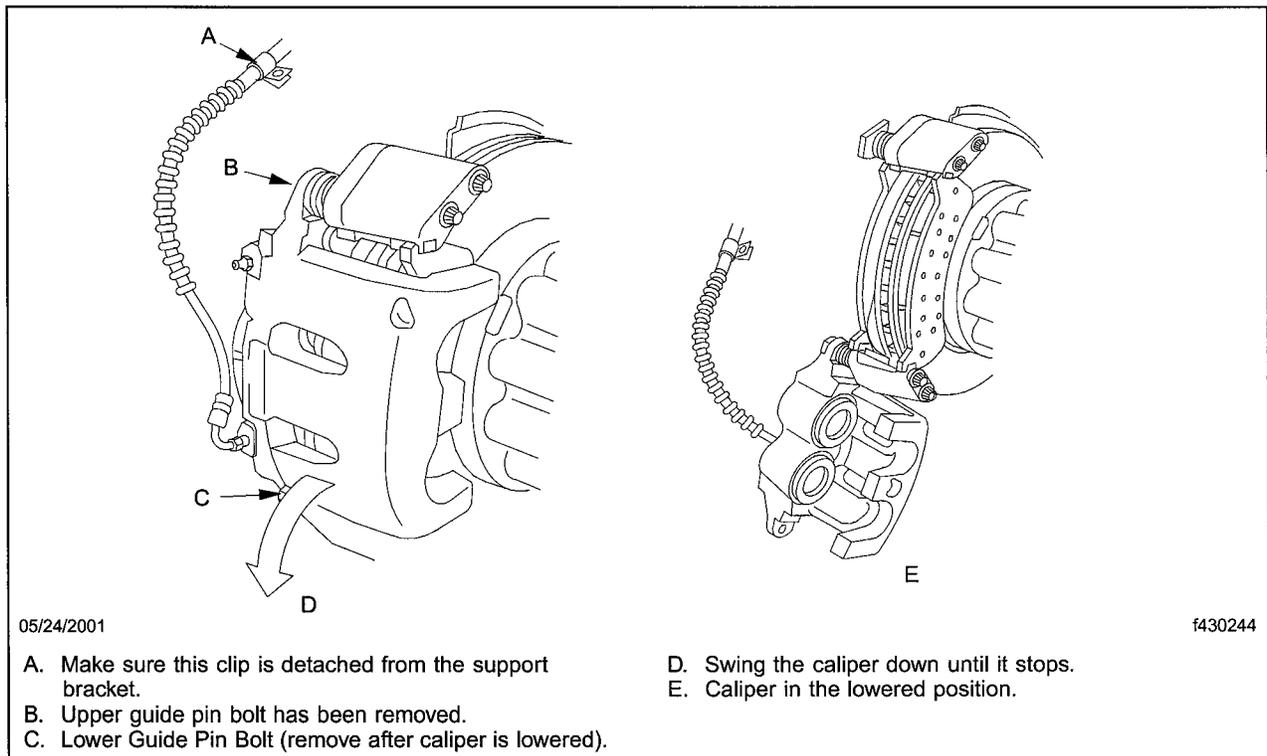
**Fig. 4, Swinging the Caliper Down (Open)**

7. Swing the caliper assembly away from the rotor by carefully rotating the caliper on the lower guide pin and bolt. See **Fig. 4**. Do not allow the brake line hose to become pinched or kinked.
8. Disconnect the brake fluid line from the caliper. See **Fig. 5**.
9. Remove the lower guide pin bolt and remove the caliper from the anchor plate.

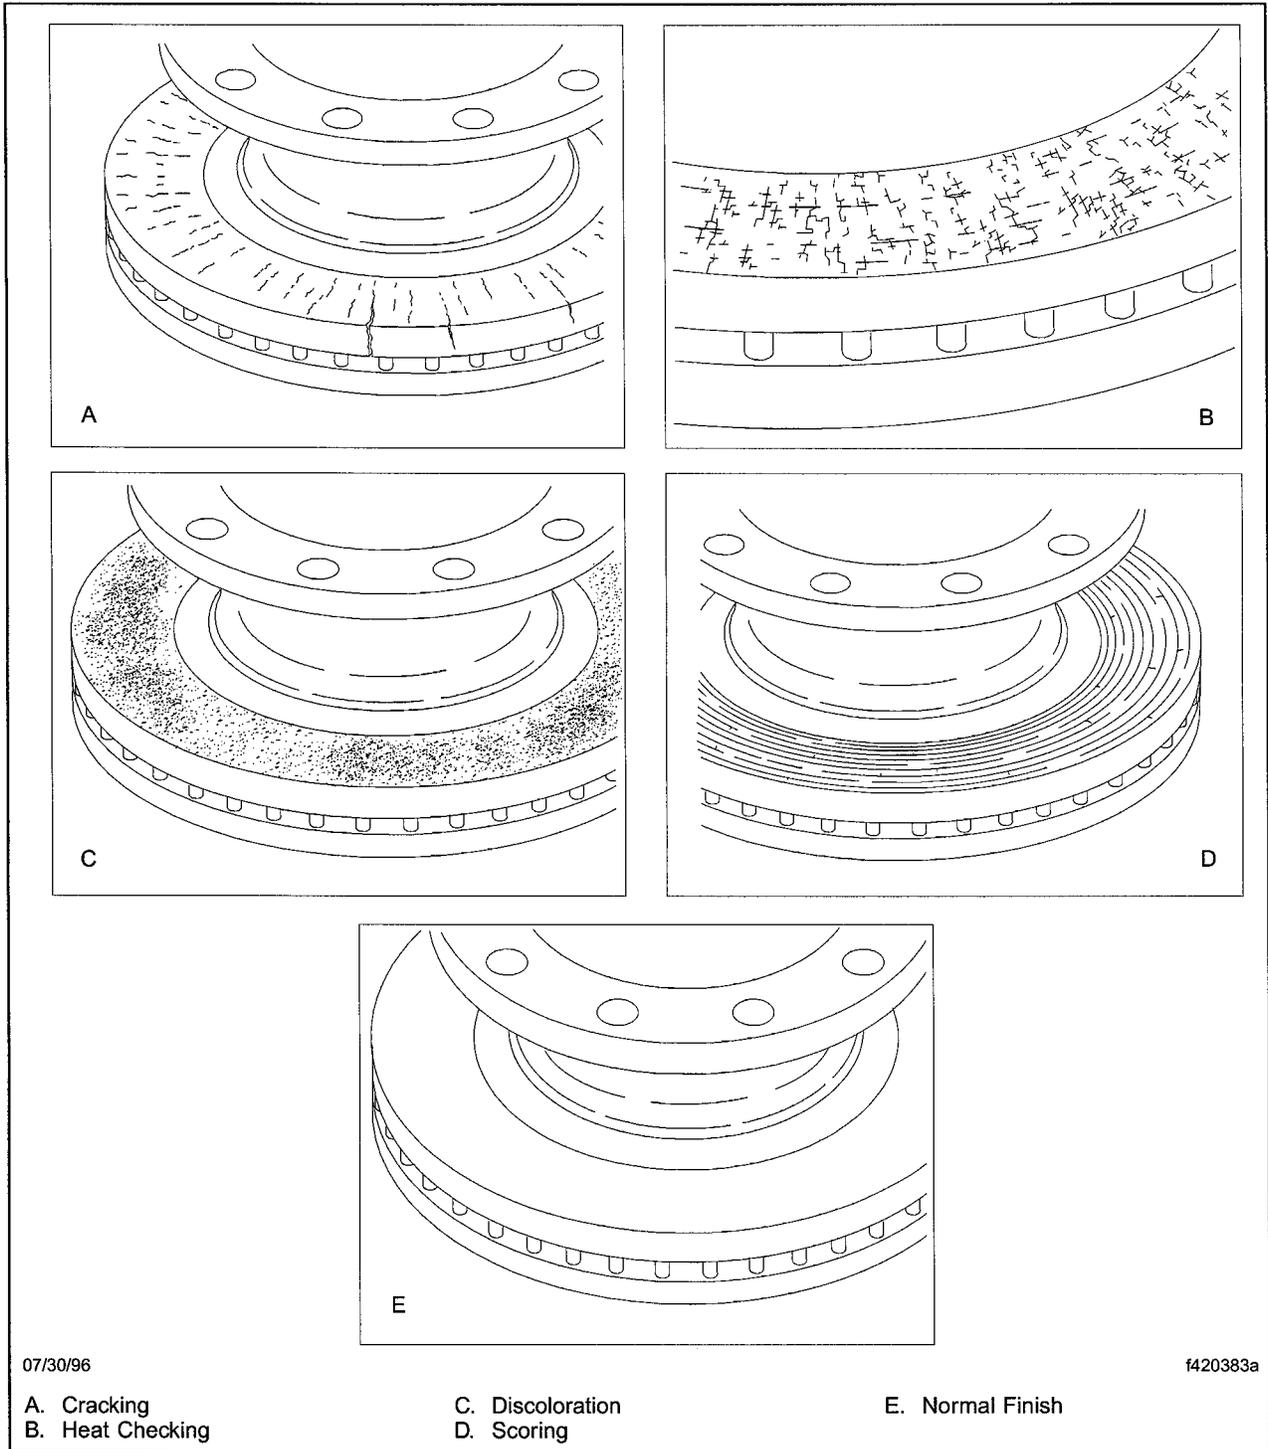
Fig. 6, Rotor Surface Check

15. Inspect the rotor for scoring, warping, large radial cracks, bluing, heat spots, or other damage. See Fig. 6. If any damage is found, replace the rotor per Table 5 - Rotor Surface Check. Heat checking, and other damage without without signs of excessive heat, is not a replaceable condition.

Item from Figure 6	Description of Rotor Issue	Action	Responsibility
Item A	Large radial crack(s) through the outer surface	Replace	With signs of heat significant damage - Recall Without signs of significant heat damage - Customer
Item B	Small radial crack(s)	Do not replace	If replaced - Customer
Item C	Minor discoloration and some transfer of material	Do not replace	If replaced - Customer
Item D	Heavy discoloration and heavy transfer of material	Replace	Recall
Item E	Normal	Do not replace	If replaced - Customer

<b>Item from Figure 6 (page 14)</b>	<b>Description of Rotor Issue</b>	<b>Action</b>	<b>Responsibility</b>
Item A	Large radial crack(s) through the outer surface	Replace	With signs of significant heat damage - Recall Without signs of significant heat damage - Customer
Item B	Small radial crack(s)	Do not replace	If replaced - Customer
Item C	Minor discoloration and some transfer of material	Do not replace	If replaced - Customer
Item D	Heavy discoloration and heavy transfer of material	Replace	Recall
Item E	Normal	Do not replace	If replaced - Customer

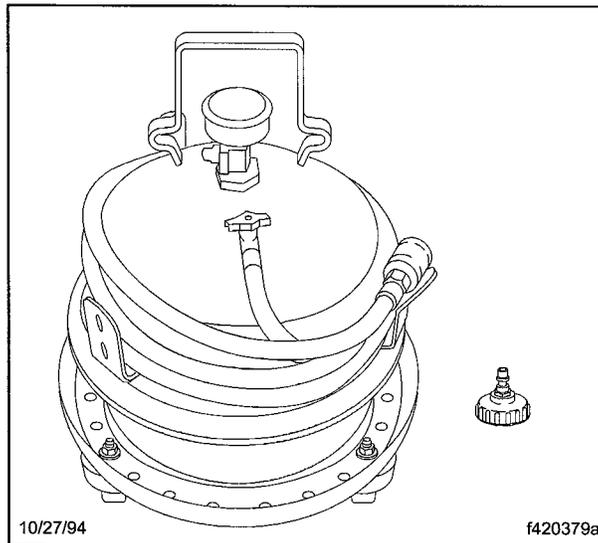
**Fig. 14, Pressure Bleeder Kit**

Pressure bleeding is the preferred method for bleeding the service brake system. It requires the use of a special pressure bleeder kit, consisting of a tank, pressure pump and valve, gauge, tubing, and adaptor. These are available from a number of manufacturers, and include instructions for use. See **Fig. 14**.

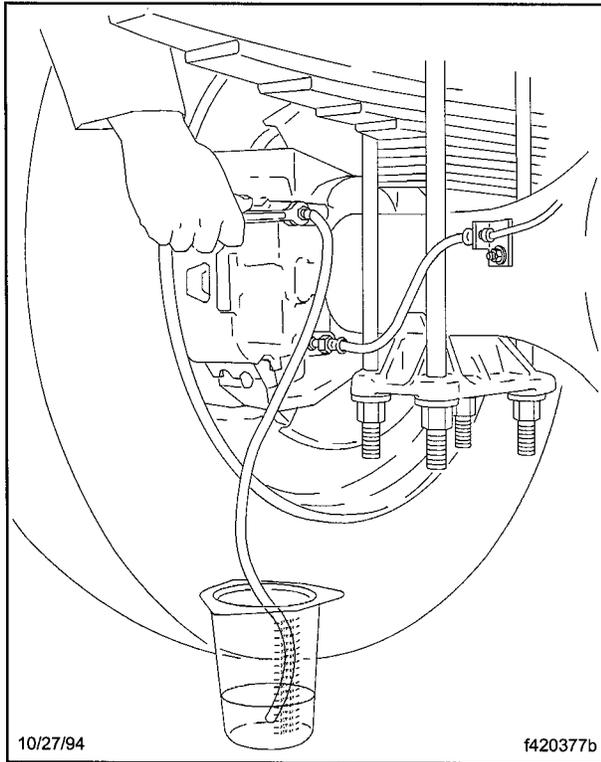
**Fig. 15, Bleeding the Connections at the Rear Wheel Calipers**

- 2.2 Loosen the bleeder fitting about 3/4 turn, and let the brake fluid flow out of the fitting until it is free of air bubbles. See **Fig. 15** and **Fig. 16**. Then tighten the fitting firmly.

- 4.2 Loosen the bleeder fitting about 3/4 turn, and let the brake fluid flow out of the fitting until it is free of air bubbles. See **Fig. 15** and **Fig. 16**. Then tighten the fitting firmly.

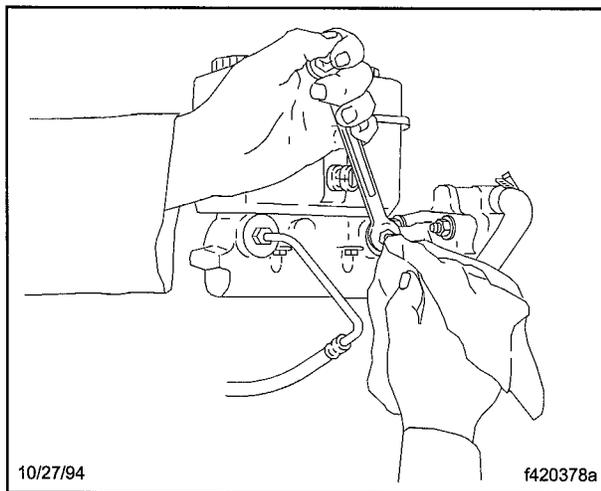
**Fig. 17, Loosening the Fitting at the Rear Outlet Port**

1. Bleed the master cylinder.
  - 1.1 Using a wrench and a rag to absorb leaking brake fluid, loosen the fitting at the rear outlet port on the master cylinder. See **Fig. 17**. Loosen the fitting about one full turn.
  - 1.2 Have someone push the brake pedal down slowly by hand, to the floor of the vehicle. Brake fluid, and any air in the master cylinder will exit from the fitting.
  - 1.3 *With the brake pedal held down*, tighten the rear hydraulic line fitting firmly.

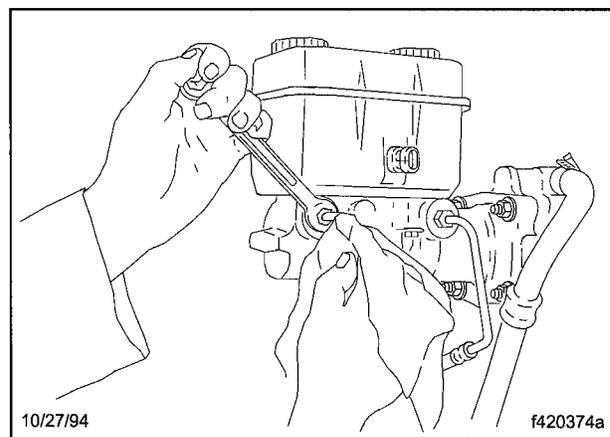
**Fig. 18, Loosening the Fitting at the Front Outlet Port**

- 1.6 Check the brake fluid level in the rear compartment of the reservoir, then add new DOT 3 approved brake fluid if needed.
- 1.7 Using a wrench and a rag to absorb leaking brake fluid, loosen the fitting at the front outlet port on the master cylinder. See **Fig. 18**. Loosen the fitting about one full turn.
- 1.8 Repeat the steps as required for the front outlet port.
- 1.9 Check the brake fluid level in the front compartment of the reservoir. Add new DOT 3 approved brake fluid if needed.
