SAFETY RECALL NOTICE

VOLUNTARY SAFETY RECALL CAMPAIGN #12E-041

Date: November 5, 2012
Subject: TK486 Engines - Fuel Delivery Guides - Safety Recall Campaign #12E-041
Bulletin Location: TSA Info Central\Bulletins\Campaign Bulletins **CB570**

Delivery Valve Replacement on Field Units

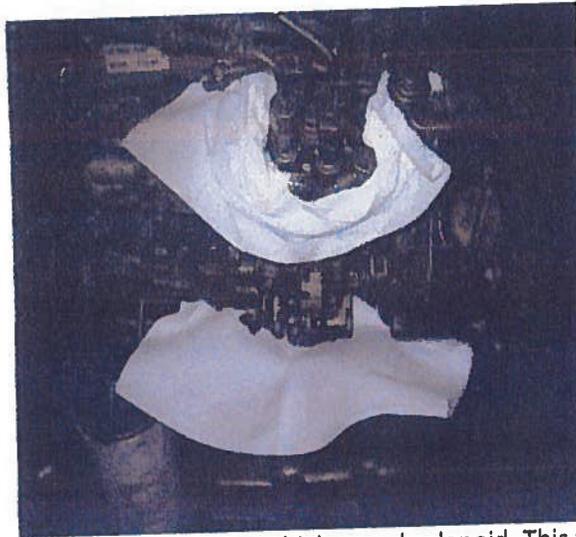
Step 2: Place rags on injection pump to catch any dripping fuel during disassembly

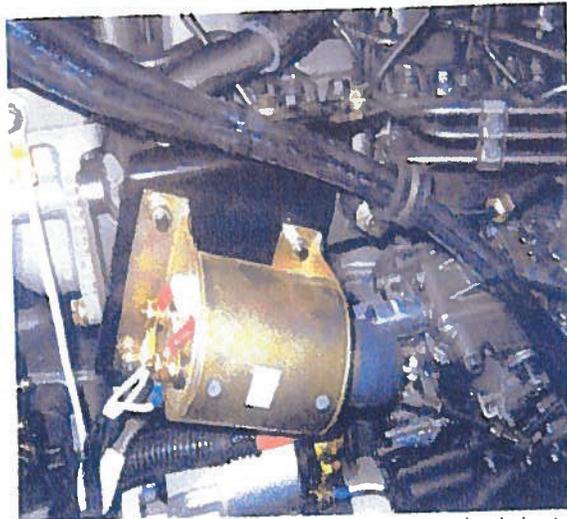
Step 3: Remove top three bolts and loosen bottom mount bolt on high speed solenoid. This will allow enough room to remove the high pressure injection lines.

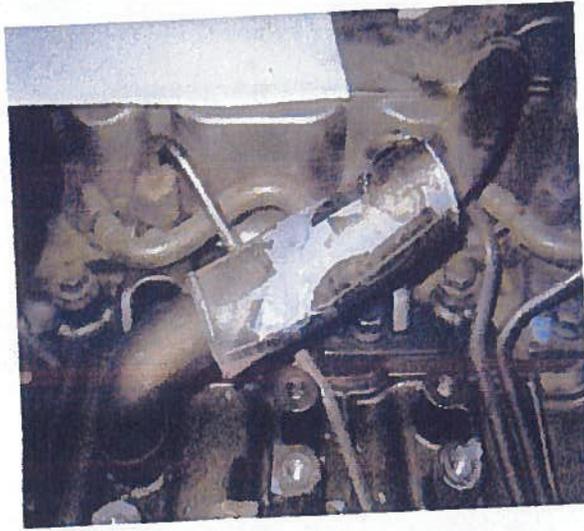
Step 4: Remove the breather pipe from the valve cover. Bend it out of the way so the injector lines can be accessed for removal.

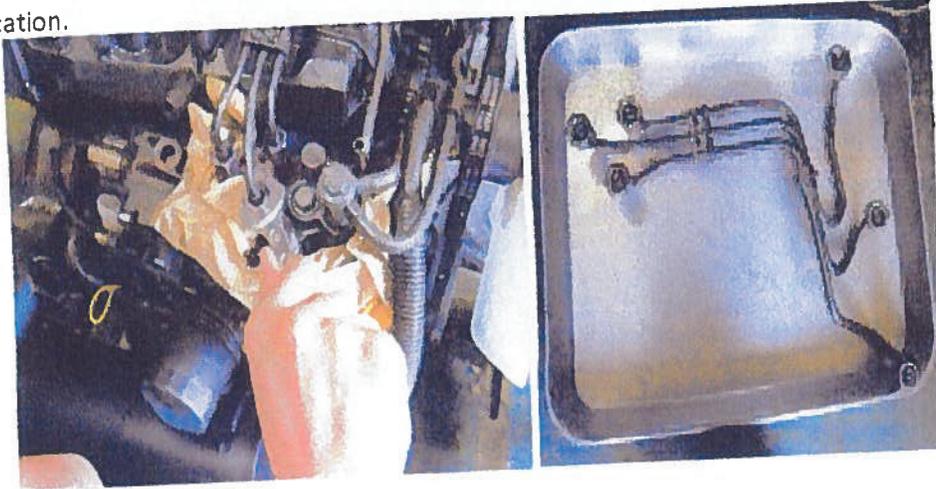
step 5: Remove the high pressure injection lines. Loosen the 17mm nuts at injection pump and at nozzle. Place the injection line assembly in a safe, clean location.

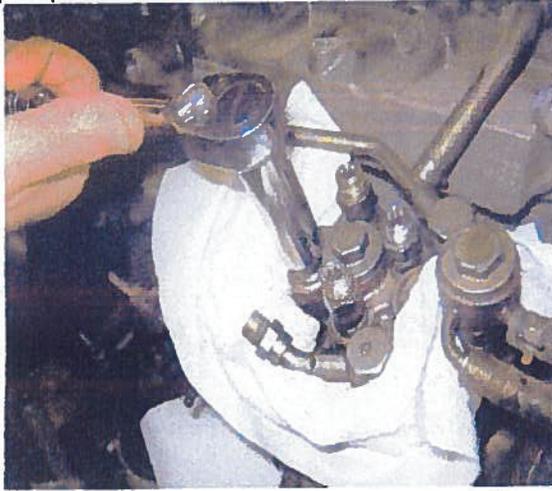
Step 1: Use a 14mm deep well socket to loosen delivery valve holder. Loosen holders 2 turns each then carefully clean up any paint chips/debris from top of injection pump

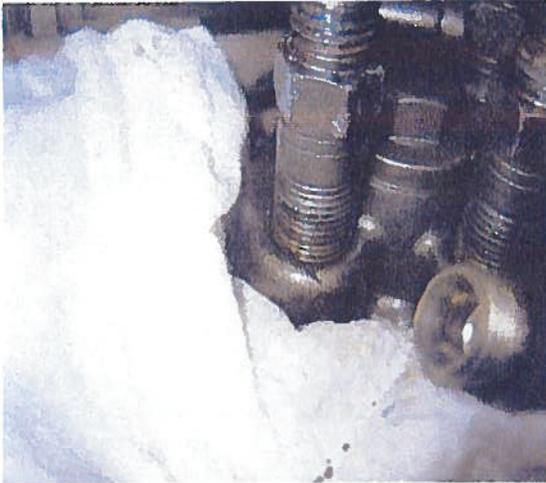
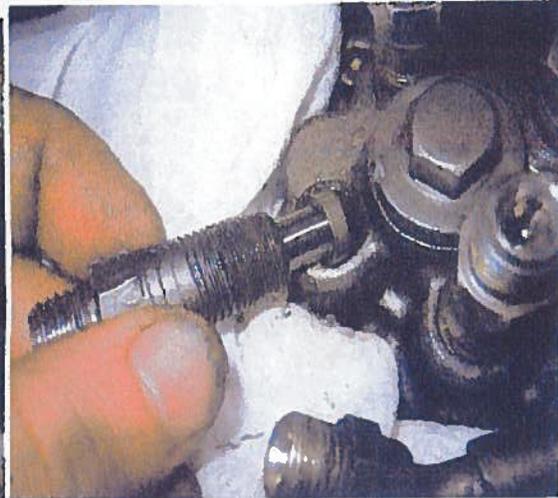
Step 2: Loosen delivery valve holder with fingers one by one. Remove holder by tilting a little so the delivery valve assembly stays in holder when removed.

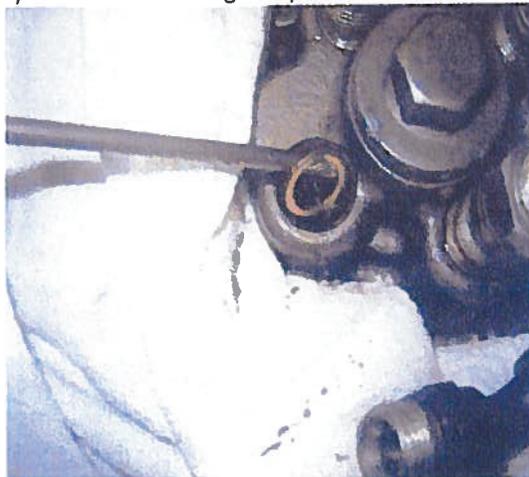
Step 3: Remove copper sealing washer from hydraulic head using 90° pick.

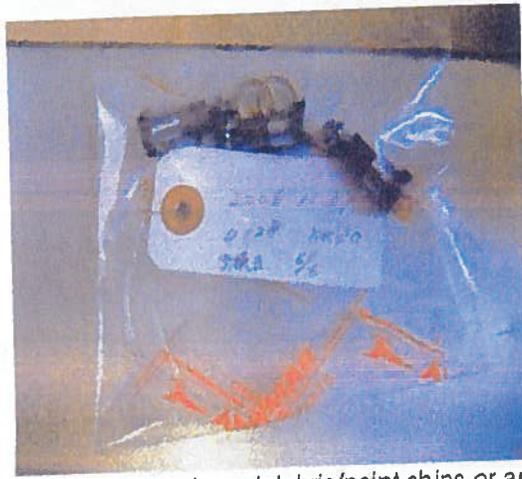
Step 4: Remove old delivery valve assembly from delivery valve holder and place in bag with copper sealing washer. Please provide pump number, engine serial number, and replacement date, inside of bag with used parts. Return removed parts to Thermo King Warranty. Top spring will be re-used with new delivery valves.

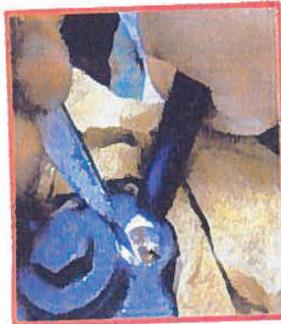
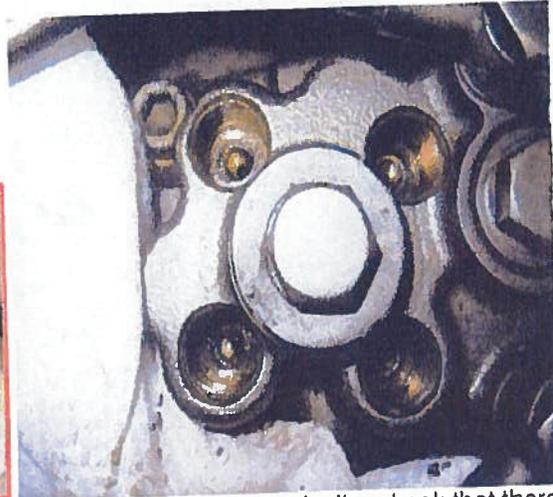
Step 5: Visually inspect delivery valve mounting hole. If there is and debris/paint chips or any kind of foreign material carefully remove. A pair of tweezers may work the best.

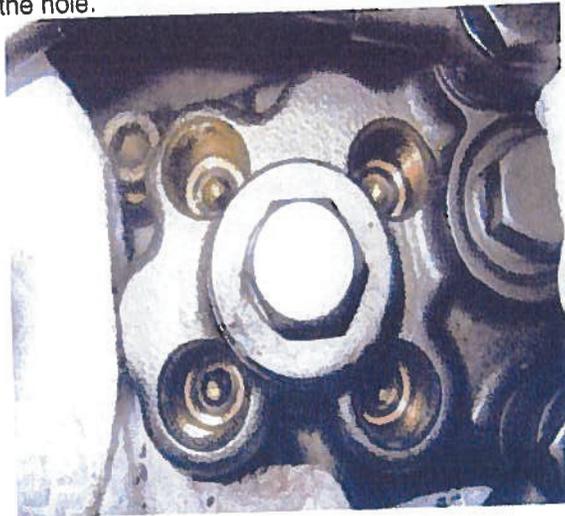
Step 6: Install 1 new copper sealing washer in each hole. After installing washers double check that there is 1 washer per hole and that they are laying flat in the bottom of the hole.

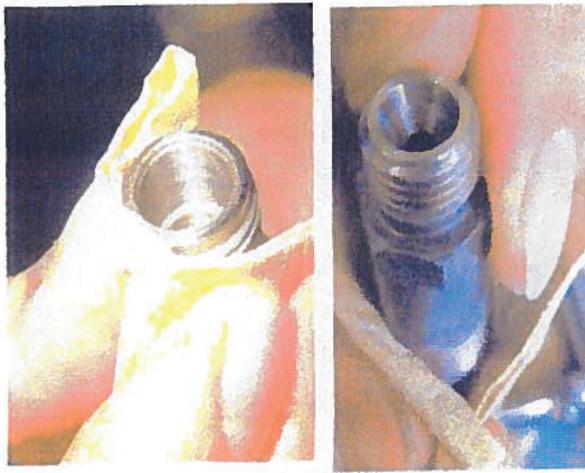
Step 7: Carefully clean and inspect the delivery valve holder. Note: if the delivery valve guide was cracked there is a chance that the delivery valve holder is damaged. Inspect end (2) for scratches/nicks. If damage is found replace holder.

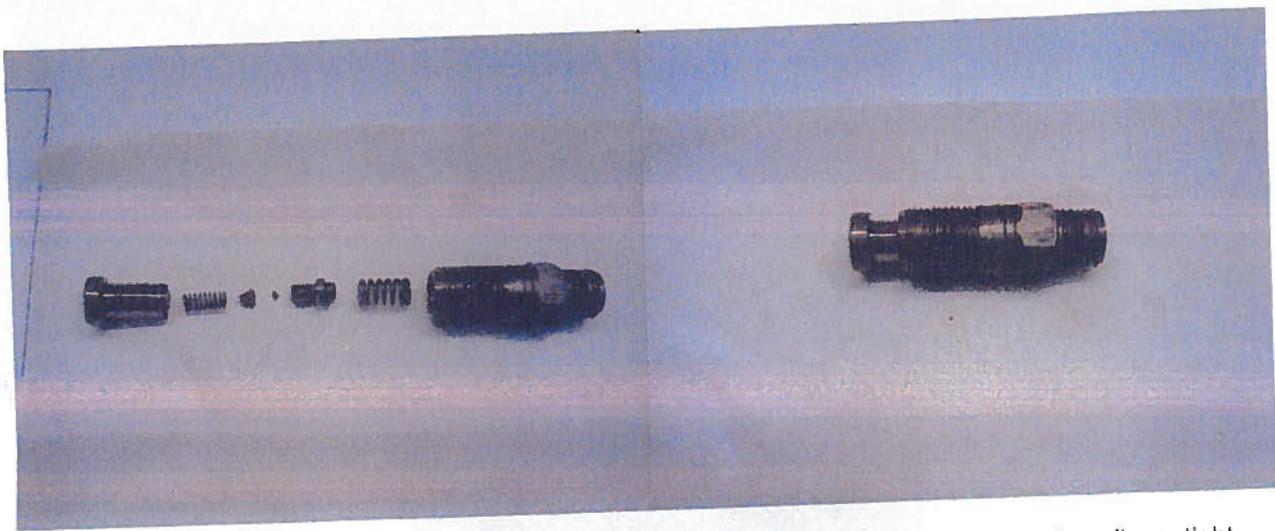
Step 8: Open cap of capsule gently and remove the delivery valve assembly. Insure it is assembled as in the picture below. **Be very careful when handling the delivery valve. The parts that fit inside of the delivery valve guide are very small.** Insert the new delivery valve assembly into the holder.

*Note: If you do not feel spring action on the delivery valve guide it has been assembled incorrectly

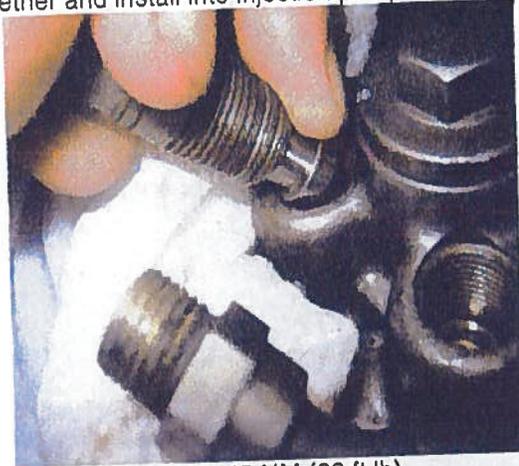
Step 9: Hold delivery valve and holder together and install into injection pump. Install all 4 delivery valves finger tight.

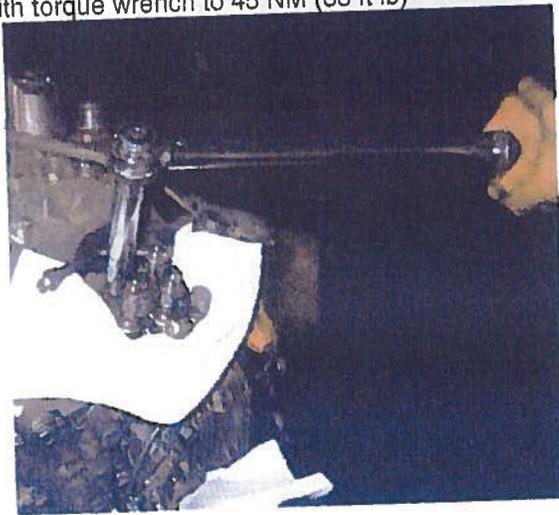
Step 10: Tighten delivery valve holder with torque wrench to 45 NM (33 ft lb)

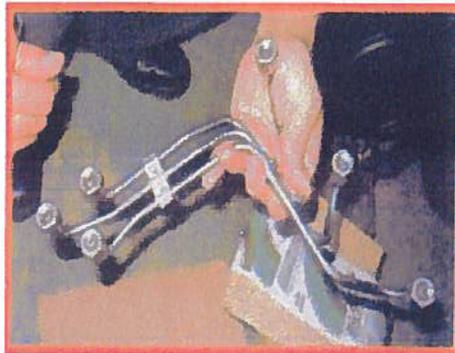
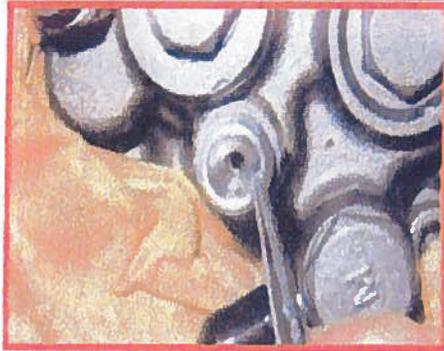
Step 1: Check mating surfaces of high pressure pipe, delivery valve holder, and injectors. Make sure these surfaces are clean so the high pressure lines will seal when tightened.

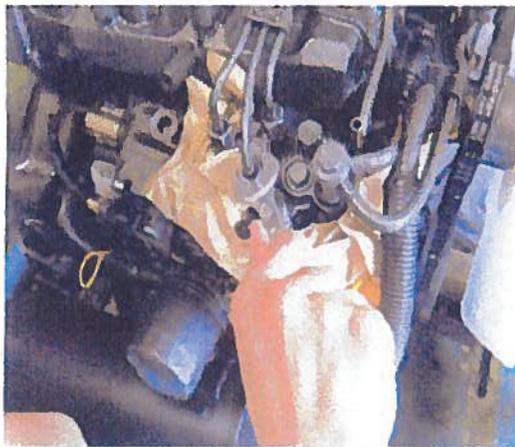
Step 2: Tighten both ends of high pressure injector lines finger tight to ensure they are not cross threaded. Torque injector lines to 29 to 34 NM (22 to 25 ft lbs)

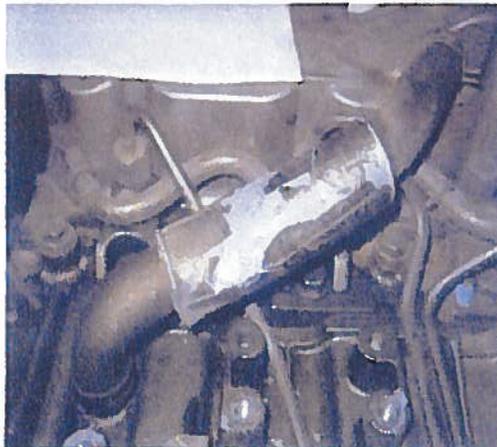
Step 3: Re-install the breather pipe to the to the valve cover

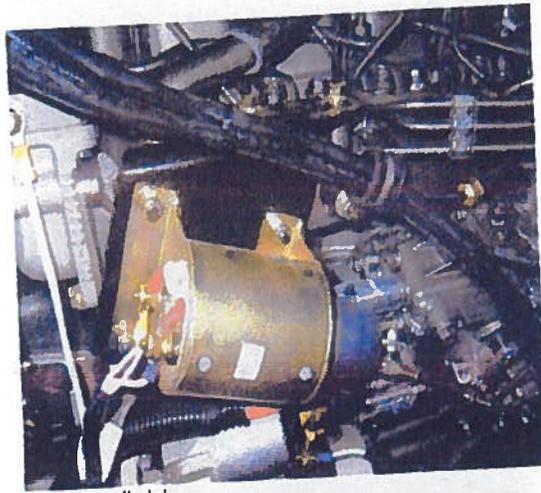
Step 4: Re-Install and tighten the high speed solenoid mounting bolts.

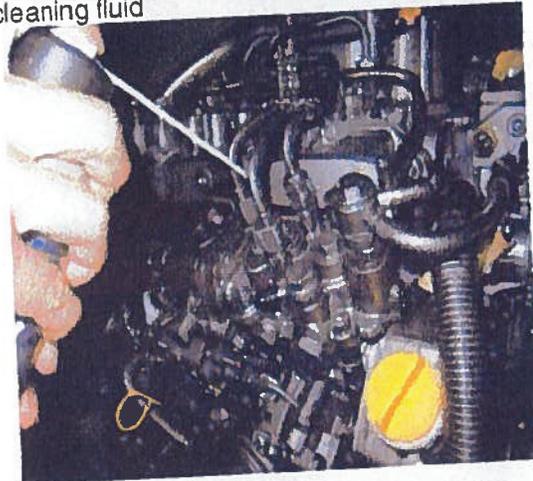
Step 5: Degrease pump and engine with cleaning fluid

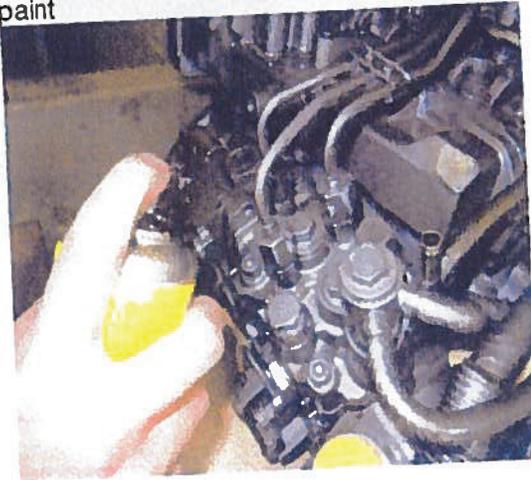
Step 6: re-paint surfaces that are missing paint

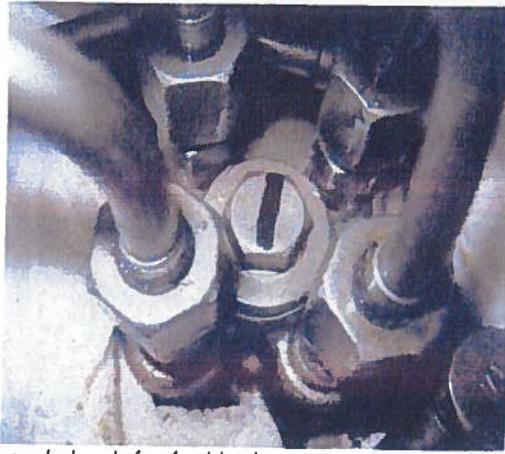
Step 7: Use a marker to put a line on the top of the distribution shaft plug to indicate the rework has been completed

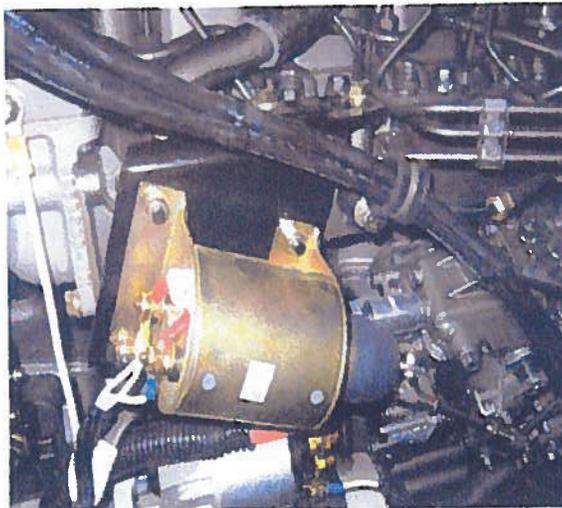
Step 3: Remove top three bolts and loosen bottom mount bolt on high speed solenoid. This will allow enough room to remove the high pressure injection lines.

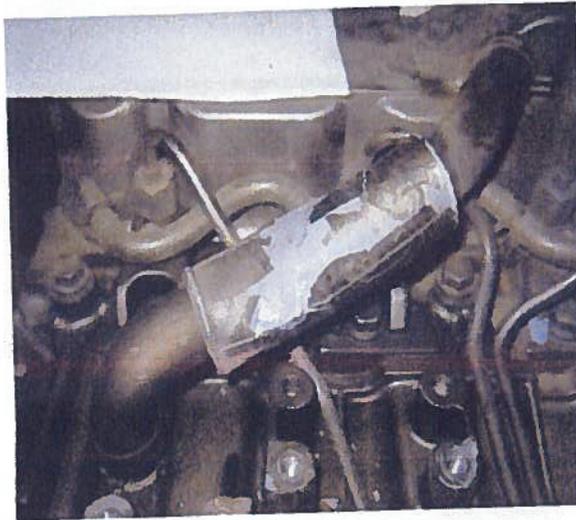
Step 4: Remove the breather pipe from the valve cover. Bend it out of the way so the injector lines can be accessed for removal.

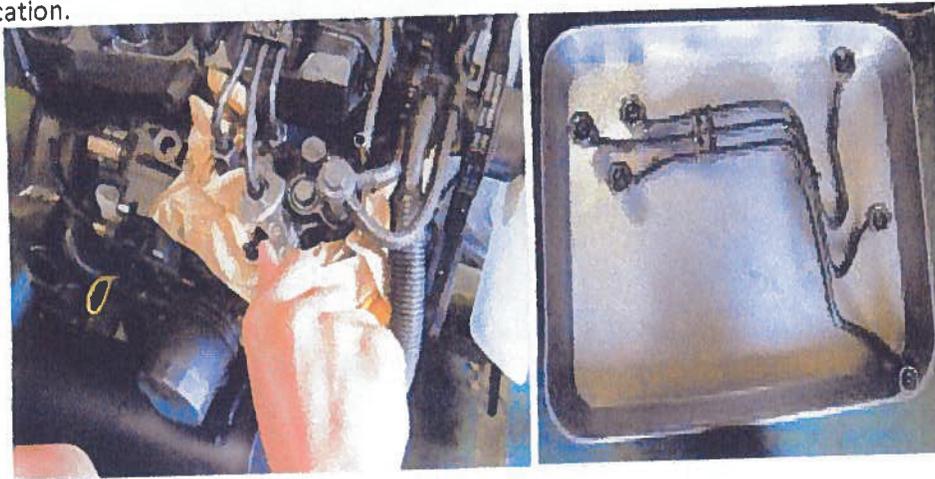
Step 5: Remove the high pressure injection lines. Loosen the 17mm nuts at injection pump and at nozzle. Place the injection line assembly in a safe, clean location.

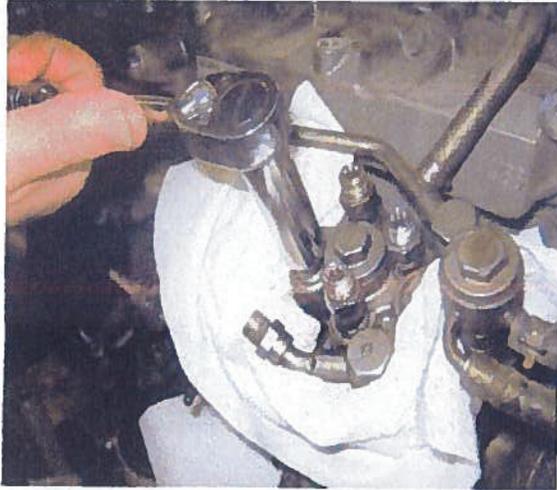
Step 1: Use a 14mm deep well socket to loosen delivery valve holder. Loosen holders 2 turns each then carefully clean up any paint chips/debris from top of injection pump

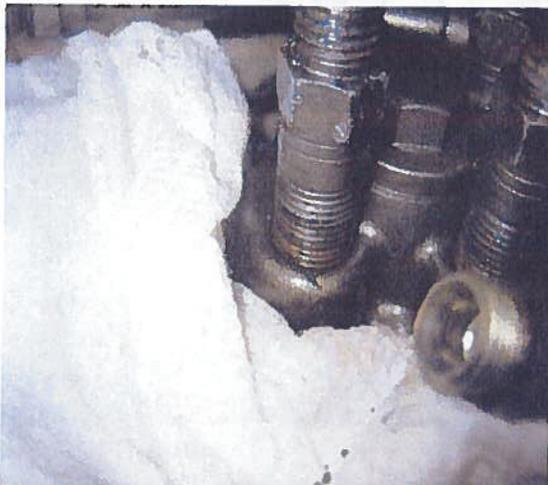
Step 2: Loosen delivery valve holder with fingers one by one. Remove holder by tilting a little so the delivery valve assembly stays in holder when removed.

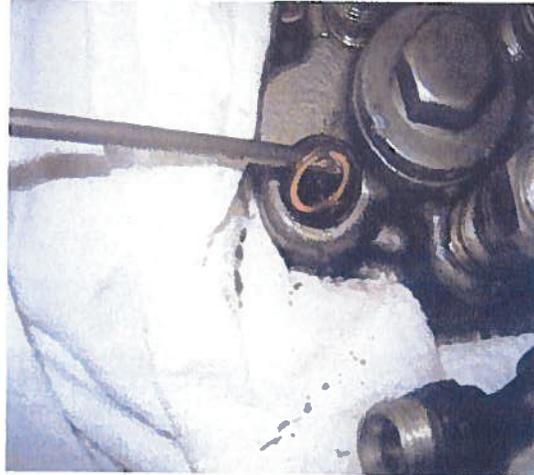
Step 3: Remove copper sealing washer from hydraulic head using 90° pick.

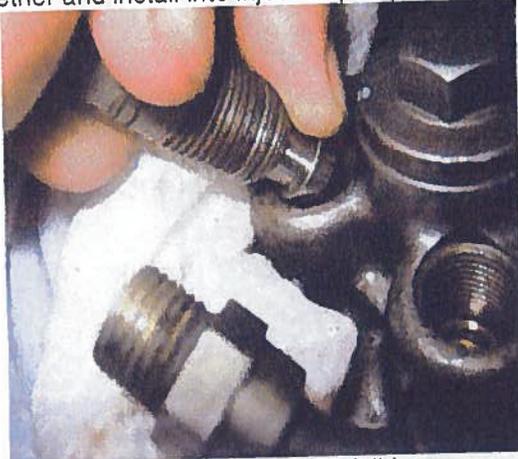
Step 9: Hold delivery valve and holder together and install into injection pump. Install all 4 delivery valves finger tight.

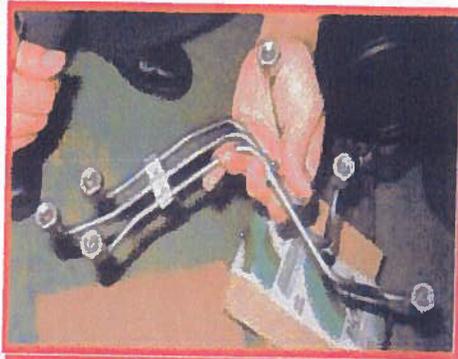
Step 1: Check mating surfaces of high pressure pipe, delivery valve holder, and injectors. Make sure these surfaces are clean so the high pressure lines will seal when tightened.

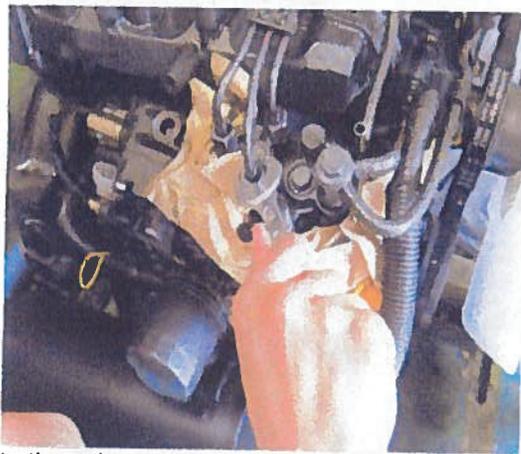
Step 2: Tighten both ends of high pressure injector lines finger tight to ensure they are not cross threaded. Torque injector lines to 29 to 34 NM (22 to 25 ft lbs)

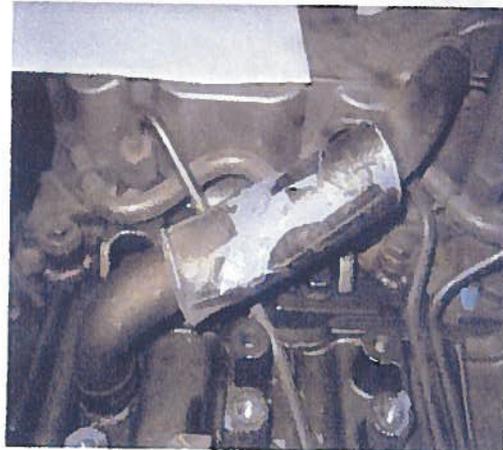
Step 3: Re-install the breather pipe to the to the valve cover

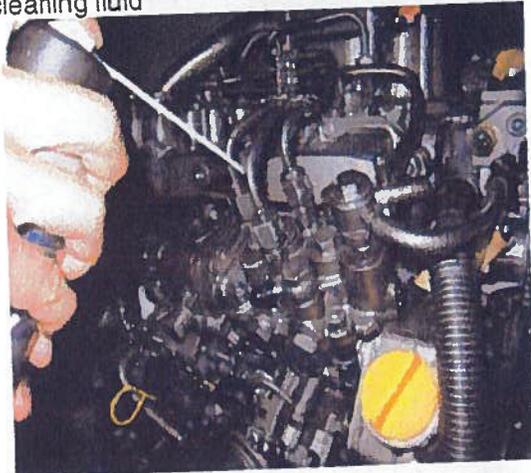
Step 5: Degrease pump and engine with cleaning fluid
