Technical information

TI No.: 15.40U08377A

MODEL: CC 500; TC 400; TRAVEGO Euro VI; INTEGRO; MC400
 MODEL SERIES: 410200; 410210; 410230; 410240; 410250; 410260; 410270; 410280;
 410320; 629540; 629557; 632400; 632430; 632450; 633330; 633660
 TITLE: **Alternator - line routing to earth connection (alternator 3)**

Rerouting the line to the earth connection at alternator 3

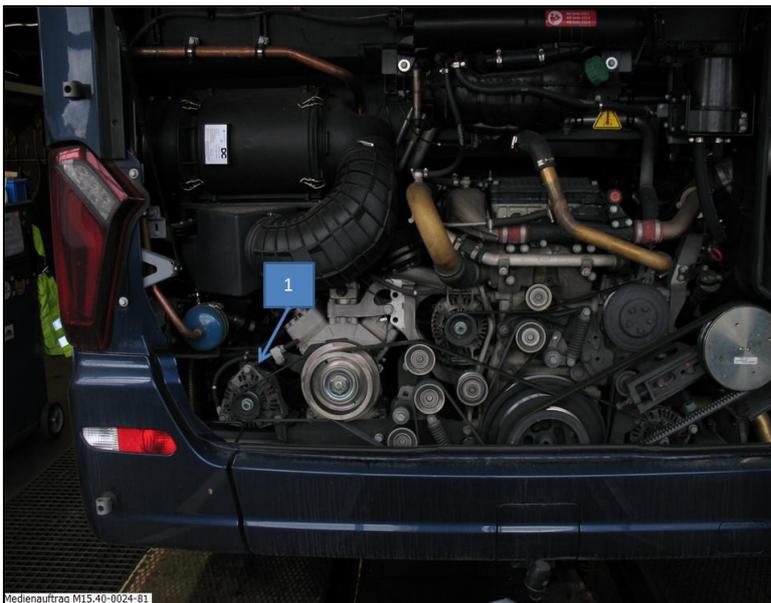
M15.40-0024-81

- Alternator 3 (1).

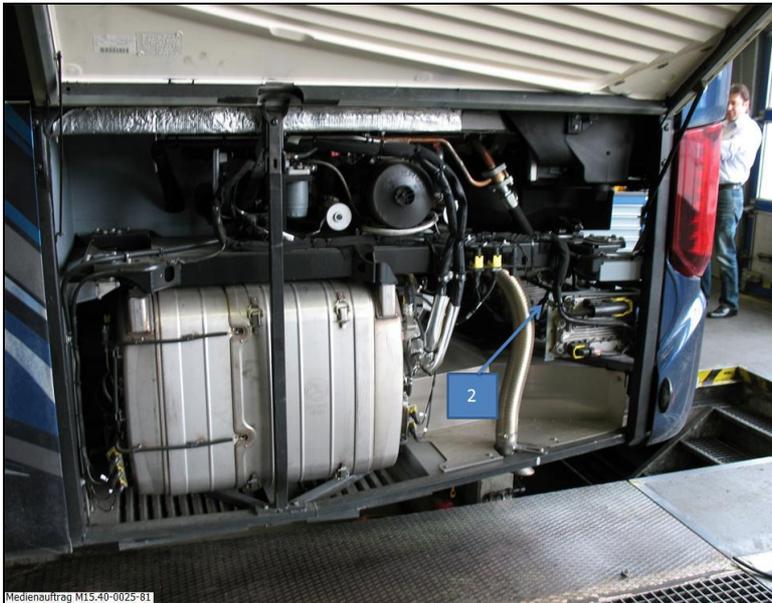
M15.40-0025-81

- Access (2) at rear side of alternator 3.

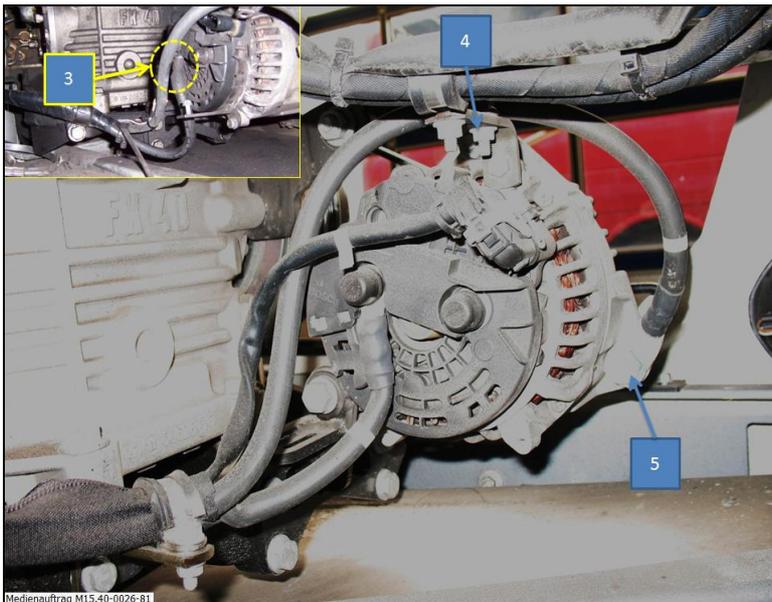
M15.40-0026-81

In unfavourable cases, the earth line suffers chafing near the B+ connection of alternator 3 and causes a short circuit.

Non-standardised routing of earth line possible at B+ connection on alternator 3.

- Possible chafe point (3) at B+ connection of alternator.
- Remove the earth cable from fastening points (4) and (5).

Reroute the earth line.

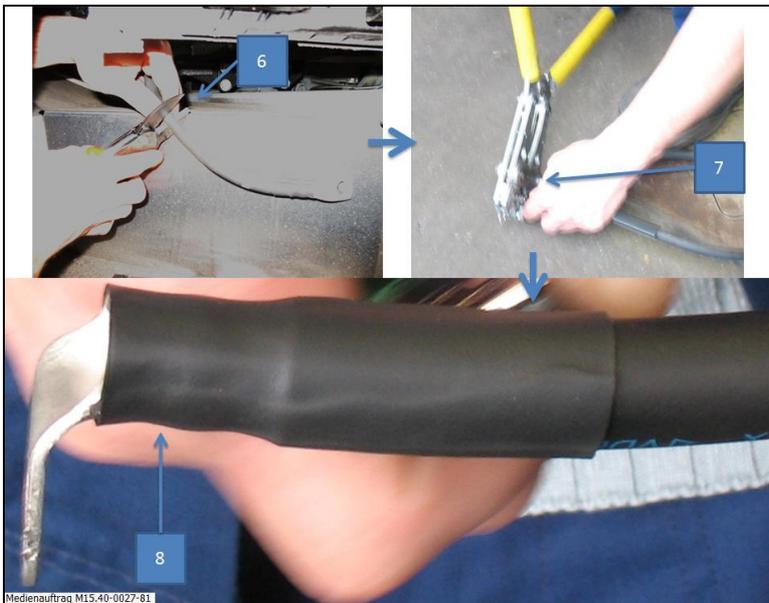
M15.40-0027-81

- Sever the earth cable at approximately 18 cm (6).

Before the earth cable is severed, check the tolerances in the wiring harnesses and adapt cable length if necessary.

- Fit cable lug (7).
- Ready prepared angled cable lug (8) with heat-shrink tubing.

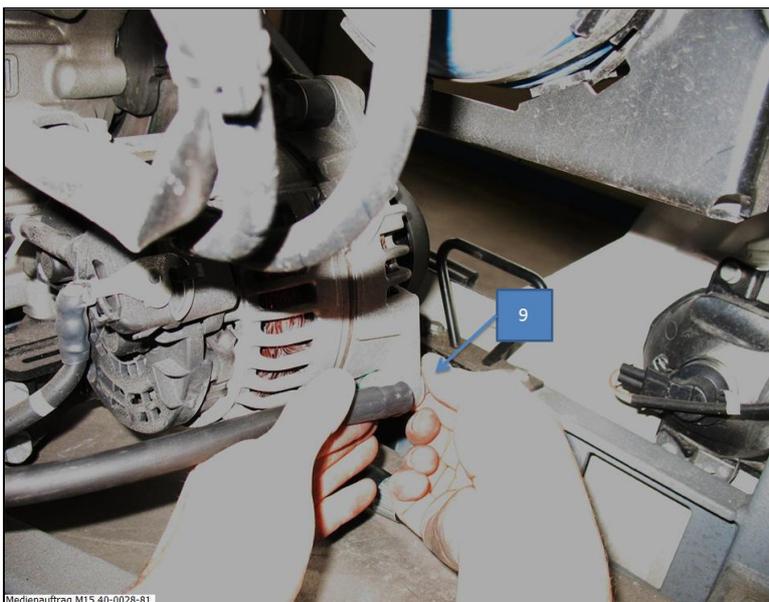
M15.40-0028-81

- Secure the earth cable to alternator 3 (9).

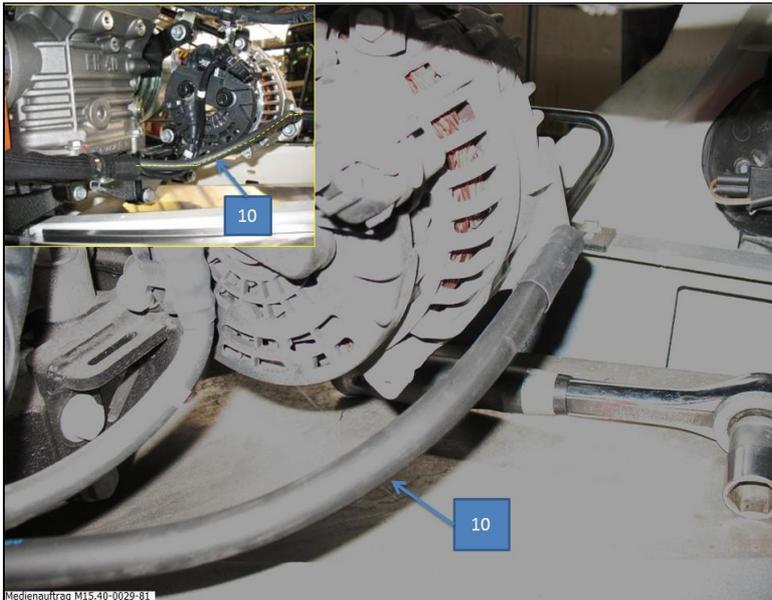
M15.40-0029-81

- New routing (10) of earth line.
