SAFETY ADVISORY # 12-186

Springdale Propane Line Relocation

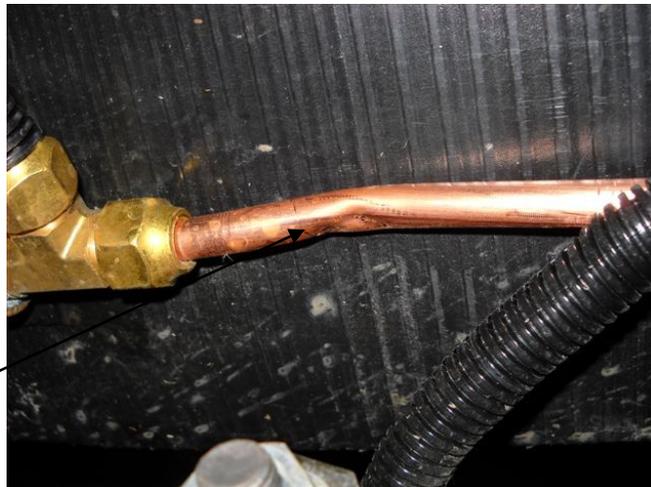
Fig. 1

Step 1 Locate the LP gas line distribution manifold mounted on the door side of the unit near the center spring hanger. Inspect the copper gas lines above the shackle links for damage from the shackle links. See figure 1. If the gas line is damaged submit photos with pre-authorization request.

INSPECT FOR
DAMAGED ABOVE
SHACKLE LINKS.

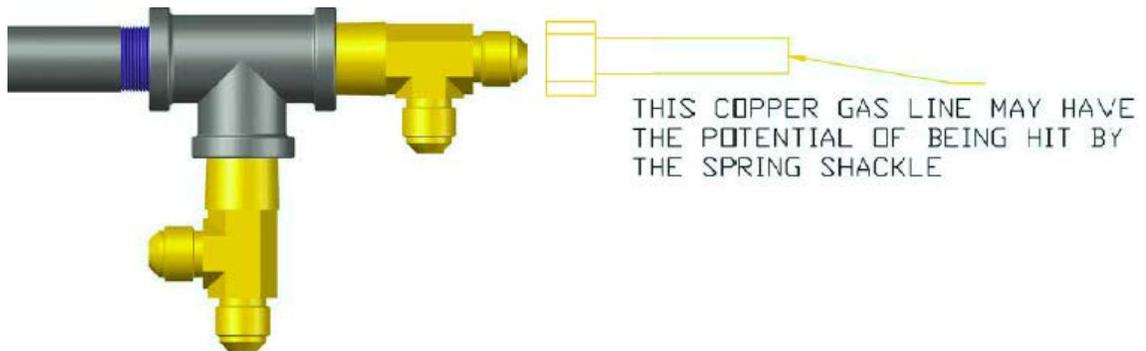
Fig. 2

Remove the mounting clamps from the LP manifold to allow the manifold to hang loose so the end fitting can be removed and replaced. Disconnect the copper supply lines from the manifold. Remove the "T" fitting from the manifold. See figure 2 & 3.

Replace the "T" fitting with a 90 degree elbow pointed to the center of the unit. Add a 1/2" close pipe nipple to the elbow. Reinstall the "T" fitting to pipe nipple as shown in Figure 2. Relocate the copper lines to reconnect to manifold. See figure 2 & 3.
