Aftersales Bulletin

Area **Service Information**
Subject 00 16 79 01 00 – Phantom (RR01) Fuel Filler Neck Missing Anti-Misfueling Device **(North American Market Only)**
Group 00 16
Reference 00 02 13
Published date 26 February 2013
Version 1
Department Service Operations/OH
Recipients All Service Managers, Aftersales Managers and Service Technicians of Rolls-Royce Motor Cars Dealers

Recall Campaign 13V047000: Fuel Filler Neck Missing Anti-Misfuelling Device – 2013 Rolls-Royce Phantom.

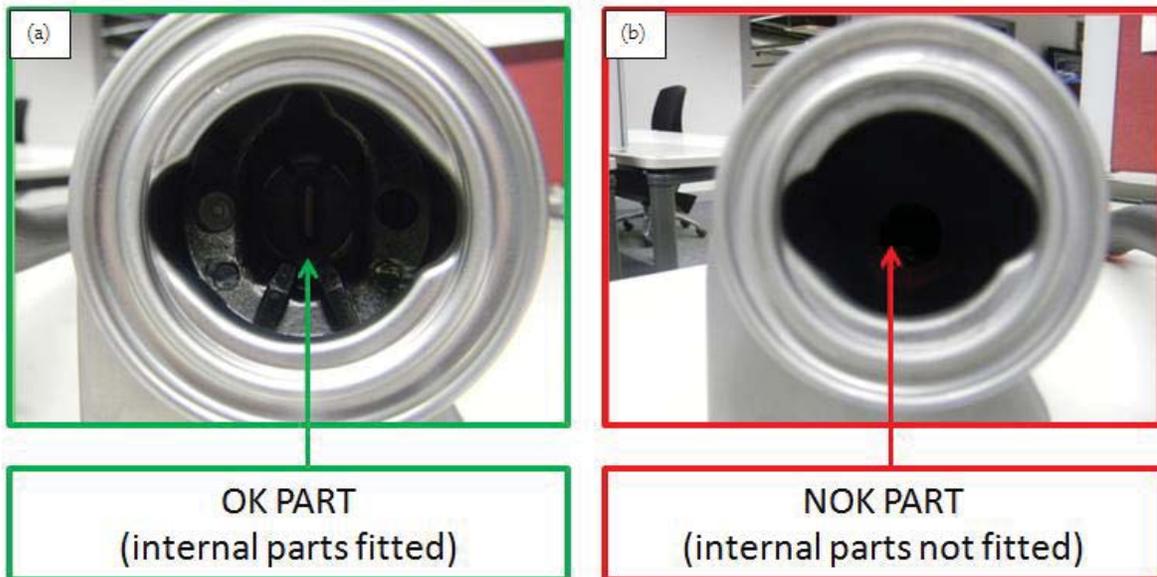
2.2 Use a light to inspect the fuel filler pipe to confirm the internal nozzle restrictor is fitted.

2.3 If the Internal parts are fitted (Photo A), no further action is required. If the Internal parts are **not** fitted (Photo B), the fuel filler pipe should be replaced (see 3. Repair procedure below).

It is possible that Rolls-Royce Phantom (RR01) models produced between 08.11.2012 and 23.01.2013 may have been built with the internal nozzle restrictor missing from the fuel filler pipes. This nozzle restrictor prevents the vehicle from being refuelled with the wrong fuel type, for example diesel, and prevents electrostatic discharge into the metallic structure of the chassis during refuelling.

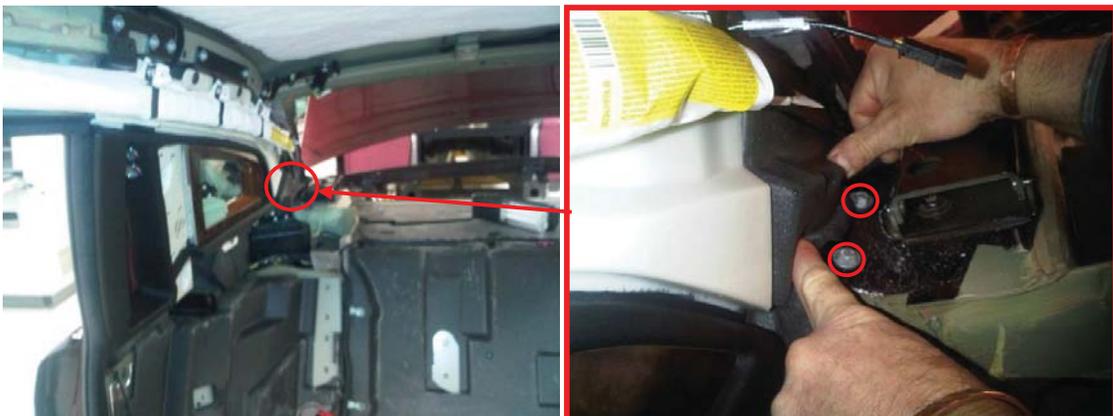
Note: The location of the fuel filler pipe bracket fixing bolts are shown in the photos below.

3.5 Remove the fuel filler pipe using ISTA 16 11 060 "Removing and Installing/Replacing Fuel Filler Pipe."

3.8 Remove the fuel filler pipe from the fuel tank by reaching up through the gap in the body with your hands and pulling the fuel filler pipe out of the fuel tank and towards the vehicle's exterior. Once the fuel filler pipe has been removed from the fuel tank, pull the fuel filler pipe down through the gap in the body to completely remove it from the vehicle.
