Subject: ICU4Me Park Brake Warning Message

Models Affected: Specific Freightliner Cascadia and Coronado vehicles manufactured November 21, 2011, through March 27, 2013.

Recall Campaign

June 2013
FL642A
NHTSA #13V-127
Transport Canada #13-110

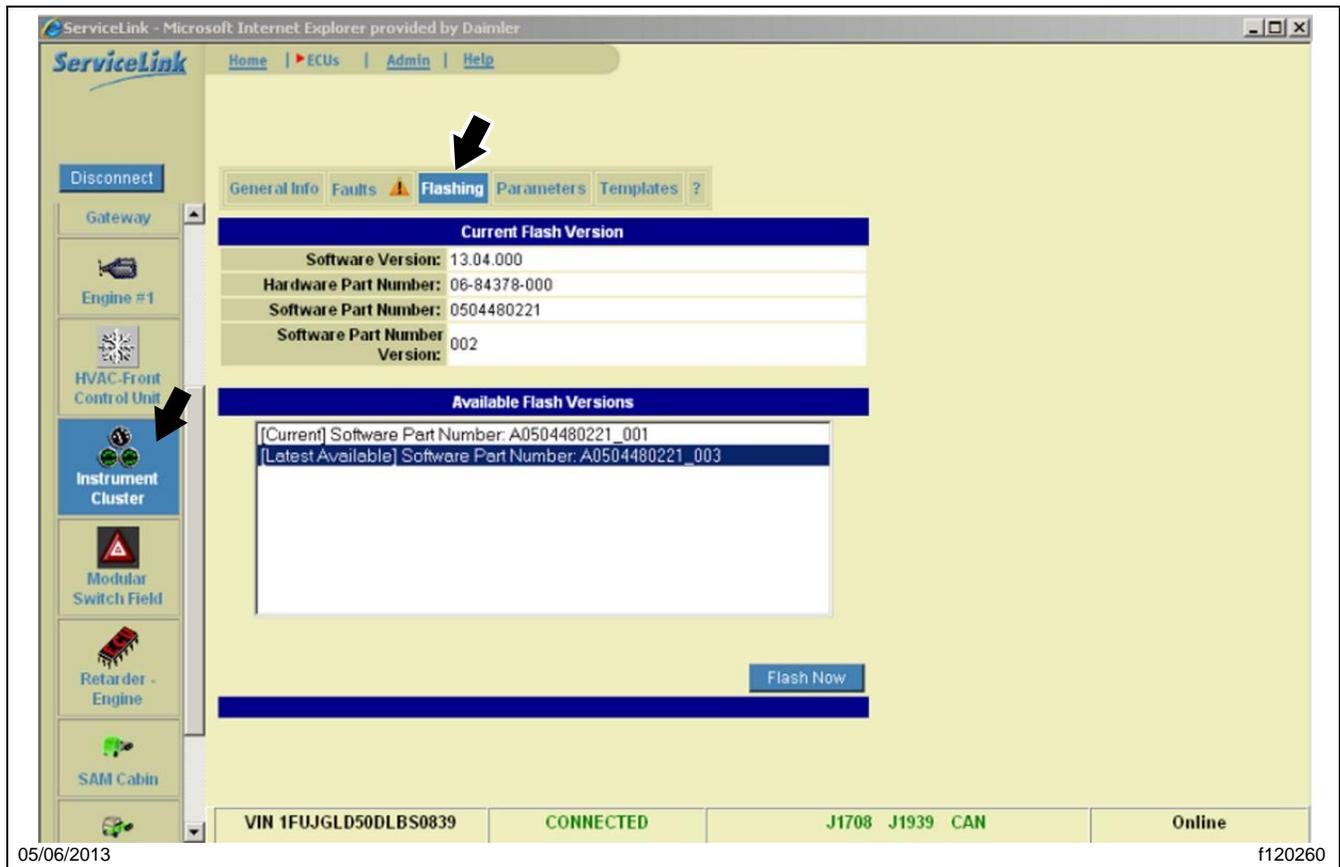
Fig. 1, Instrument Cluster Flashing Screen

1. Check the base label (Form WAR259) for a completion sticker for FL642 (Form WAR260), indicating this work has been completed. The base label is usually located on the passenger-side door, about 12 inches (30 cm) below the door latch. If a completion sticker is present, no work is needed. If a completion sticker is not present, proceed to the next step.
2. Shut down the engine and apply the parking brakes. Chock the tires.
3. Connect the vehicle to ServiceLink.
4. Select the "Instrument Cluster" icon on the far left-hand side of the screen. Then click the "Flashing" tab. See Fig. 1.

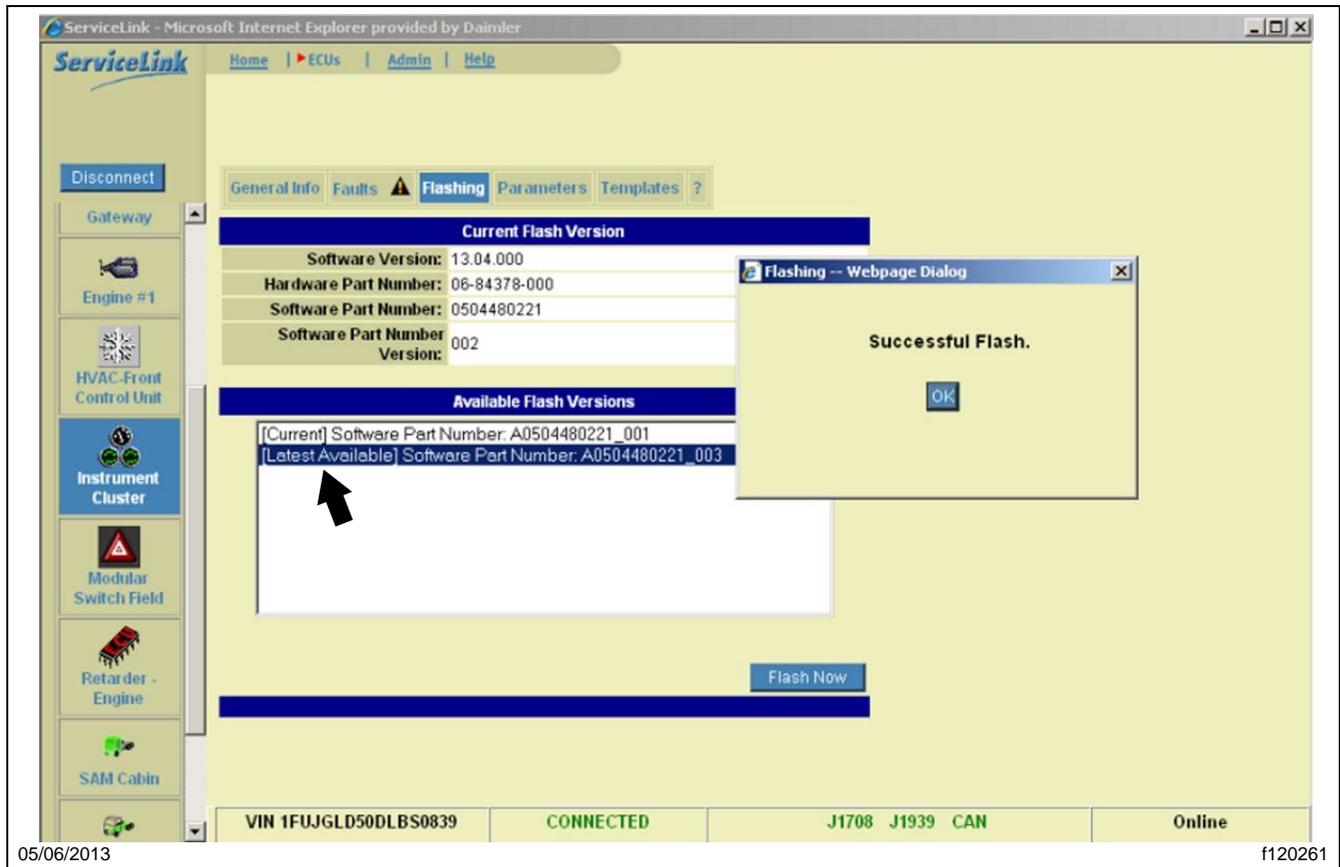
Fig. 2, Features Drop Down List

5. Select the "Latest Available" flash version. Then click the "Flash Now" button. See **Fig. 2**.
6. Once the flash is complete, a popup window indicating a "Successful Flash" will appear. Click "OK" on the popup window.

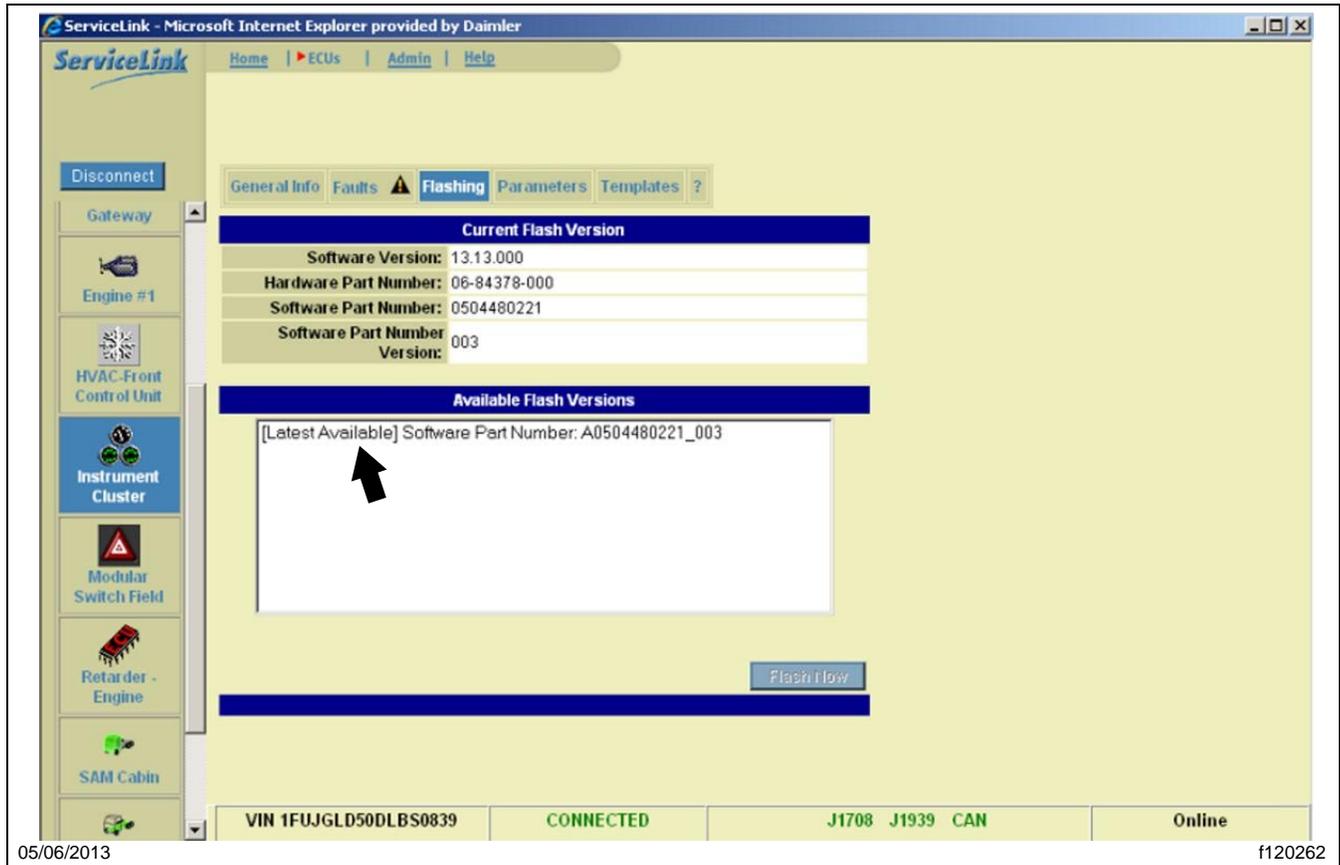
Fig. 3, Parameter Selection

7. ServiceLink will now only display the latest software version for the ICU. See **Fig. 3**.
