**RE: Defect Information Report – Supplemental Report No. 2
13V-364, FL-643, Auxiliary Fuel Pickup Tube
Dealer Notice**

Recall Campaign

FL643A

Subject: Auxiliary Fuel Pickup Tube Labels

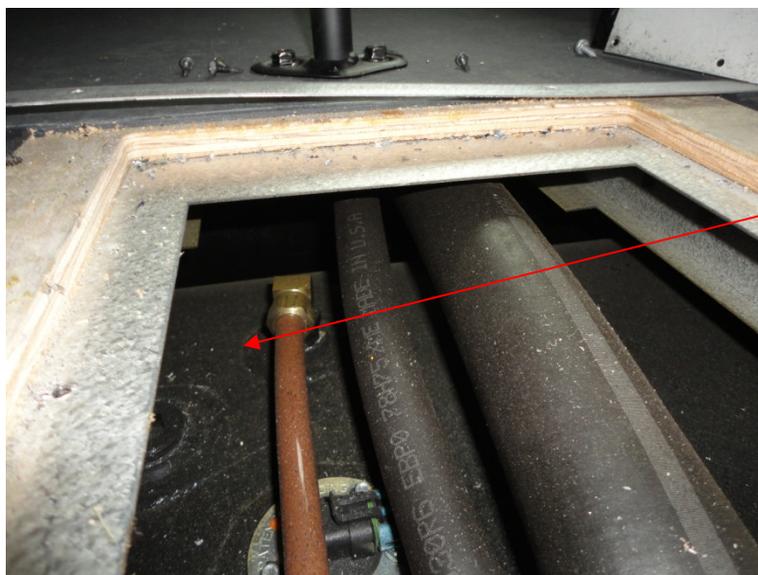
Figure 1

- 1) Chock wheels on the bus and make sure parking brake is set and the bus is in park or neutral along with the key being off.
- 2) Remove the fuel sending plate inside the bus that allows access to the top of the fuel tank.
- 3) At this point you should be able to see the fuel hose that draws fuel from tank to the engine. See Figure 1.

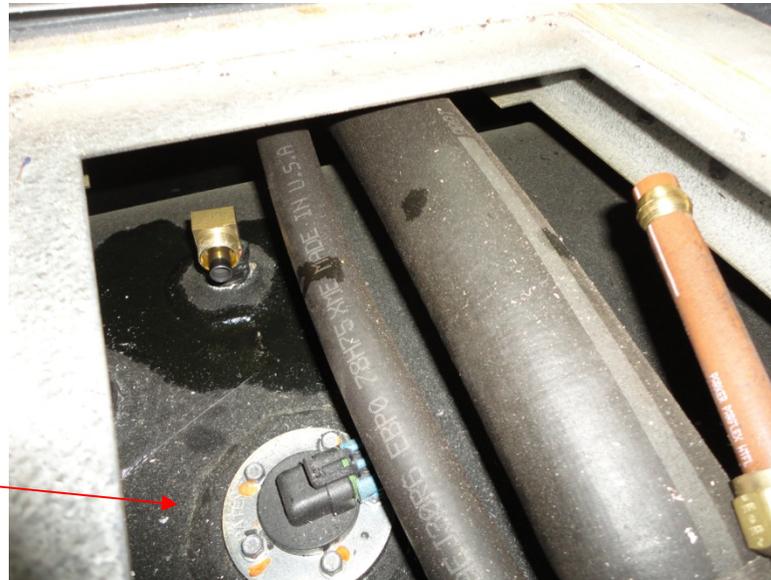
- 4) Remove the hose by loosening the compression fitting using a 15/16" wrench.
- 5) Next, push the hose out of way so that the fuel tube mounting can be reached as in Figure 2

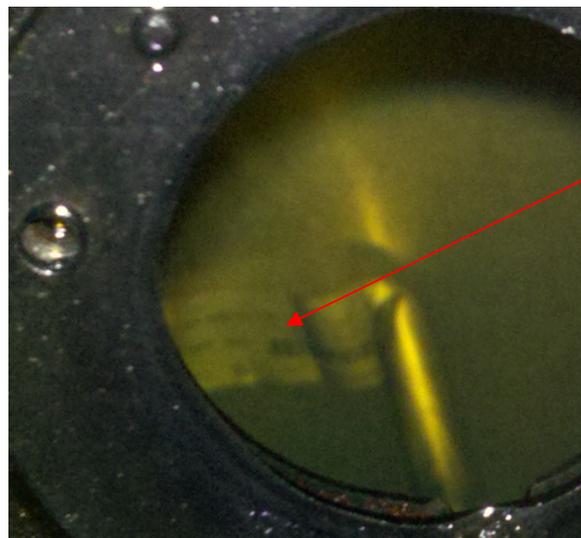
Figure 3

- 6) Remove the fuel sending unit using 5/16" socket. Look inside tank to see if label is still on the Webasto fuel pick-up tube. (See Figure 3) If so, the tube needs to be removed and tag and residue removed before reinstalling. Reinstall fuel sending unit. If the tag is not there then you can skip to step 11

- 7) To remove the pick-up tube for the Webasto heater you need to remove the hose from the tube first. This is done by using a 3/4" wrench on the hose side and a 9/16" wrench on tube side. Once you have loosened the hose and removed it, slide it to the side.
- 8) Next, you will have to use a pipe wrench or a large pair of channel locks to loosen the pick-up tube from the fuel tank at the base of the tube.
- 9) Pull out the tube and remove the label and clean off any residue from the tube.

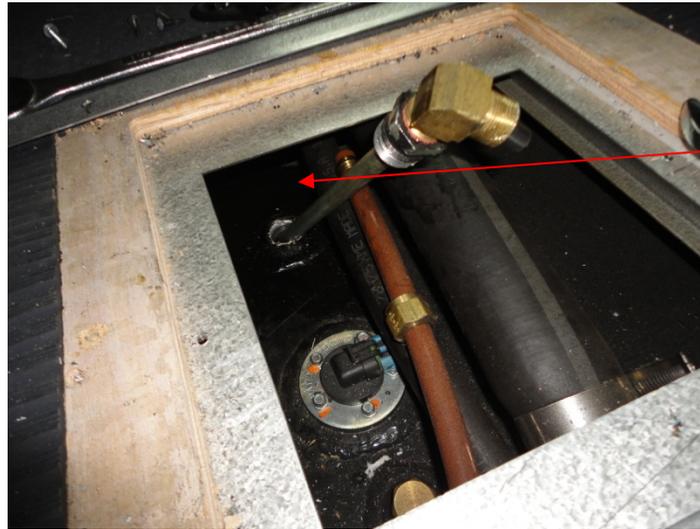
Figure 4

- 10) Reinstall the tube and hose then proceed to next step.
- 11) Remove the main pick-up tube. Loosen the pickup tube in the tank using a pair of pliers or a 15/16" wrench on the head of elbow. Next, turn the tube at an angle to remove as shown in Figure 4.

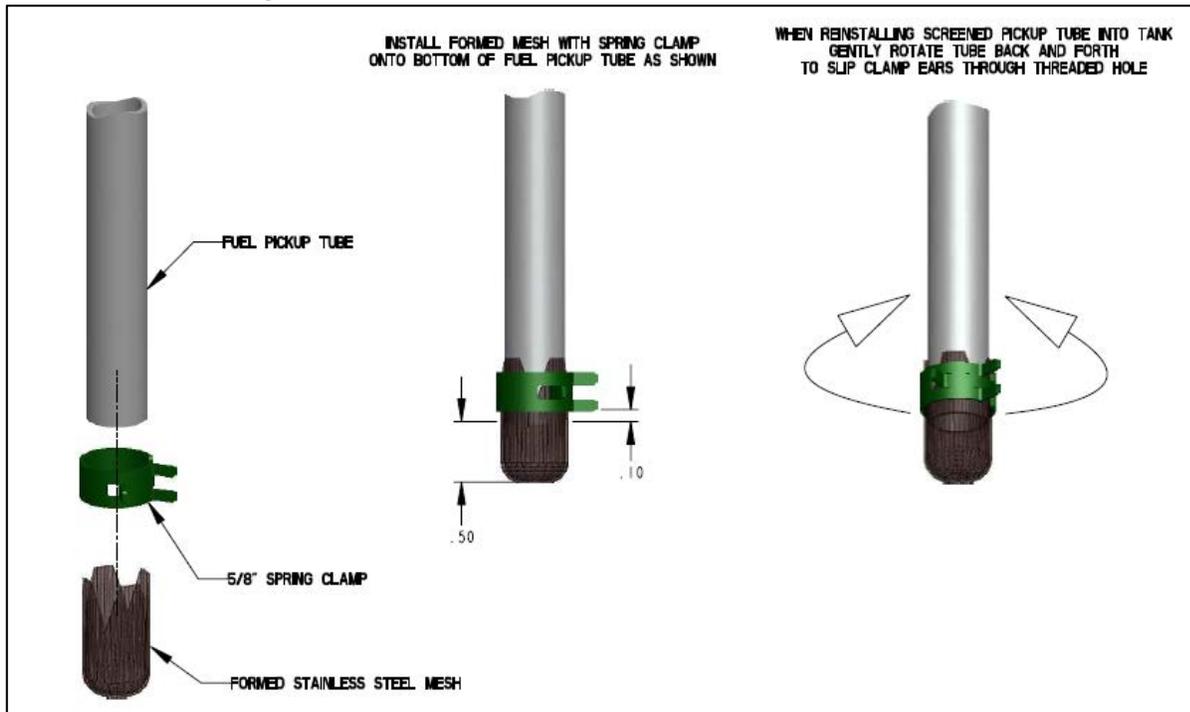
Figure 6

- 13) After retrieving the components from TBB 184921, take the fuel pick-up tube and install the screen on the end of tube as shown in Figure 6.

- 14) If the head of the pick-up tube is marred to where it would affect reinstallation, replace the head with TBB 61361038, 90-degree elbow, before reinstallation.
- 15) Reinsert the pick-up tube end into the hole in the tank and gently rotate tube back and forth, as it is inserted to allow for the ears of clamp to go through hole.
- 16) Tighten down the head of the tube with a 15/16" wrench until tight.
- 17) Reinstall the fuel hose.
- 18) Before putting the cover back, start the bus and make sure there are no leaks at the fuel hose connection.
