Subject: Safety Recall E0S (E1S) **Interim Notification**
Originally Sold In and/or Currently Registered In Specific 20 Cold Climate States
Excessive Corrosion of the Spare Tire Carrier Cable
REVISED REMEDY UNDER DEVELOPMENT

Safety Recall E0S (E1S) - **Interim Notice**
2004 through Certain 2011 Model Year Toyota Sienna (2WD) Vehicles
Originally Sold In and/or Currently Registered In Specific 20 Cold Climate States
Excessive Corrosion of the Spare Tire Carrier Cable
REVISED REMEDY UNDER DEVELOPMENT - FAQ

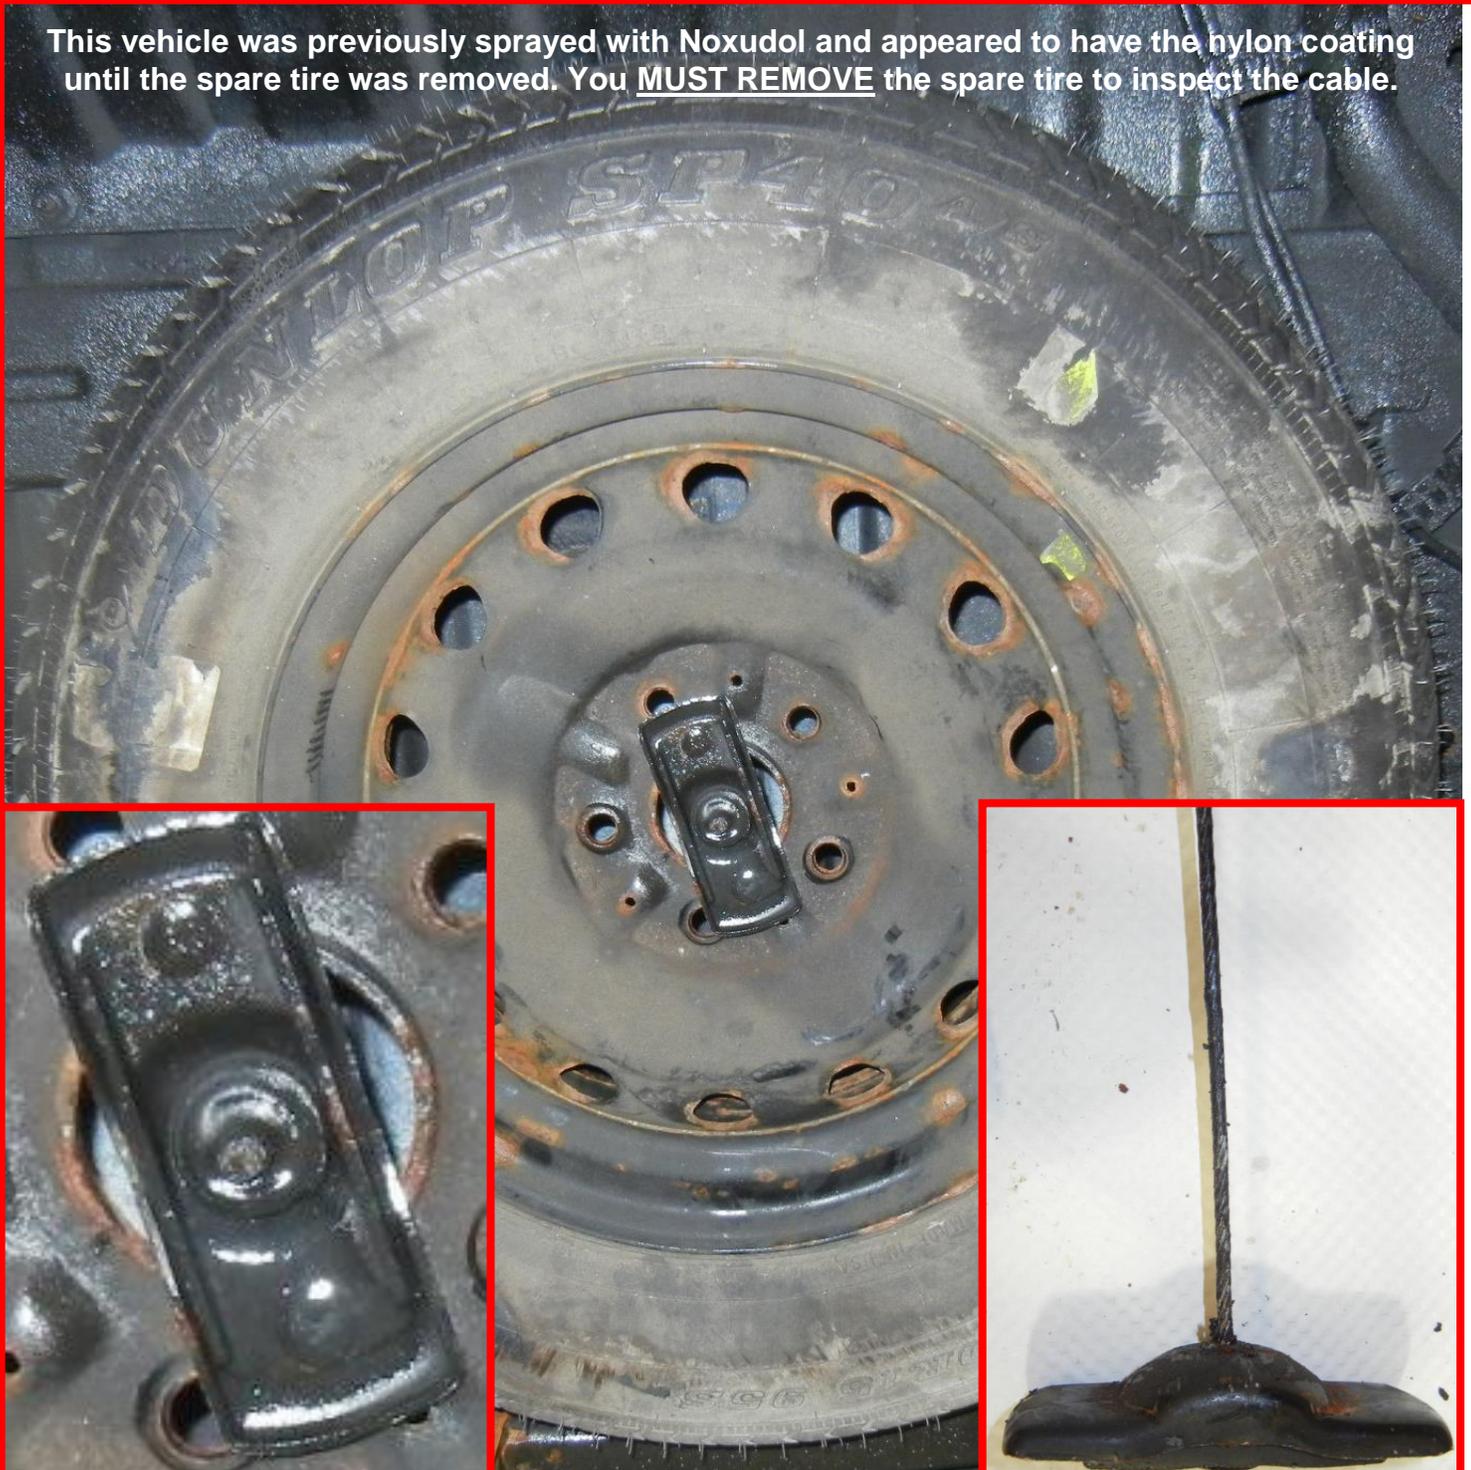
This vehicle was previously sprayed with Noxudol and appeared to have the nylon coating until the spare tire was removed. You **MUST REMOVE** the spare tire to inspect the cable.

- If you are unable to determine if the cable is nylon coated or was previously applied with Noxudol, automatically relocated the spare tire.
- A low percentage of spare tire carriers were replaced under Safety Recall A9E, it is anticipated that the majority of spare tires will need to be relocated.

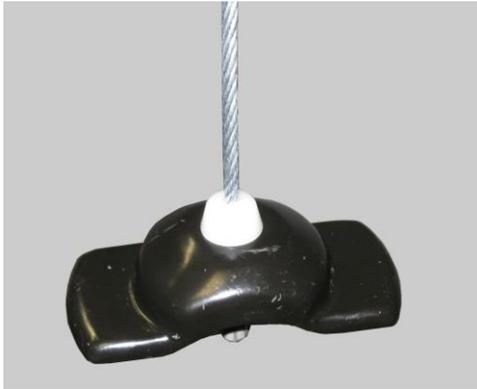
- Raw Steel Cable
- Raw Steel with Corrosion
- Raw Steel with Noxudol
- Black Resin Coated with Exposed Ferrule

All of the above cable type and cable conditions must have the spare tire relocated.

- Relocation of the spare tire is required. Go to Section V.D.1 for the tire relocation process.
- If you are unsure of what type of spare tire cable your vehicle is equipped with relocate the spare tire.

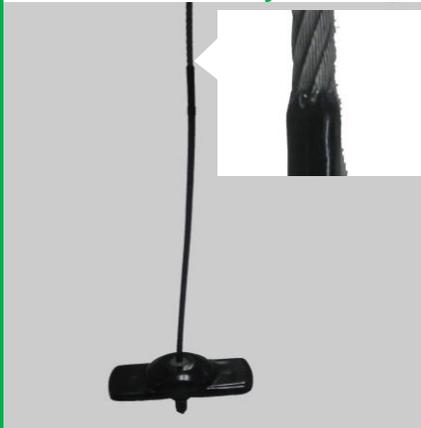
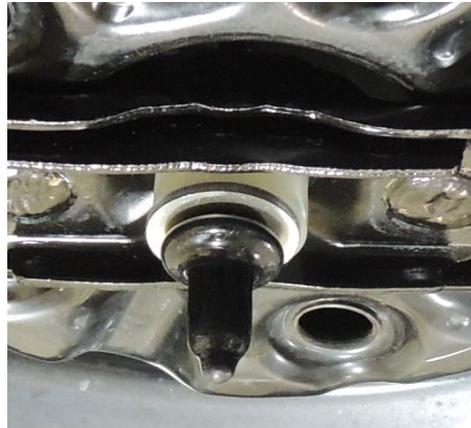
Nylon Coated with Coated Ferrule

If the vehicle appears to have a nylon coated spare tire carrier cable that is in good condition, proceed to section V.C.1 to validate the spare tire carrier part number.

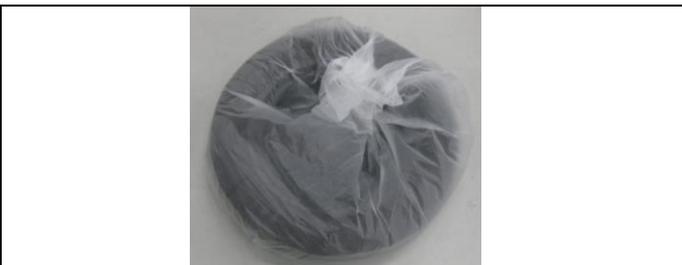
1. CUT THE SPARE TIRE CARRIER LIFT PLATE

- a) Cut the spare tire lift plate off of the spare tire carrier cable to ensure it cannot be used.
- b) Retract the cable back into the housing of the carrier so it will not drag on the road.

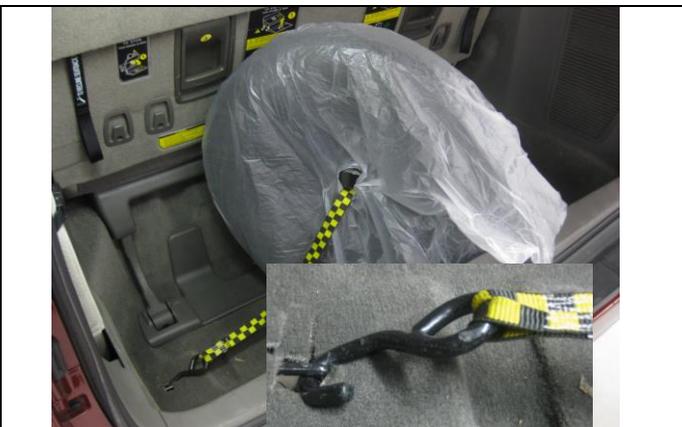
2. PLACE THE SPARE TIRE IN A TIRE BAG

- a) Check the air pressure of the spare tire and adjust if necessary.
- b) Place the tire in the tire bag to protect the vehicles interior from dirt and debris.

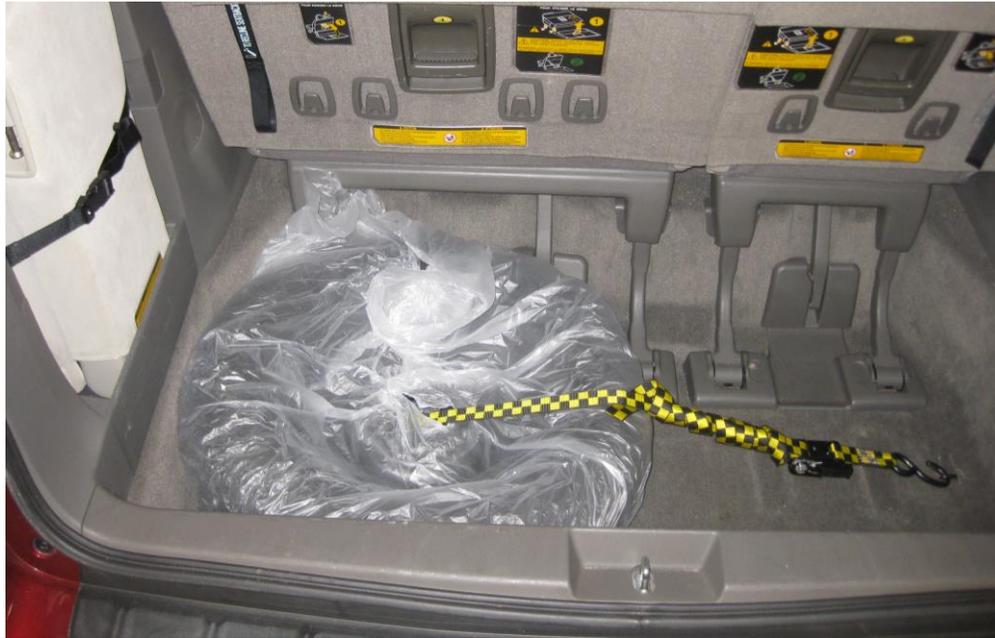
Ensure not to ratchet the tie down too tight where it will be difficult for the customer to release the ratchet mechanism.

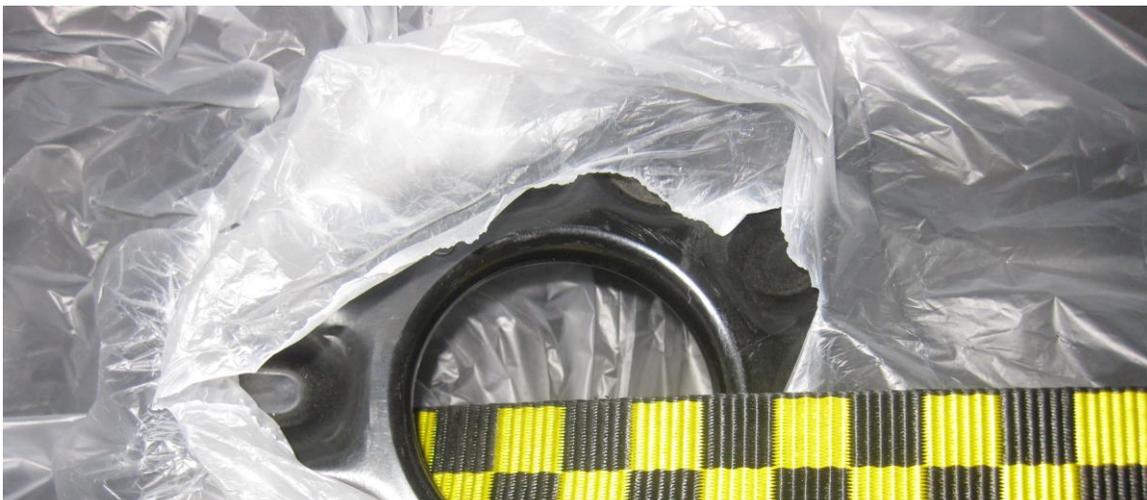
- g) Confirm that the tie down strap is in not rubbing or pinched on the flange of the wheels hub.
