# SERVICE BULLETIN

UTILITY TRAILER MANUFACTURING CO.

## SB-07-011

**Subject: Pintle Hook LOOP for the Secondary (Safety) Chain – INSPECTION**

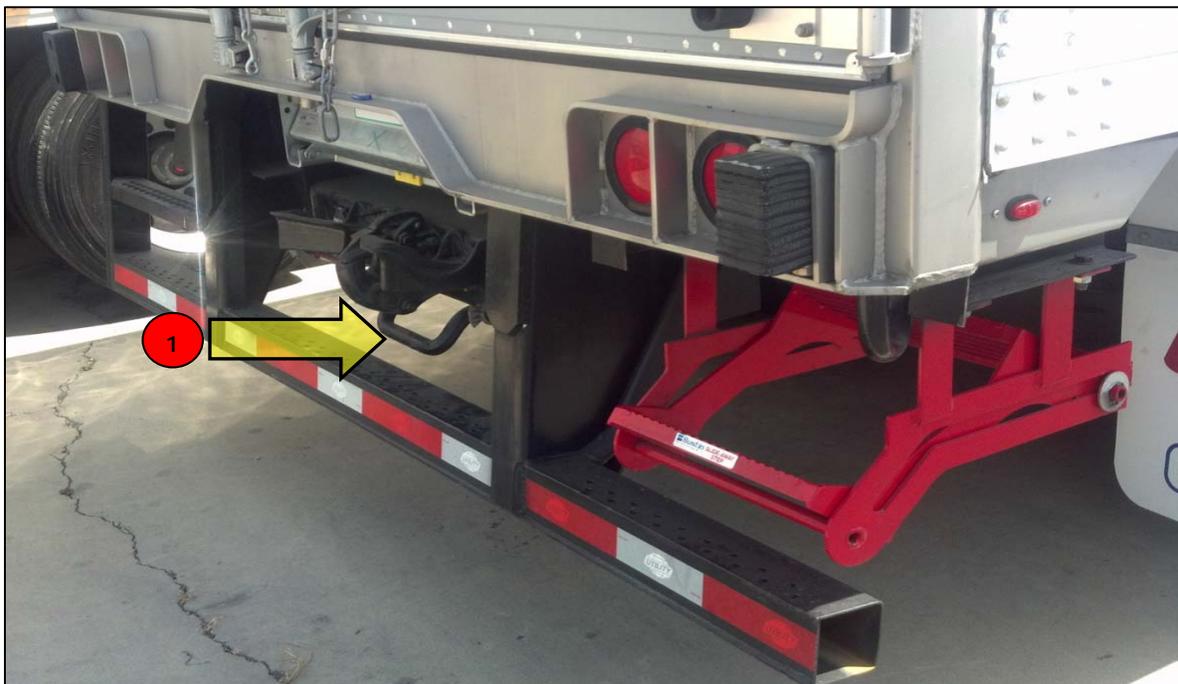
## Field Test Procedure (1):

- Stand at the rear of the trailer perpendicular to the pintle hook loop.
- Swing the 10 lbs. sledge and strike the safety loop's rearward surface, striking towards the front of the trailer.
- The impact should leave a mark but not crack the loop in any location.
- Inspect for cracks at the welds to the box beam and any cracks to the loop.

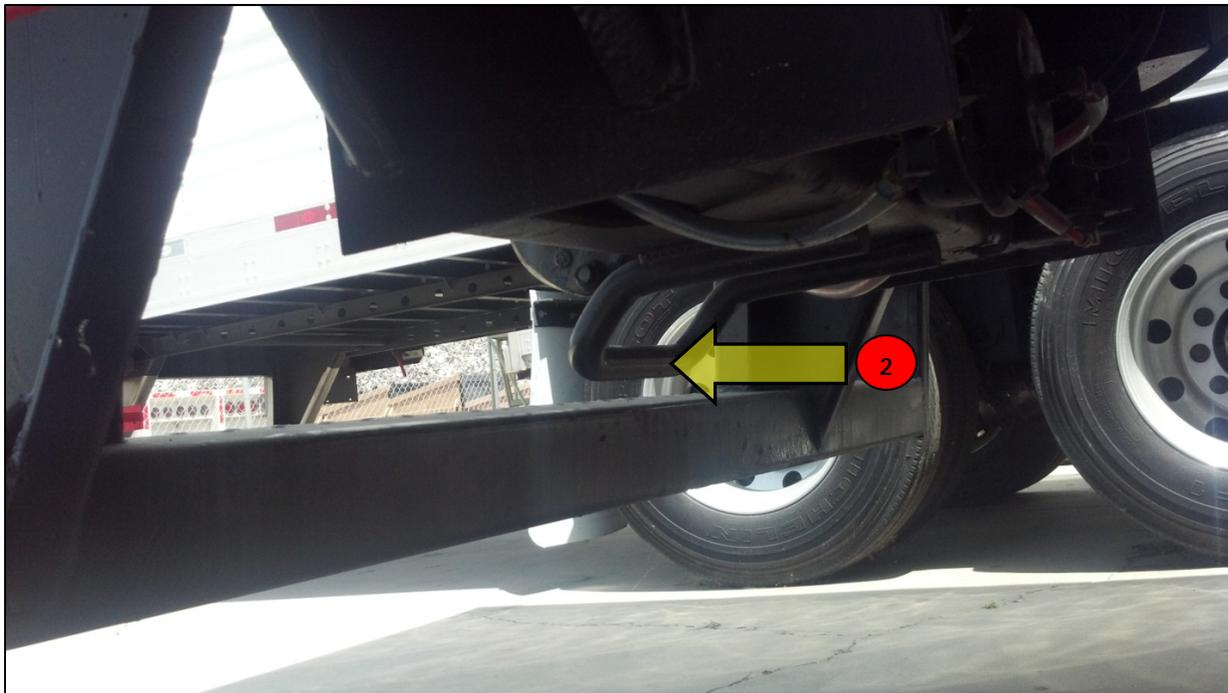
## Field Test Procedure (2):

- Repeat sledge hammer strike procedure on the rearward surface of the loop, striking towards the rear of the trailer.
- The impact should leave a mark but not crack the loop in any location.
- Inspect for cracks at the welds to the box beam and any cracks to the loop.

- If you observe any cracks on the pintle hook loop, remove and replace the loop, as follows:
  - Vans and reefers with 1-1/4" diameter loop: [PN 03-5300-027](#)

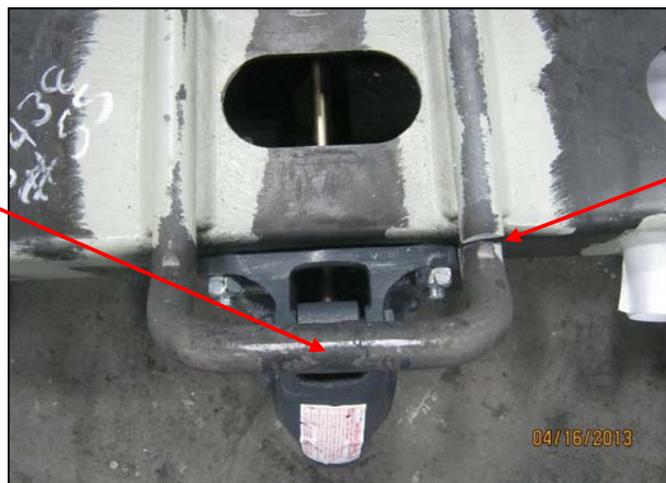
Example of flat mark from sledge hammer impact.

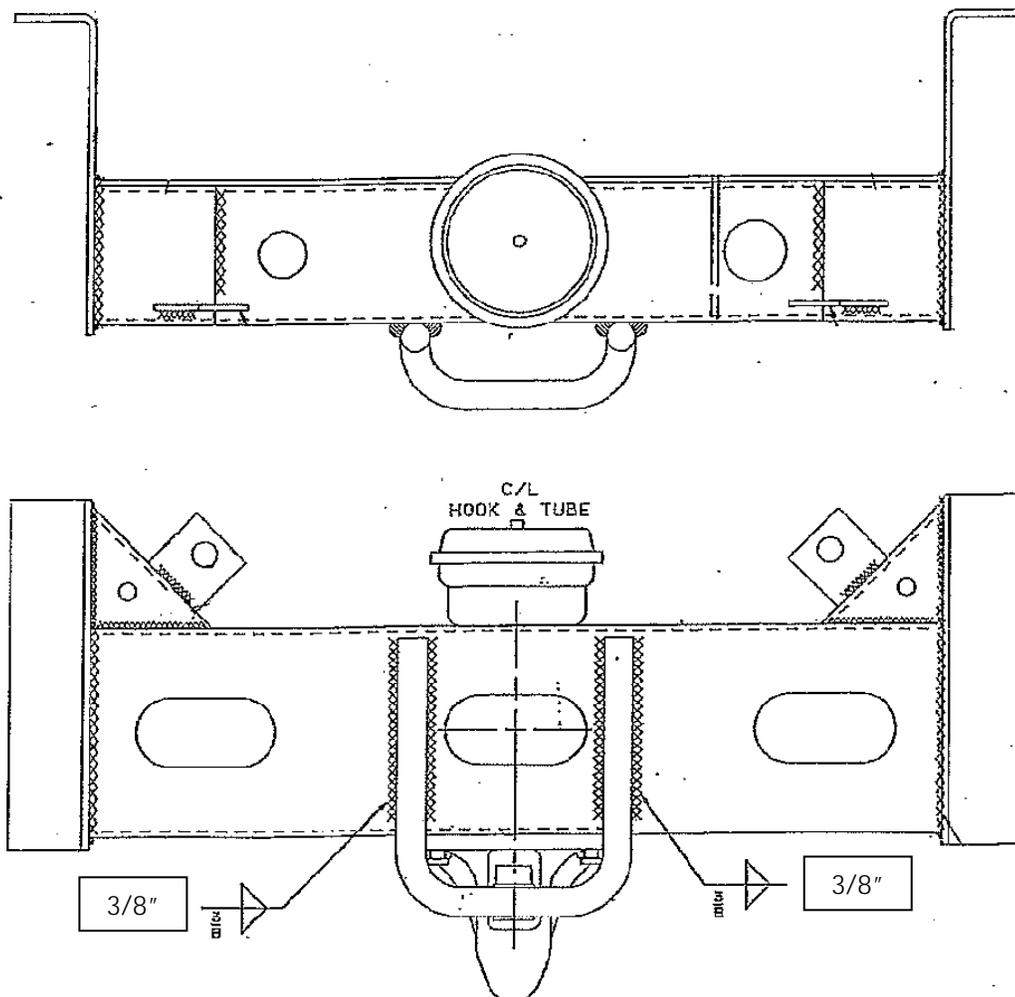
- Weld detail as follows:

## Installation:
