“SAFETY RECALL NOTICE”
NATIONAL HIGHWAY TRAFFIC SAFETY ADMINISTRATION
RECALL NO: 15E013

HSM Inc., “formerly known as Hickory springs Manufacturing”, has determined that a defect which relates to motor vehicle safety exists in certain “RV Step” models manufactured by HSM, which were shipped between October 18th, 2012 and January 9th, 2015. Shipping records indicate that you have purchased these steps through our distributor Lippert Components, Inc. aka “LCI”.

RV QUAD STEP 24" x 8 x 8, RIVET REPLACEMENT	SRP 1502-0001 REV.B032715
---	-------------------------------------

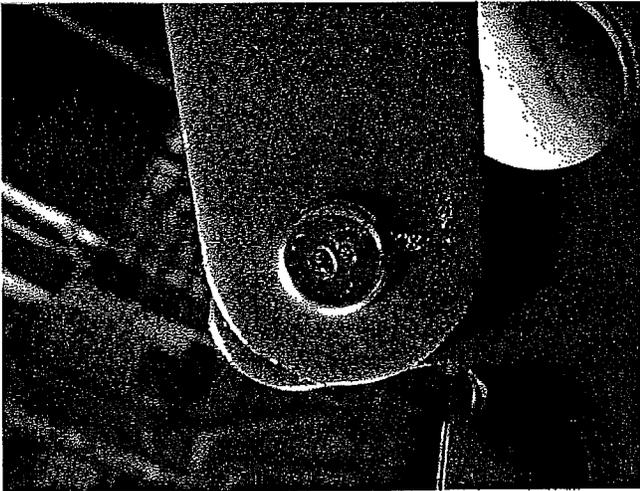
HINGE POINT RIVET MARKED #96 @ 2nd & 3rd STEP

5.1.1 This configuration has a hinge point rivet marked with the #96 at the 2nd & 3rd Step (2nd & 3rd step, defined as the 2nd step from the ground level and the 3rd step from the ground level).

NOTE: CONFIGURATION "A" - MUST BE REPAIRED IN ACCORDANCE WITH SRP-APPENDIX "A".

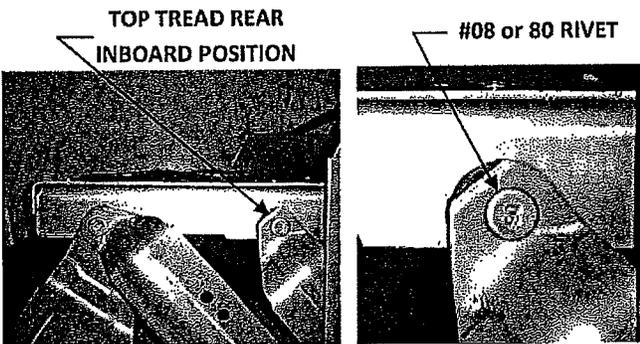
5.1.2 And a Top Tread mount point rivet marked with the # 08 or 80 at the rear inboard mounting position, both left and right sides.

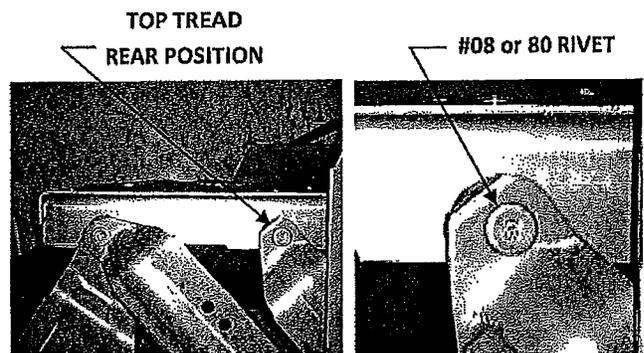
5.2.2 And a Top Tread mount point rivet marked with the # 08 or 80 at the rear inboard mounting position, both left and right sides.

NOTE: CONFIGURATION "B" - MUST BE REPAIRED IN ACCORDANCE WITH SRP-APPENDIX "B".
