NSA-122jlq  
EA99-013

This letter is to request additional information regarding NHTSA's investigation of crash-induced fuel filler neck assembly failure in 1996 through 2000 DaimlerChrysler NS-minivan vehicles. As you know, a second NHTSA crash test of a subject vehicle has resulted in a failure of the fuel filler neck assembly. On January 6, 2000, a left-side impact test (NHTSA No. MY0303) of a 2000 Dodge Caravan for NHTSA's New Car Assessment Program (NCAP) resulted in the fuel filler neck hose separating from the fuel tank spud and most of the tank contents spilling onto the ground.

The NS-body DaimlerChrysler minivan was introduced in MY 1996 and production continued through MY 2000. Prior to 1996, DaimlerChrysler produced its minivans on the AS-body platform. The earlier AS minivans do not share the same filler neck assembly design as the subject NS minivans. The fuel filler tube on the AS minivan is a one-piece steel tube connected to a metal fuel tank by a rubber grommet. The filler tube on the NS minivan is a steel tube connected to a plastic fuel tank by a 5-inch rubber hose. A more detailed description of the NS fuel system design is provided below.

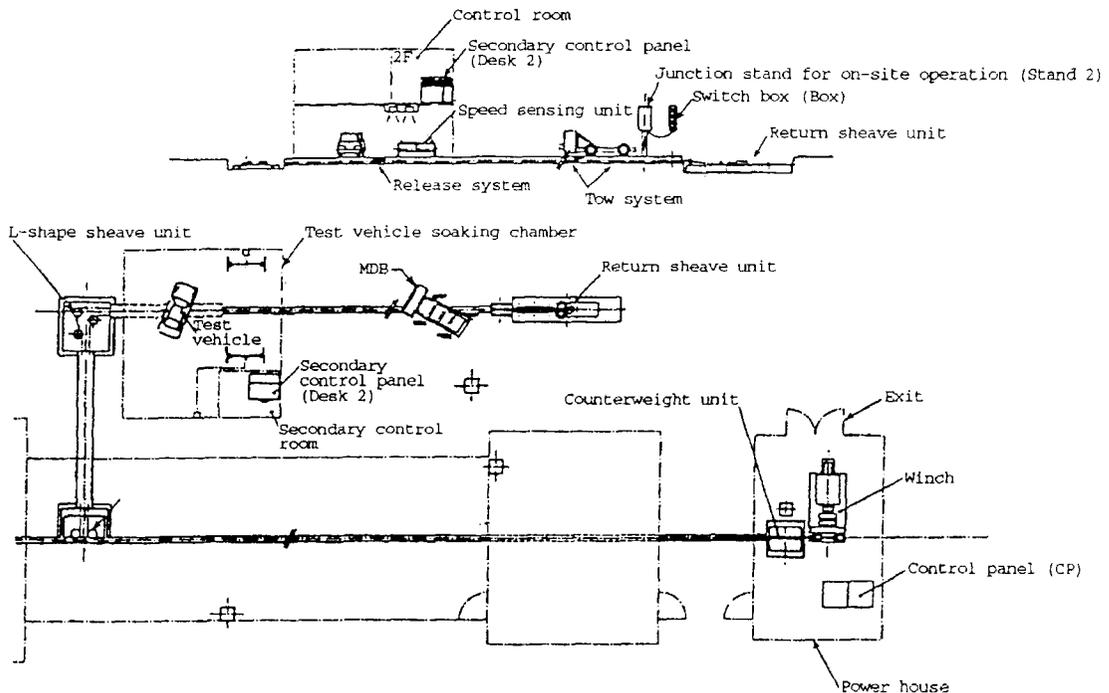
Fig. 3 Example of Test Site Layout for Motor-Driven System

The acceleration system is a system that accelerates an MDB smoothly to an intended speed, using a DC motor or a drop weight. Fig. 3 shows an example of the test site layout for a motor-driven system:

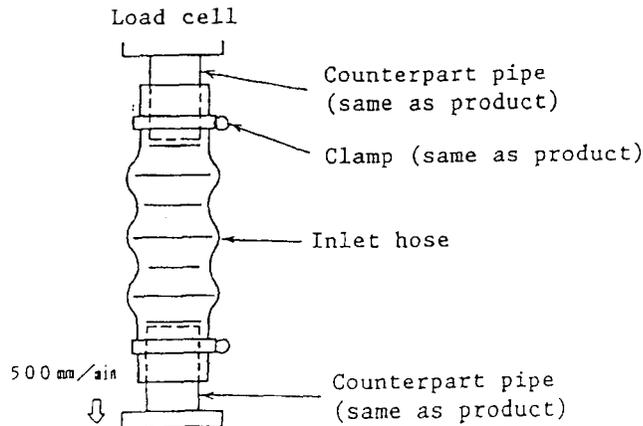
Fig. 21 Sample Settings

For mating pipes (complying with Fig. 17) and clamps, use product samples. For clamps, the tightening margin<sup>(4)</sup> shall be at its minimum. (Or the tightening force shall be at its minimum.)

Insert pipes in both ends of the hose with an insert margin used for an actual vehicle. Store for 24 h under this condition. Place the sample on a tensile tester as shown in Fig. 21. Apply force at a tension rate of 500 mm/min. Report the maximum load and displacement obtained at the moment of hose's withdrawal or breakage.

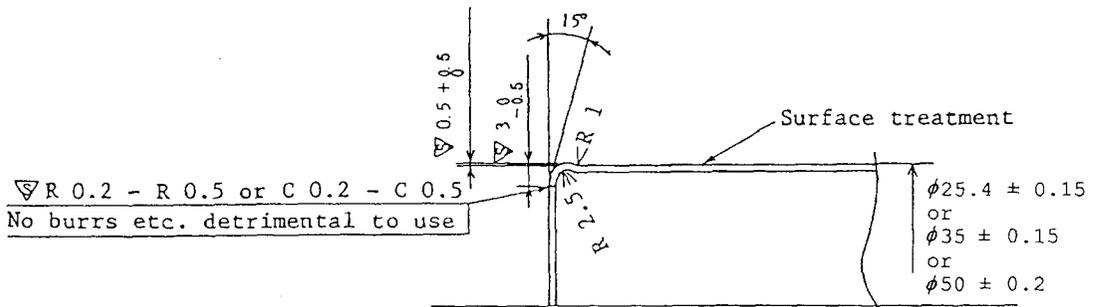
Fig. 17 Shape of Pipe

Surface treatment method: in accordance with TSH6500G

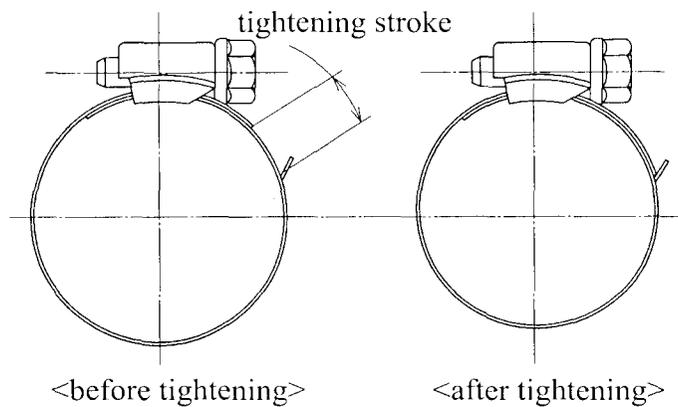
figure 1 :Clamp

a	filler hose	inner diameter	$\phi 40.0 +0.5/-1.0$ mm [general portion] ( $\phi 1.57 +0.02/-0.04$ in.) $\phi 34.0 +0.5/-1.0$ mm [connecting portion] ( $\phi 1.34 +0.02/-0.04$ in.)
		wall thickness	$2.8 \pm 0.4$ mm [general portion] ( $0.11 \pm 0.02$ in.) $5.0 \pm 0.5$ mm [connecting portion] ( $0.20 \pm 0.02$ in.)
		length	$345.0 \pm 6.0$ mm ( $13.58 \pm 0.24$ in.)
b	tank spud fitting	outer diameter	$\phi 35.0 \pm 0.2$ mm ( $\phi 1.38 \pm 0.01$ in.)
		wall thickness	$1.0 \pm 0.04$ mm ( $0.039 \pm 0.002$ in.)
		length	$38.0 \pm 1.2$ mm ( $1.50 \pm 0.05$ in.)
c	tank spud	bead diameter	$\phi 36.6 \pm 0.2$ mm ( $\phi 1.44 \pm 0.01$ in.)
		back angle	$62^\circ$
		ramp angle	$11.5^\circ$
d	clamp	description	worm screw type (see figure 1 below)
		supplier	Takagi mfg. co. ltd.
		torque range	N/A (see tightening stroke on figure 1)
e	lubricants allowed for use as assembly aids	KEROSENE	
f	any reinforcement sleeves/ferrules used in the tank spud	none

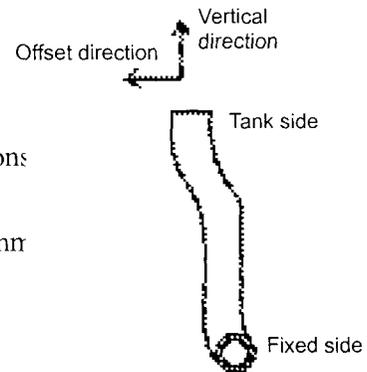
- Test date March 7, 2000
- Test place Hose/fuel laboratory, Tokai Rubber Industries, Ltd.
- Test conditions
  - Pull-off direction ..... In the directions of arrows in the sketch at left (pulled in two directions)
  - Pull-off speed ..... 500 mm/min
  - Assembling condition... Length of insertion onto pipe 30 mm  
 Clamp tightening margin  
 14 mm under neck
  - Installed posture ..... Same as installed in actual vehicle

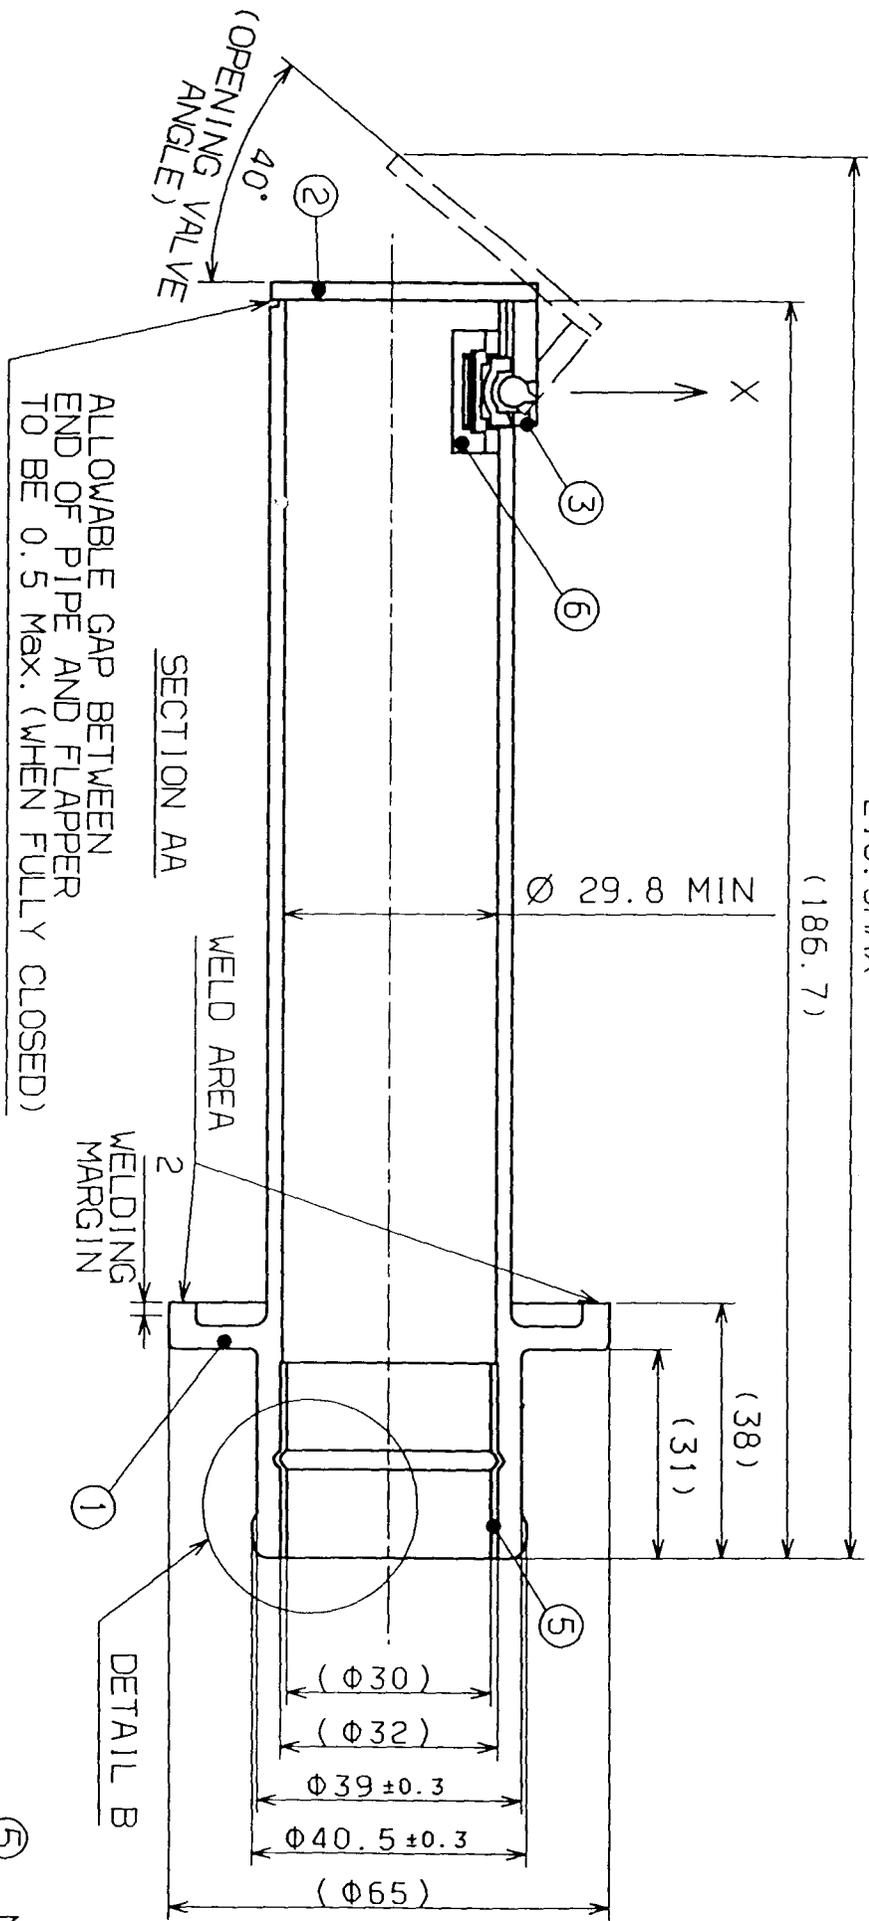
# Attachment #6

215.5 MAX  
(186.7)

ALLOWABLE GAP BETWEEN  
END OF PIPE AND FLAPPER  
TO BE 0.5 MAX. (WHEN FULLY CLOSED)

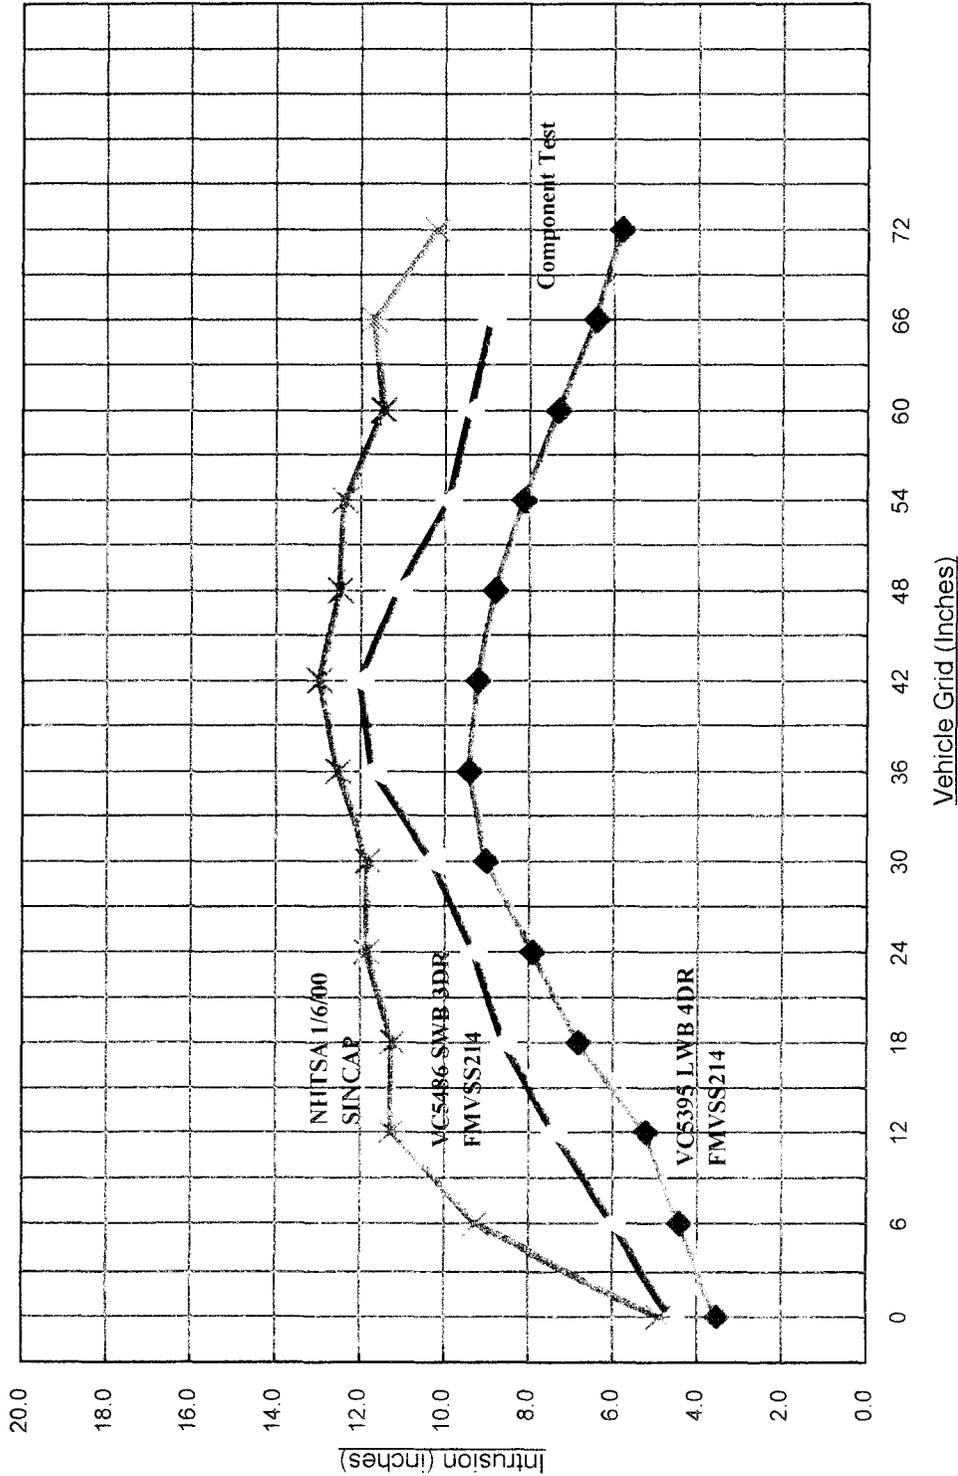
**NS Post-Test Crush Measurements**  
**Door Sill Plane**

VC05395 VC05486 Series5

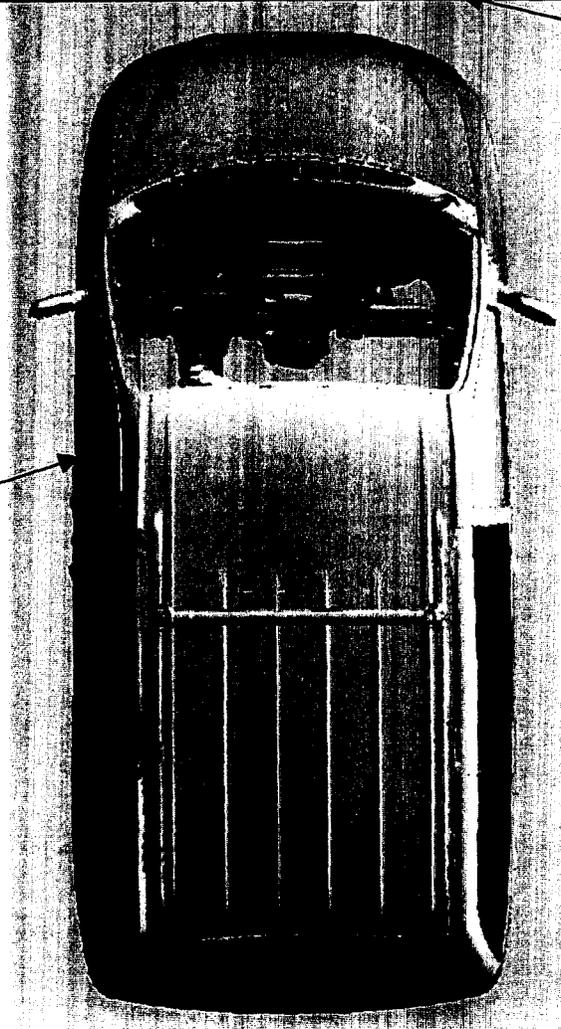
# 30 MPH IMPACT SIMULATION WITH NS MINIVAN

NS MINIVAN

9 LOAD CELLS  
EQUALLY SPACED

CONCRETE WALL

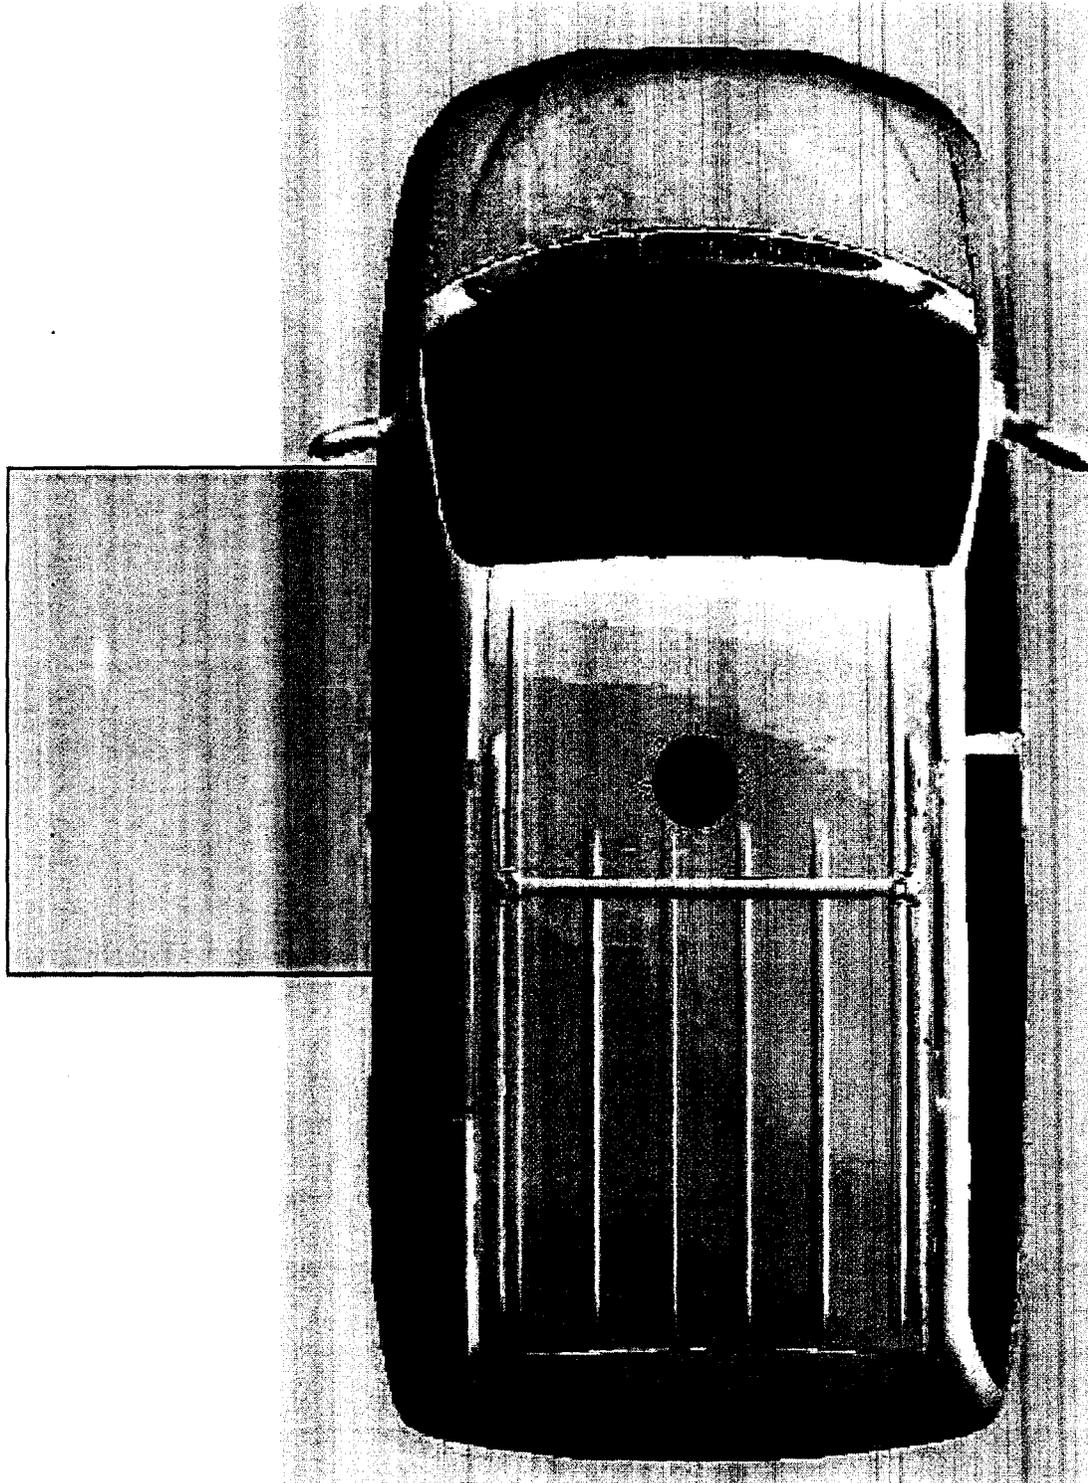
<b>NS LWB</b>	<b>At FMVSS-214 Location</b>
<b>Angular Velocity (rad/s)</b>	<b>0.47</b>
<b>Energy Dissipated *</b>	<b>73,717ft - lbf</b>

\* Energy dissipated includes the crush of the barrier and the vehicle.

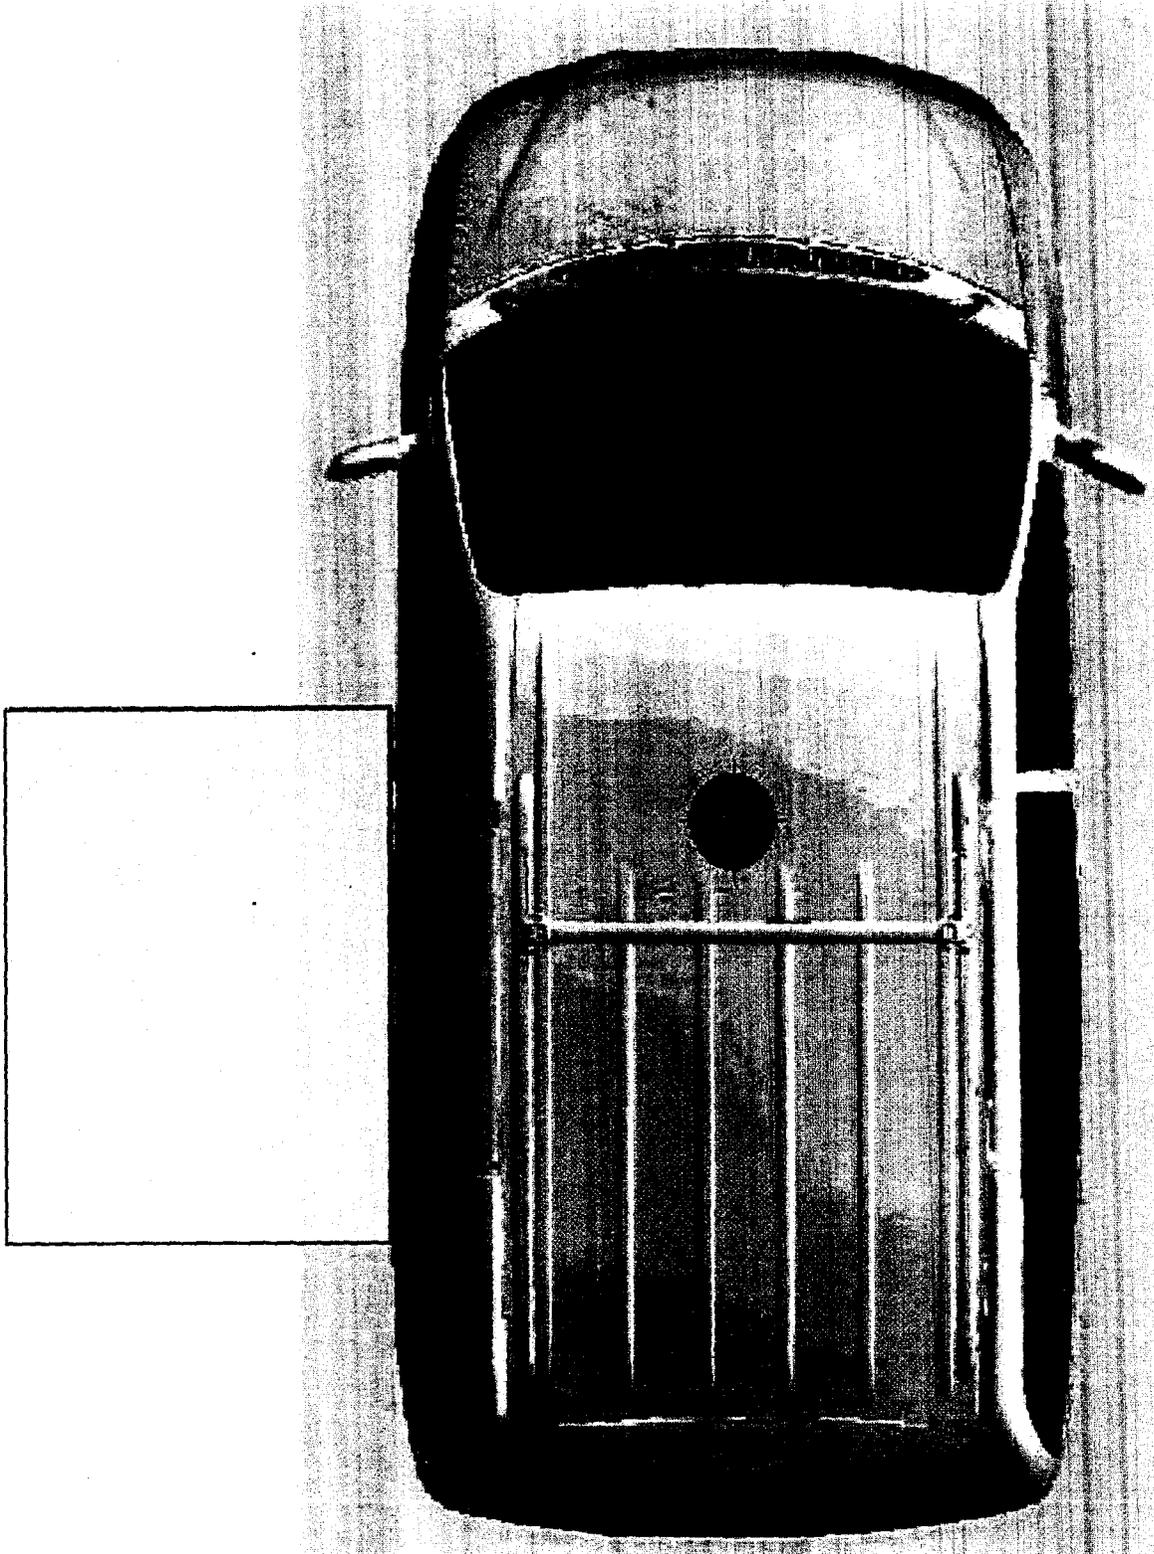
<b>NS LWB</b>	<b>Between 214 pos &amp; Rear Axle</b>
<b>Angular Velocity (rad/s)</b>	<b>2.54</b>
<b>Energy Dissipated*</b>	<b>62,582 ft - lbf</b>

\*Energy dissipated includes the crush of the barrier and the vehicle.

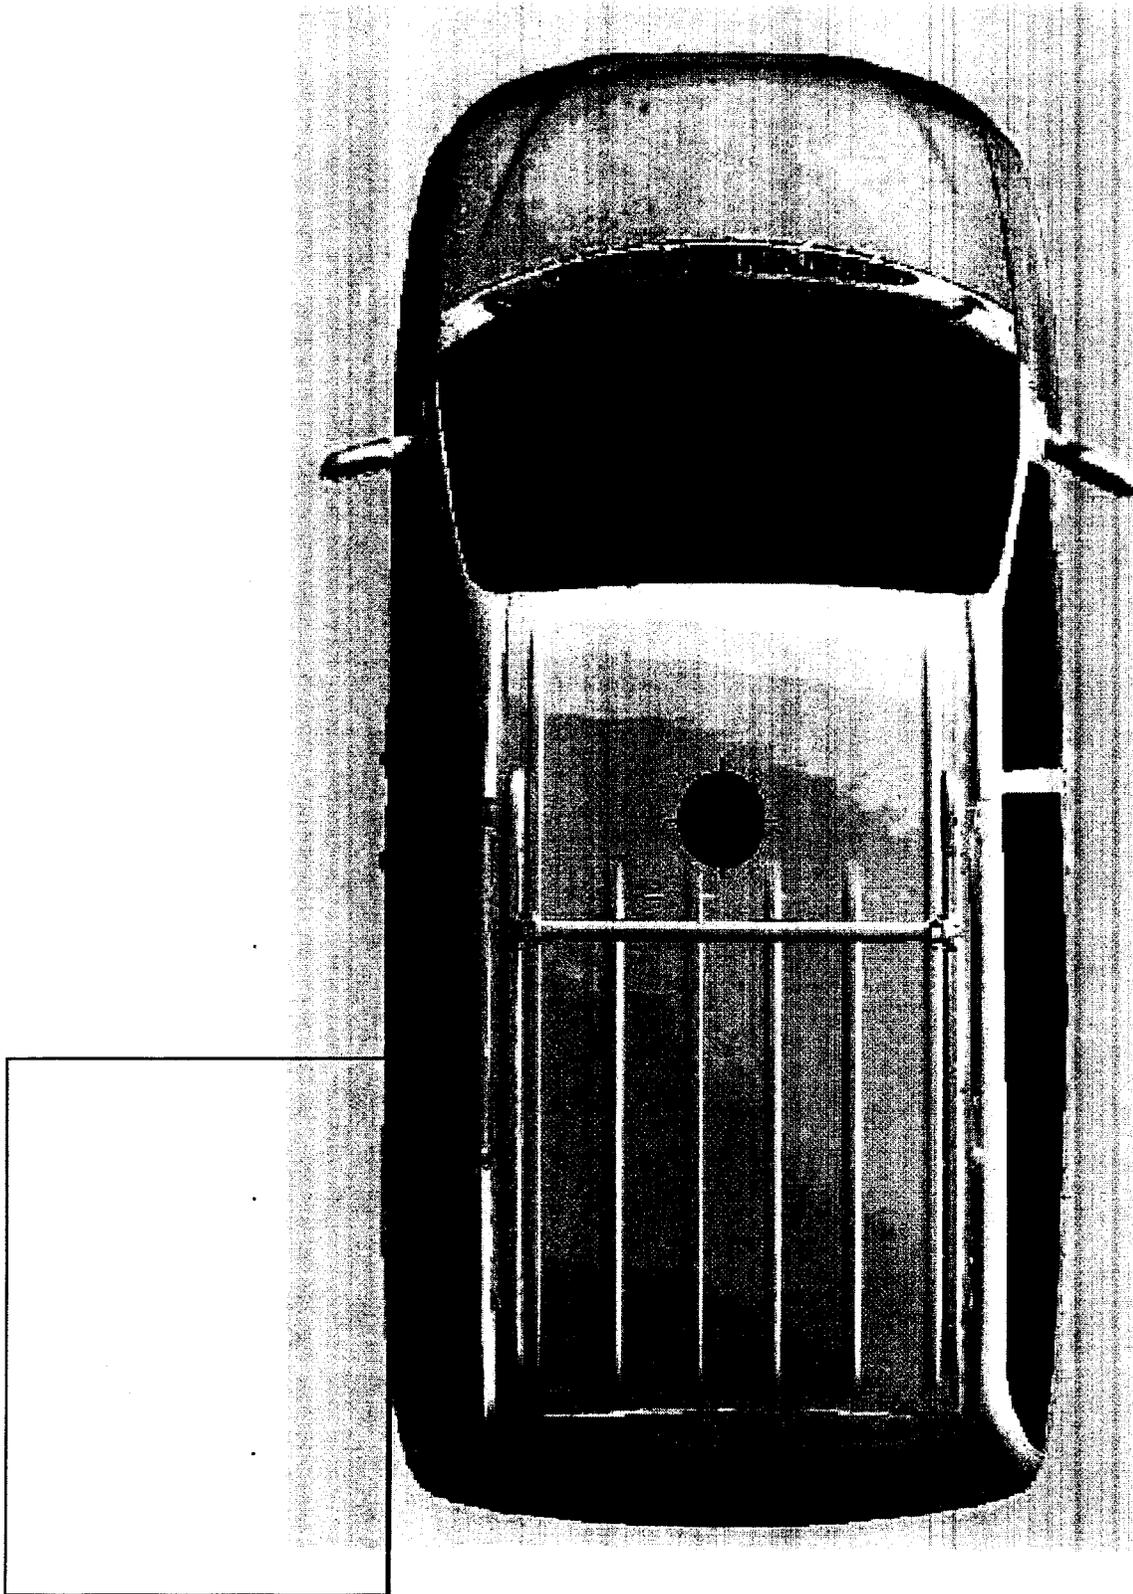
<b>NS LWB</b>	<b>Centered on Rear Axle</b>
<b>Angular Velocity (rad/s)</b>	<b>3.40</b>
<b>Energy Dissipated*</b>	<b>46,041 ft - lbf</b>

\* Energy dissipated includes the crush of the barrier and the vehicle.

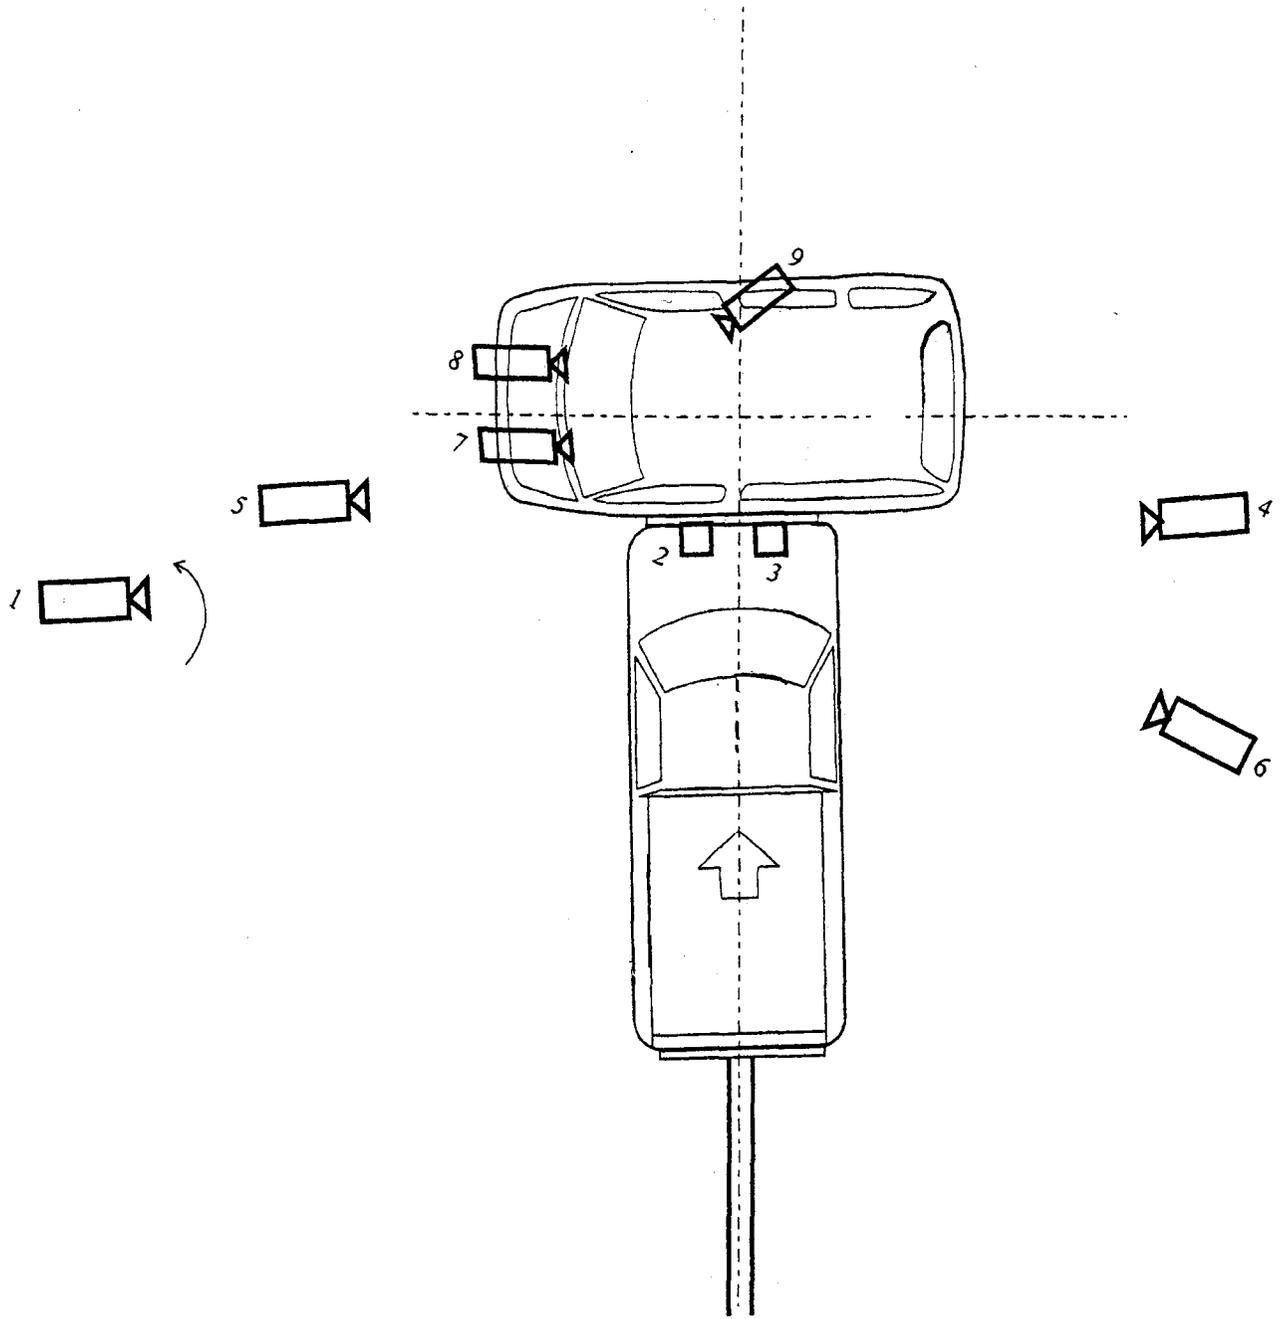
**Figure 2.1 – Sketch of Test Setup for 90° Side Impact Test on a 2000 Chrysler Voyager**

The moving 1996 Dodge Dakota was used to impact the stationary 2000 Chrysler Voyager on the left (driver's) side. The crash test was a 90° side-impact and the nominal impact speed of the striking vehicle was 30 mph. The impact point was near the fuel filler neck. The right edge of the Dakota front bumper was aligned near the centerline of fuel tank spud where the filler hose is attached. Dummy response data, fuel leakage measurements, and films of the tests were obtained. Static rollover tests were conducted under the test conditions specified in FMVSS No. 301, "Fuel System Integrity," after the impact test.

A sketch of the test setup for this crash test (excerpted from TRC report page showing camera positions) is shown in Figure 2.1

Note: 2, 3 were overhead cameras

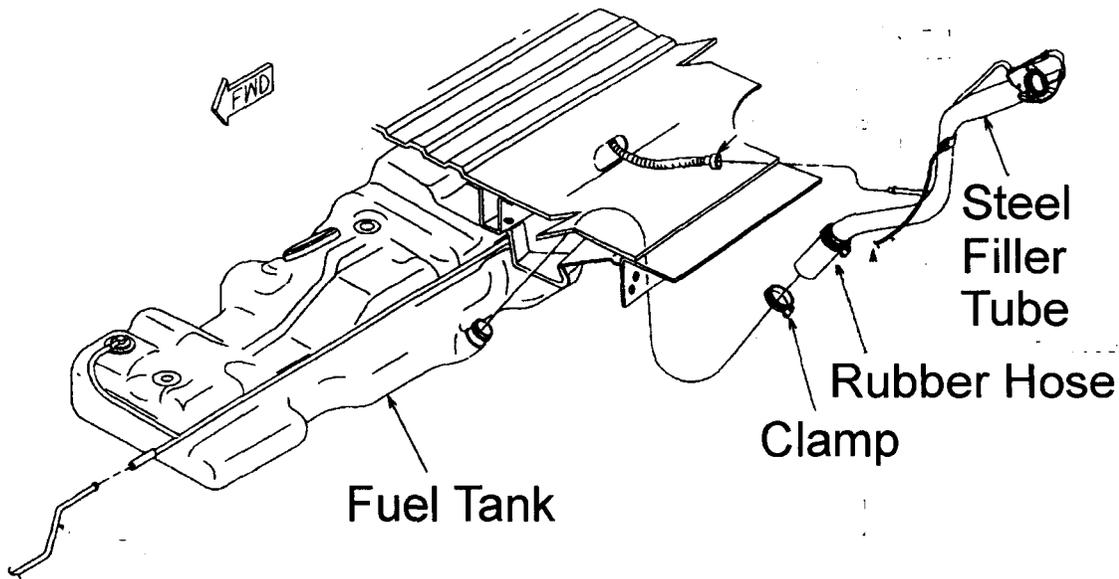
Figure 2 Fuel tank and filler pipe

inches. The rubber hose is secured to the filler tube and tank spud by standard worm drive type hose clamps (see Figure 2).

Several aspects of DaimlerChrysler's design of the filler neck assembly for the subject minivans contribute to an overall lack of robustness in the design to withstand either a high tensile load or significant displacement input during a moderate to severe crash. This is confirmed by NHTSA's evaluation of data collected from other manufacturers of minivans (NHTSA sent peer information request letters to five other manufacturers to obtain information about their filler neck assembly designs). For example, the rubber hose connected to the fuel tank inlet is significantly shorter than the hose on other peer minivans (giving rise to higher tensile load for a given amount of displacement), and the bead on the tank spud (which provides resistance to pull-off force) is ramped with a shallower angle than peer minivans. The location of the filler neck assembly and the surrounding vehicle structure does not isolate the filler neck from crash forces as well as other minivans. For this reason, the filler neck assemblies of some other minivans will experience less loading and displacement on the filler neck during a crash. Also, DaimlerChrysler did not reinforce the tank spud on the subject minivans with a metal liner, as some other manufacturers did on their minivans, which would have reduced compression deformation of the tank spud during high tensile loading. Finally, DaimlerChrysler does not have performance specifications for the minimum pull-off force of the rubber hose from the filler pipe or fuel tank spud as do some other minivan manufacturers, and the company did not test the capability of the hose to withstand such a force during development of the subject minivans.
