EA99-013

**JUNE 1, 2000 DAIMLERCHRYSLER
PRESENTATION TO NHTSA**

Re: NSA-122j1q; EA99-013

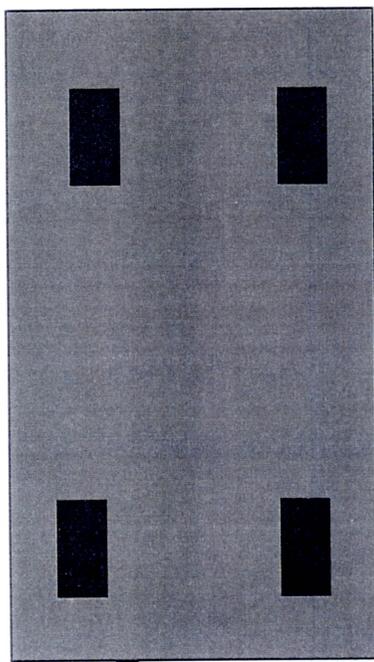
30 MPH IMPACT SIMULATION WITH MOVEABLE DEFORMING BARRIER

**MOVEABLE DEFORMING
BARRIER**

**9 LOAD CELLS
EQUALLY SPACED**

CONCRETE WALL

A typical vehicle has more front-end sweep than does the FMVSS 214 barrier. The intrusion caused by the vehicle is typically greater at the more rigid center than at the softer corners. By comparison, the barrier face has no sweep and will show uniform load distribution across its entire face. This is shown in the load distribution curves for vehicle and barrier testing (see pages 1 - 14). The vehicle is much softer at the outside and does not pick up significant loads at the edges. The FMVSS 214 barrier, on the other hand, picks up consistent load across its entire face. It is this rigid edge of the barrier that creates the intrusion that created the NS fuel filler hose separation in the laboratory tests.

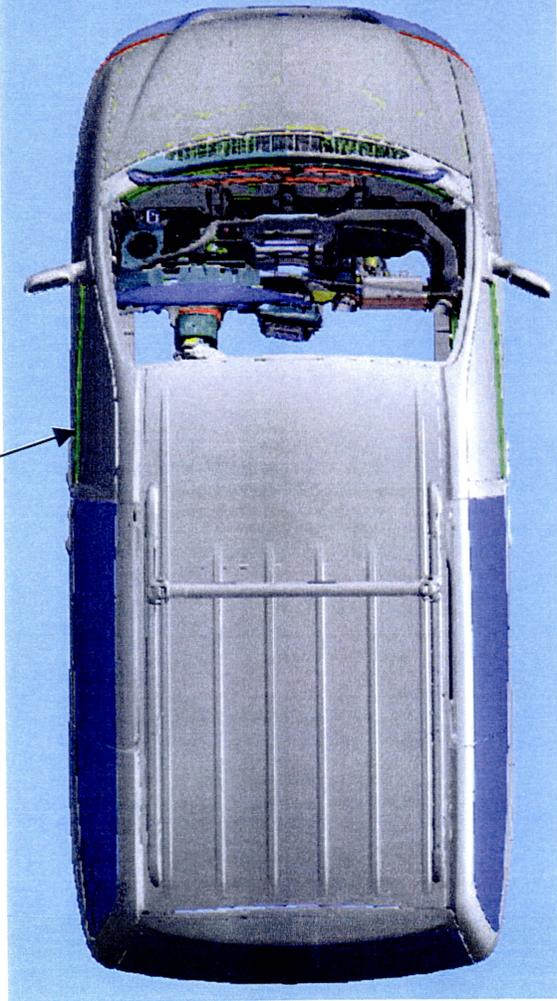
30 MPH IMPACT SIMULATION WITH NS MINIVAN

NS MINIVAN

**9 LOAD CELLS
EQUALLY SPACED**

CONCRETE WALL

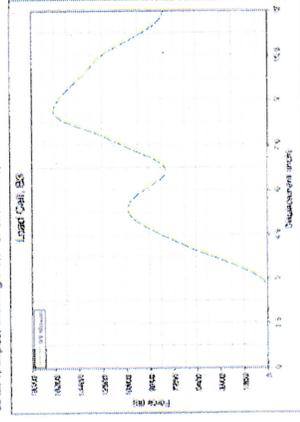
30 MPH Impact with Rigid Barrier Simulation,
Load Cell B5

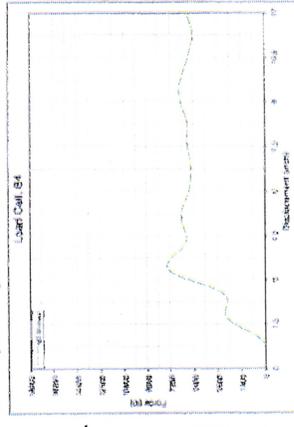
30 MPH Impact with Rigid Barrier Simulation,
Load Cell B4

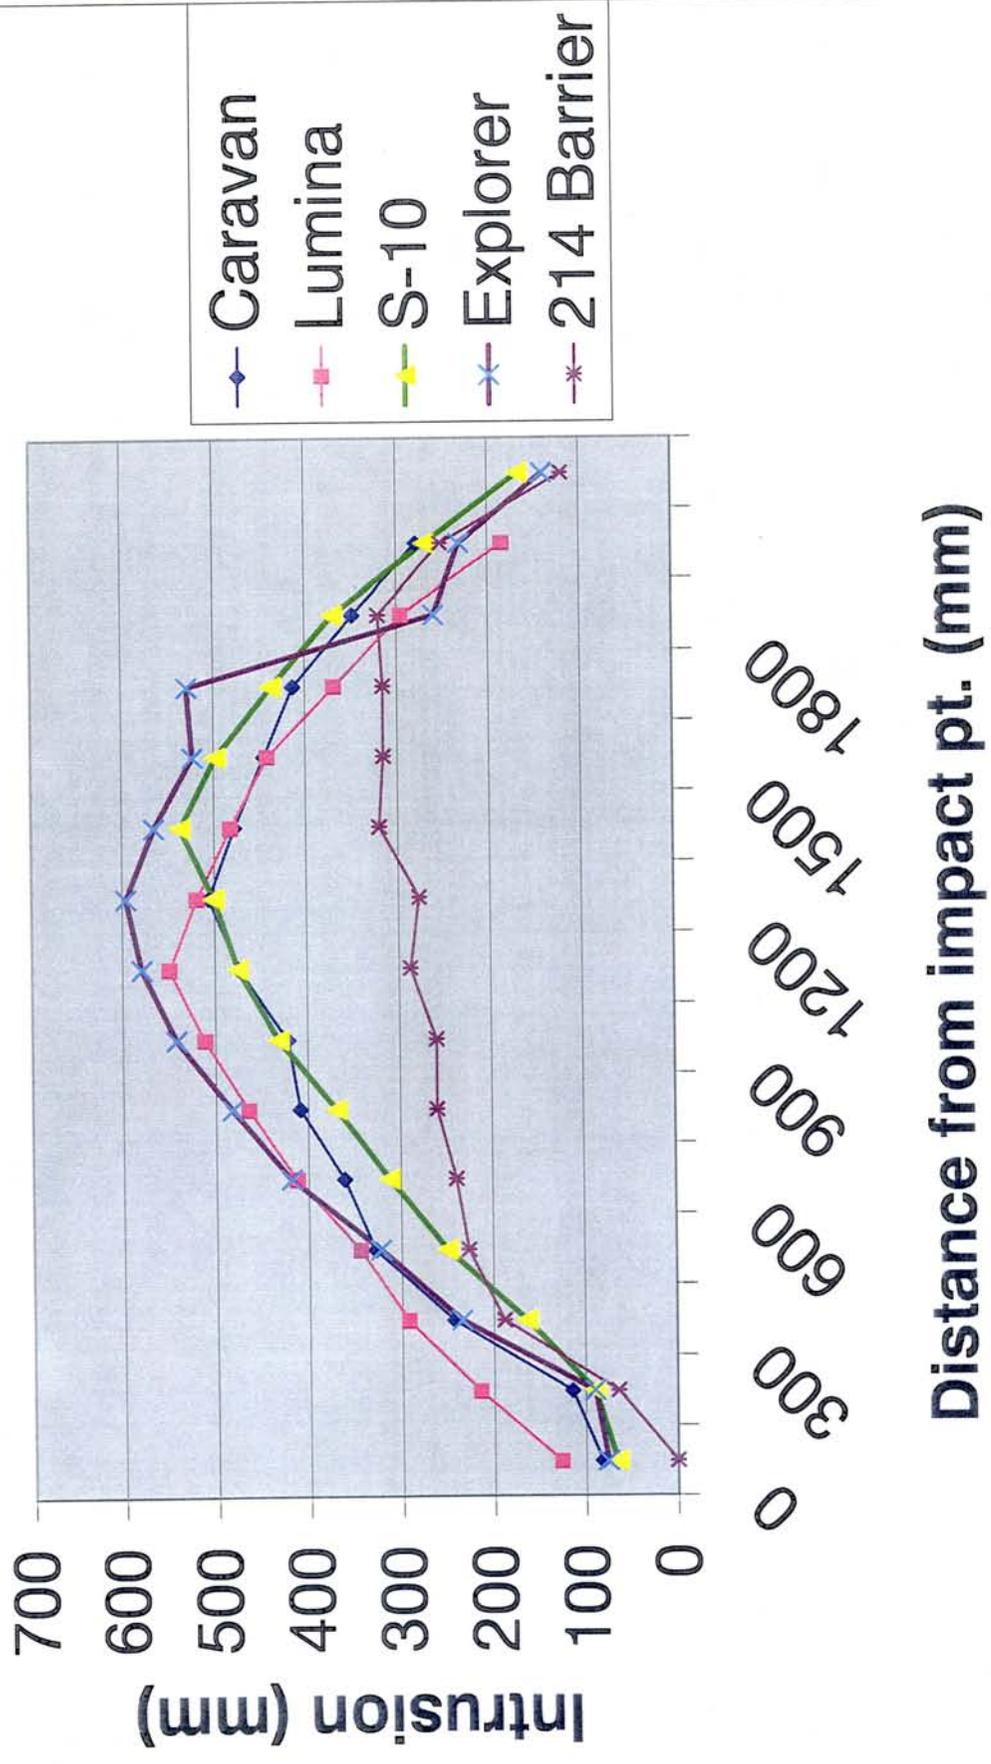
Accord Mid-door Displacement Struck w/ Various Vehicles Using 214 Protocol

To further illustrate the difference between the side barrier tests and real world impacts, NHTSA's test data of the Honda Accord was used (see page 15). NHTSA tests were run using various bullet vehicles and the moving deformable barrier in a FMVSS 214-type impact into the side of the Accord. The intrusion pattern shown on page 15 is data taken at sill height that represents the height of the intrusion in the laboratory tests. . The intrusion pattern of the FMVSS 214 barrier is not comparable to any of the bullet vehicle intrusion patterns. This data indicates that the FMVSS 214 barrier is not a good predictor of structural performance in this area of an actual vehicle to vehicle impact.

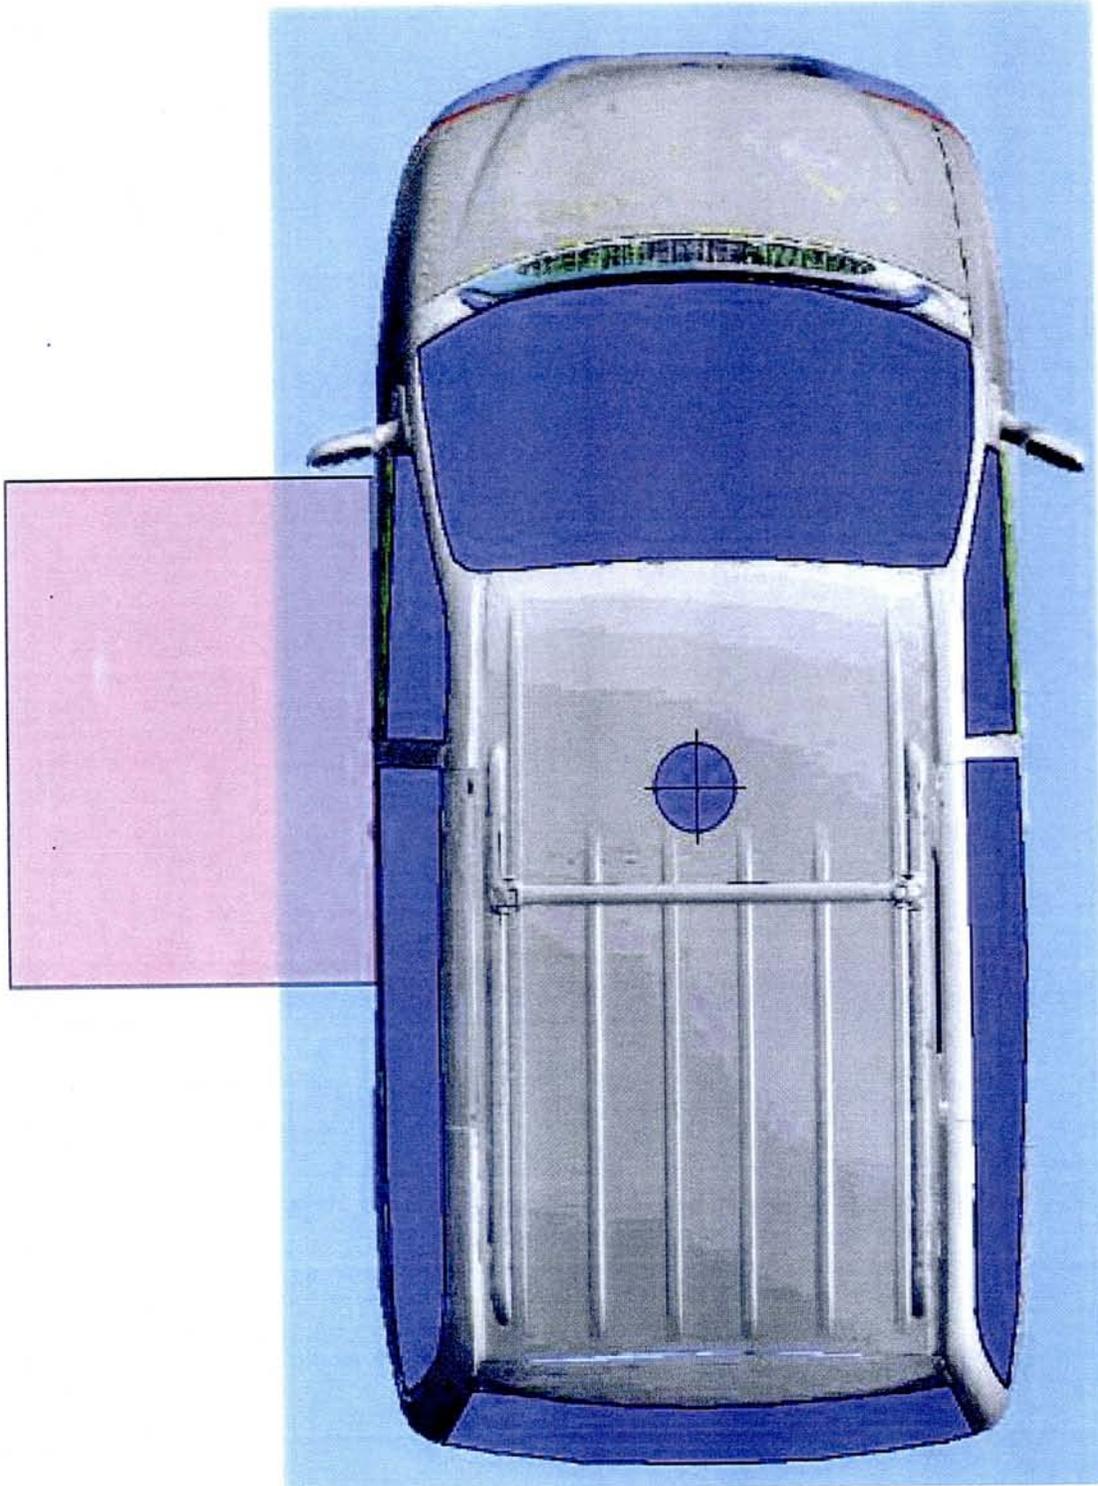
| NS LWB | At FMVSS-214 Location |
| Angular Velocity (rad/s) | 0.47 |
| Energy Dissipated * | 73,717 ft - lbf |

* Energy dissipated includes the crush of the barrier and the vehicle.

As the bullet vehicle strikes closer to the fuel filler system the center of impact moves rearward away from the longitudinal center of gravity of the vehicle. As the impact moves away from the center of gravity, the struck vehicle will experience greater rotational forces and more of the energy of the event will be absorbed by rotational energy and less on deformation and intrusion. A simple model was evaluated to demonstrate this principle. (See pages 16 - 19) The model was evaluated with the FMVSS 214 barrier impacting the vehicle in three locations: at the normal FMVSS 214 position, centered at the rear axle, and half way between the first two positions. As seen on the slides, pages 20 - 22, the angular velocity increases as the barrier moves rearward, away from the longitudinal center of gravity. As angular velocity increases less energy from the event is dissipated in deformational energy. Approximately 37% less energy goes into the intrusion of the vehicle in the rearmost impact when compared to the FMVSS 214 position.

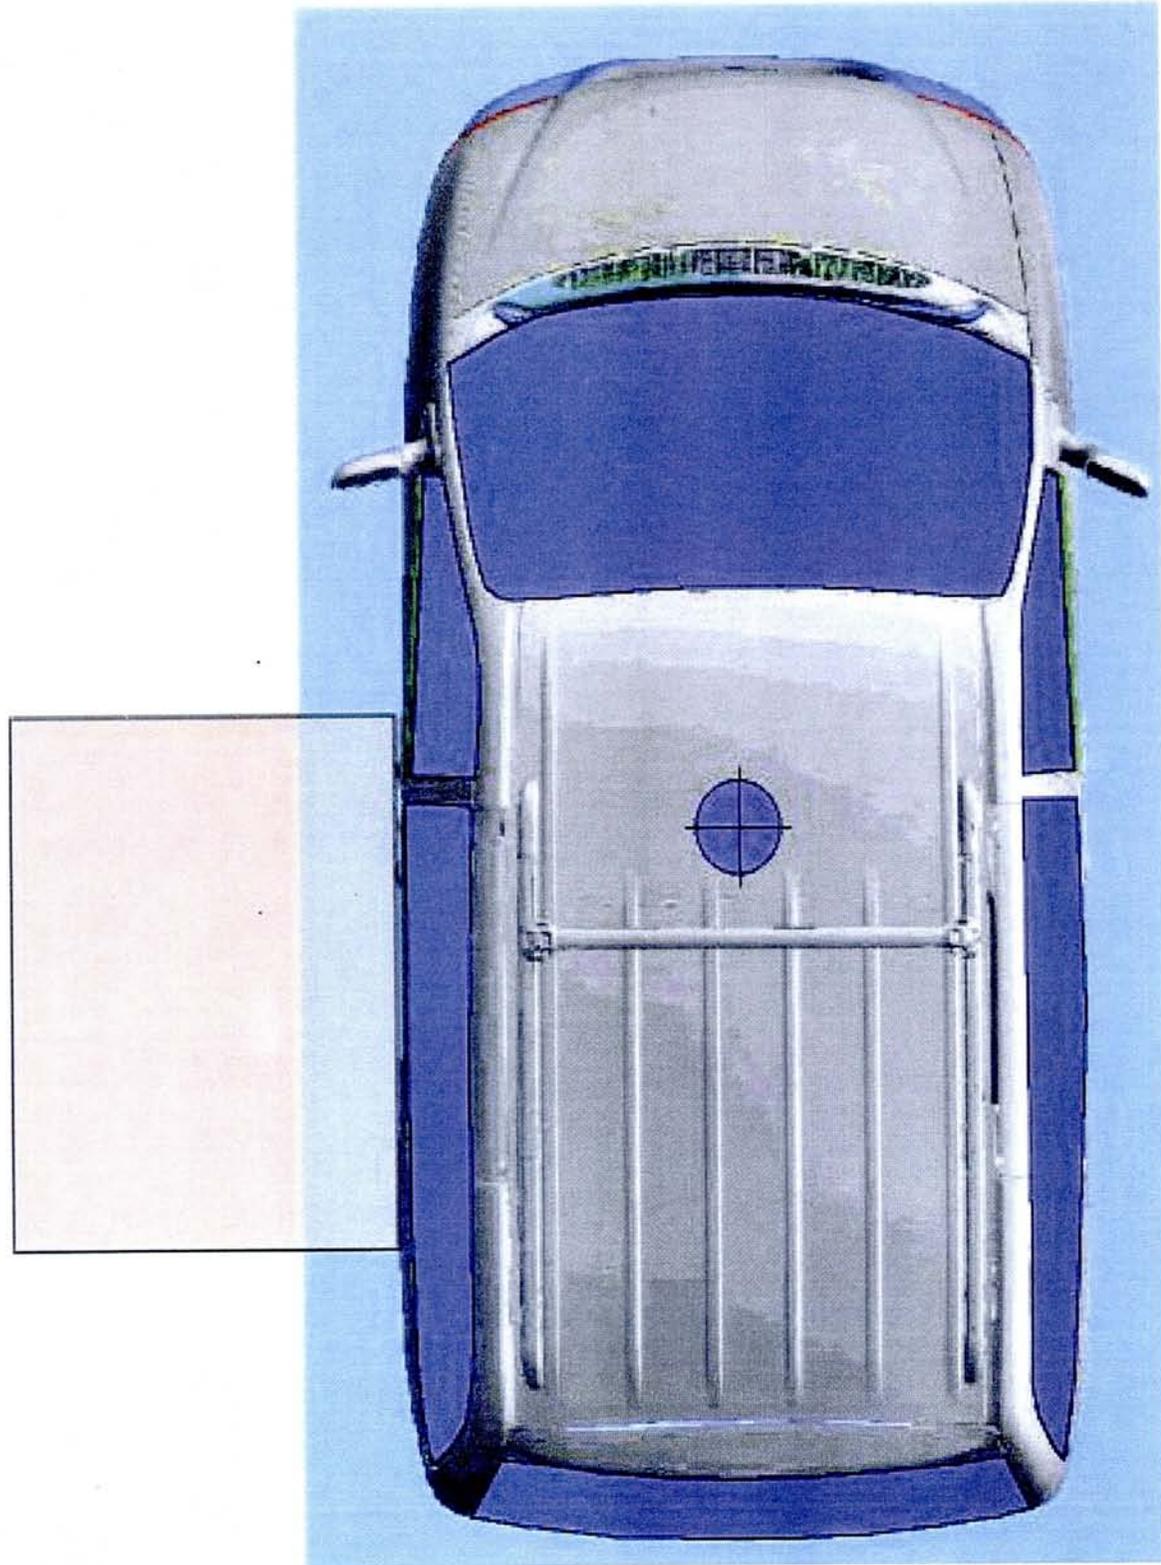
| NS LWB | Between 214 pos & Rear Axle |
| Angular Velocity (rad/s) | 2.54 |
| Energy[*] Dissipated | 62,582 ft - lbf |

*Energy dissipated includes the crush of the barrier and the vehicle.

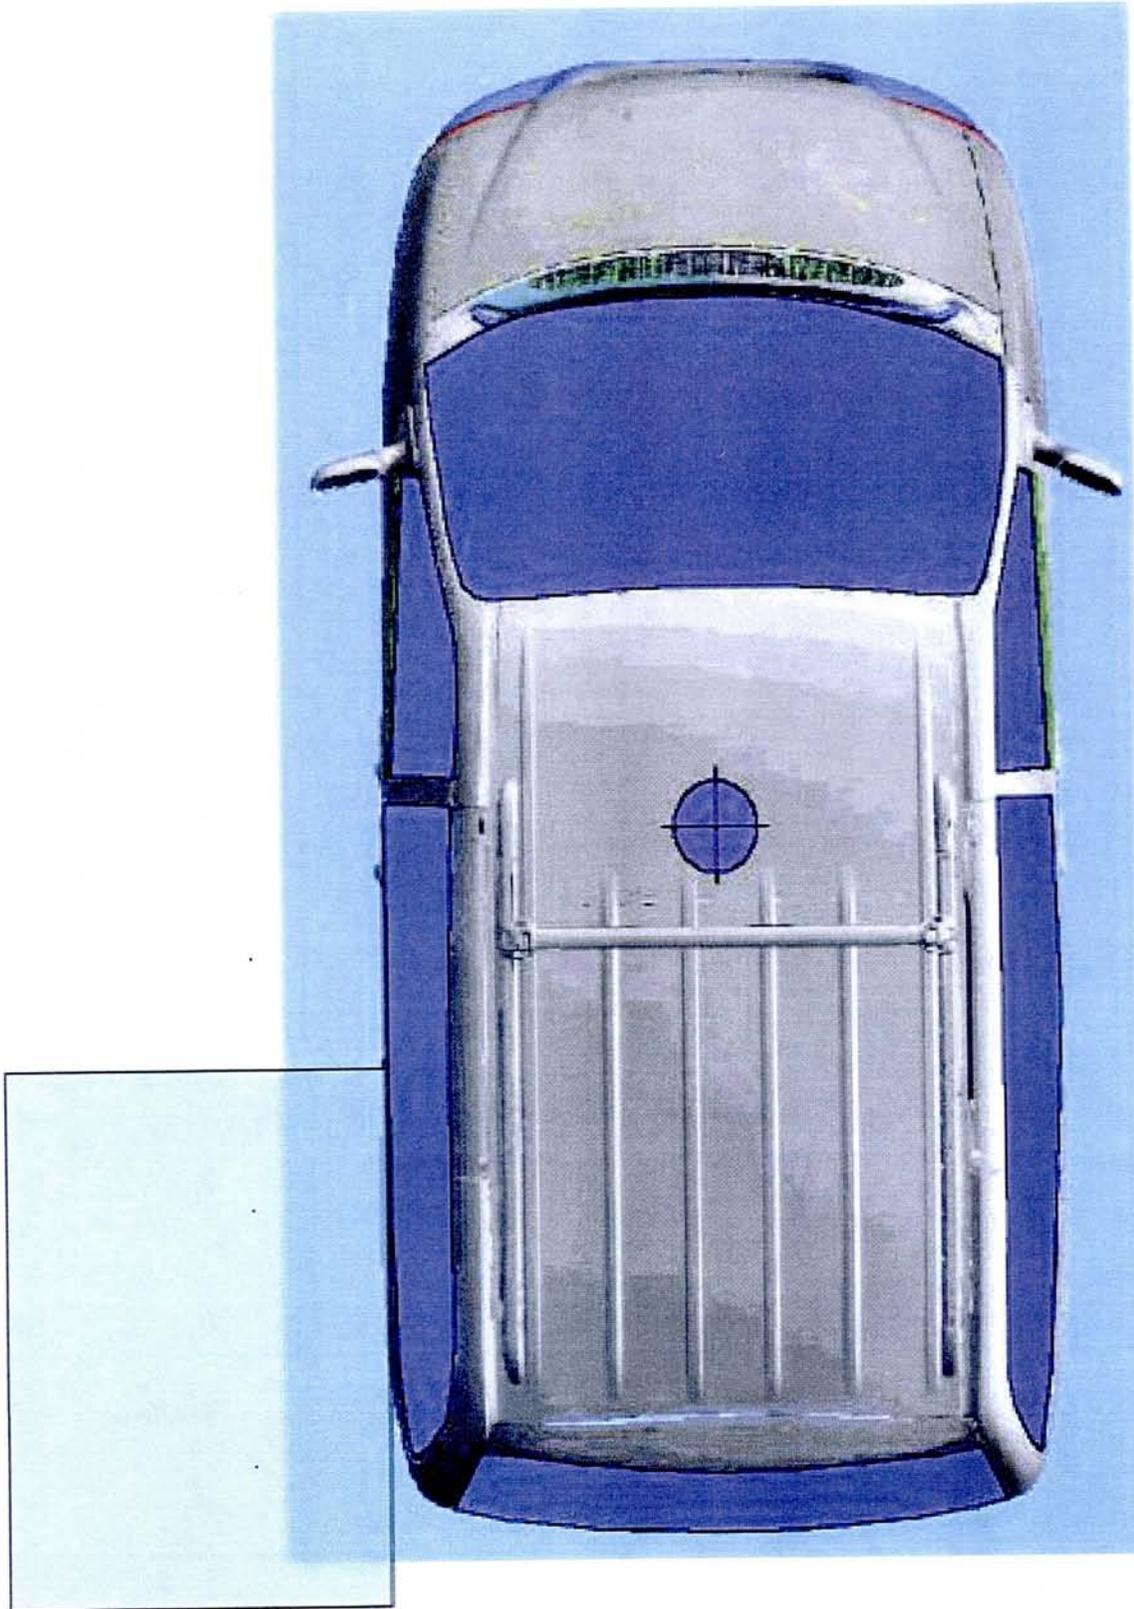
| NS LWB | Centered on Rear Axle |
| Angular Velocity (rad/s) | 3.40 |
| Energy Dissipated* | 46,041 ft - lbf |

* Energy dissipated includes the crush of the barrier and the vehicle.
