## SAFETY RECALL G-09501

FEBRUARY 2009

### INTERIM NOTICE

**INTERIM ACTION REPAIR PROCEDURE**  
**OPTIONAL – SEE REVERSE SIDE**

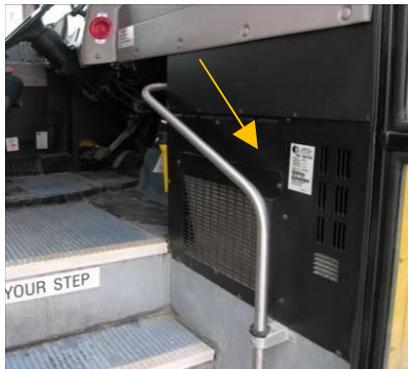
Figure 1. Stepwell Heater

This notice is being sent to you in accordance with the requirements of the National Traffic and Motor Vehicle Safety Act. IC Bus has decided that a defect which relates to motor vehicle safety exists in certain BE, CE/ IC/ CS, and FE model commercial and school buses built 2/2/00 thru 6/2/08 with a stepwell heater feature code 0048PMS or 0548001 (Figure 1), and/or rear wall mounted 75,000 BTU heater feature code 0048TAR or 0048PSX (Figure 2).

1. This recall is only applicable to the heaters shown in Figure 1 and Figure 2. The bus may be equipped with only one or both. This recall does not apply to any other heater configuration.

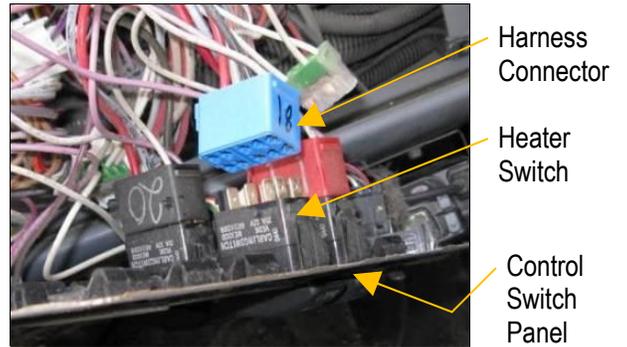
4. Depress the locking tab and remove the harness connector from stepwell / wall mount heater blower motor switch.

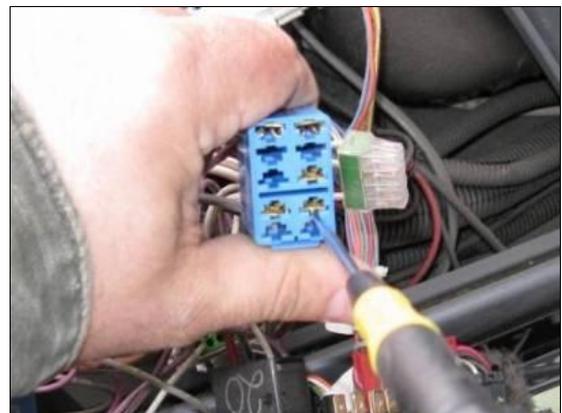
5. Depin the 12 gauge blue wire in cavity 3 of the harness connector using a spade tool to depress the terminal tab while simultaneously pulling the wire.

6. Tape the depinned blue wire out of the way to prevent damage to the terminal. This wire is not energized to power and will be reinstalled in the final repair.
