SAFETY RECALL G-09501

MARCH 2009

INTERIM NOTICE REVISED INSTRUCTIONS – PLEASE TAKE NOTE

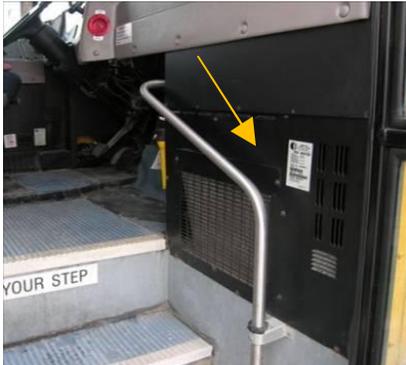
Figure 1. Stepwell Heater

IC Bus has decided that a defect which relates to motor vehicle safety exists in certain BE, CE/ IC/ CS, and FE model commercial and school buses built 2/2/00 thru 6/2/08 with a stepwell heater feature code 0048PMS or 0548001 (Figure 1), and/or rear wall mounted 75,000 BTU heater feature code 0048TAR or 0048PSX (Figure 2).

The heater blower motor may overheat during low speed operation possibly resulting in a vehicle fire.

1. You should provide clear instructions to all bus drivers to not operate the heater motor on low speed. Only operate the heater motor on high speed;
2. If the heater is not needed, remove its fuse or circuit breaker; or
3. The low speed setting of the heater blower motor may be disabled by performing the procedure on the reverse side of this letter.

1. This recall is only applicable to the heaters shown in Figure 1 and Figure 2. The bus may be equipped with only one or both. This recall does not apply to any other heater configuration.

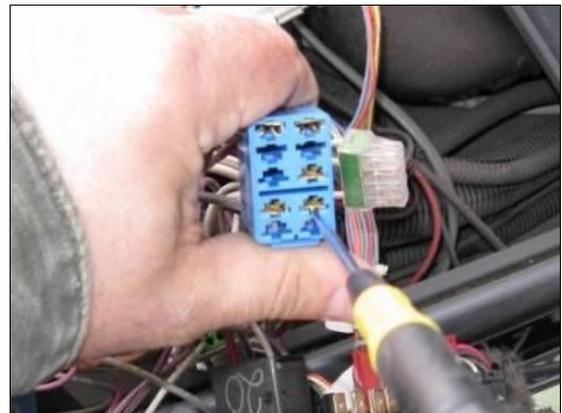
5. Depin the 12 gauge blue wire in cavity 3 of the harness connector using a spade tool to depress the terminal tab while simultaneously pulling the wire.

6. Wrap electrical tape around the terminal covering all the metal area well. Fold the depinned blue wire back on itself and tape. **This wire is energized when the motor is operated on high speed.**
