Safety Recall

G—09501 Interim Notice Revised

Subject: Bus Stepwell Heater Blower Motors

SAFETY RECALL G-09501

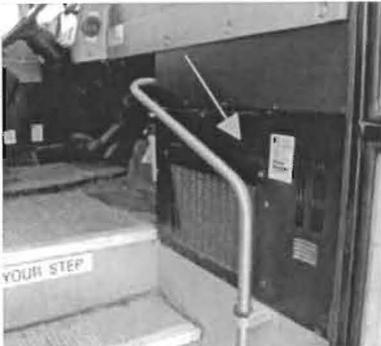
Figure 1. Stepwell Heater

IC Bus has decided that a defect which relates to motor vehicle safety exists in certain BE, CE/ IC/ CS, and FE model commercial and school buses built 2/2/00 thru 6/2/08 with a stepwell heater feature code 0048PMS or 0548001 (Figure 1), and/or rear wall mounted 75,000 BTU heater feature code 0048TAR or 0048PSX (Figure 2).

1. This recall is only applicable to the heaters shown in Figure 1 and Figure 2. The bus may be equipped with only one or both. This recall does not apply to any other heater configuration.

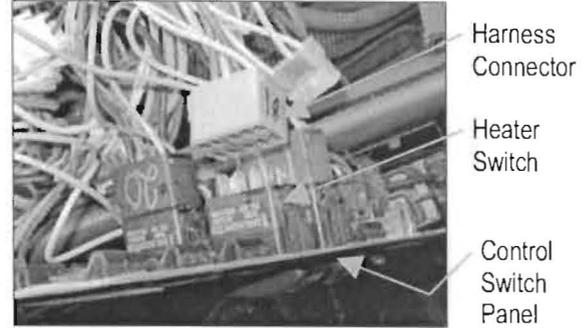
4. Depress the locking tab and remove the harness connector from stepwell / wall mount heater blower motor switch.

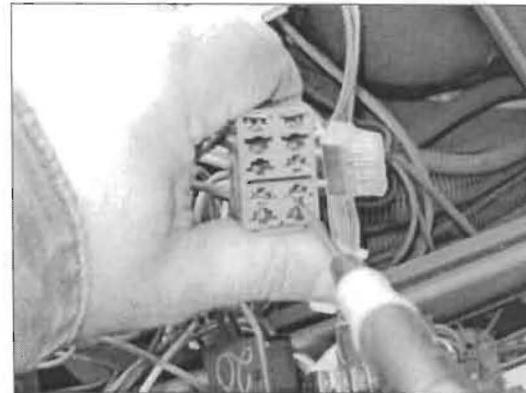
5. Depin the 12 gauge blue wire in cavity 3 of the harness connector using a spade tool to depress the terminal tab while simultaneously pulling the wire.

6. Wrap electrical tape around the terminal covering all the metal area well. Fold the depinned blue wire back on itself and tape. **This wire is energized when the motor is operated on high speed.**
