RE: NHTSA Recall 08E-055, Hyundai Recall 085

Subject: Campaign 085 - 2007/2008 Santa Fe and Veracruz Models - Trailer Hitch Wiring Harness Replacement

Subject TRAILER HARNESS REPLACEMENT PROCEDURE - CAMPAIGN 085	Group	CAMPAIGN
	Number	08-01-015
	Date	OCTOBER, 2008
	Model	2007-2008 VERACRUZ, SANTA FE

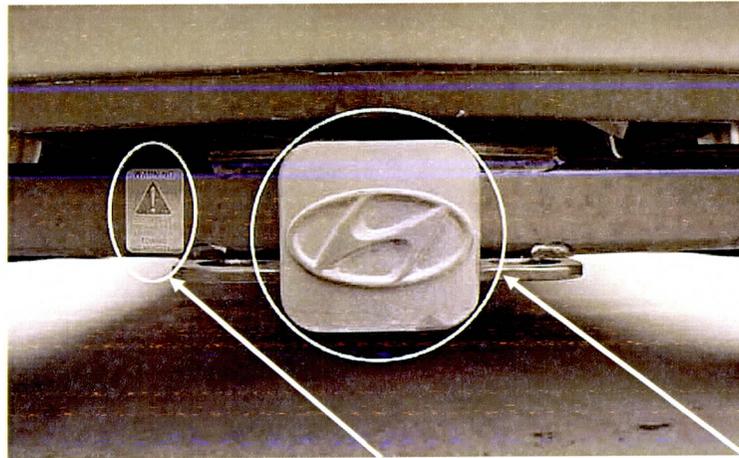
This notice applies only to 2007 or 2008 Hyundai Santa Fe or Veracruz vehicles that are equipped with a distributor-installed or dealer-installed accessory trailer hitch as shown below.

The affected hitch can be identified by the warning label and the distinctive end cap provided.

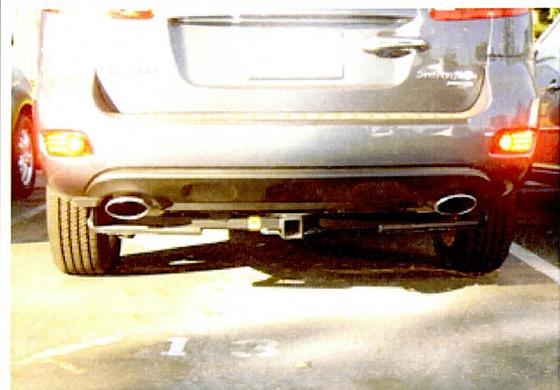
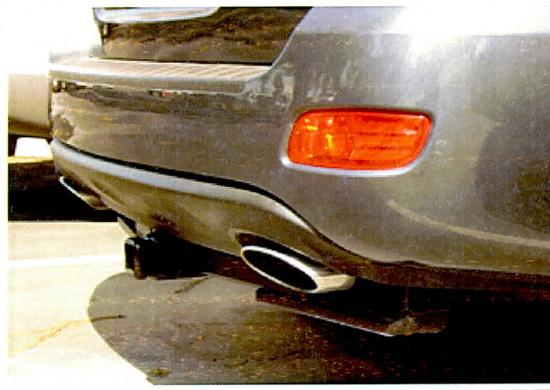
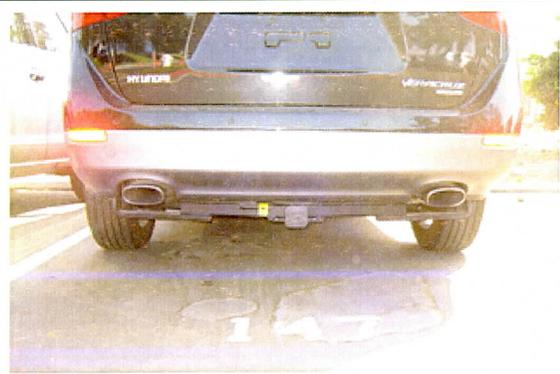
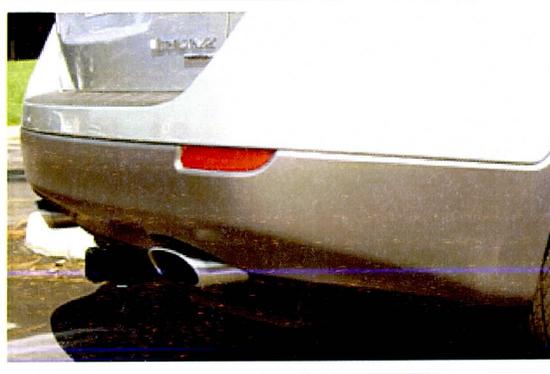
NOTE: PREVIOUS DESIGN TRAILER HITCH CONTROL MODULES ARE MOUNTED ON THE REAR BUMPER BEAM. ALL PREVIOUS DESIGN TRAILER HITCH MODULES, MUST BE REPLACED WITH MODULE THAT MOUNT UNDER THE VEHICLE.

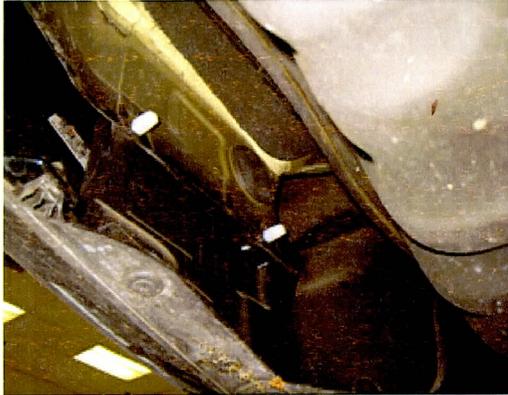
Direct To Battery
(No Harness)

NOTE: Two (2) types of trailer hitch wiring circuits have been installed on the 2007-2008 Santa Fe. The type of circuit will determine the proper service procedure. Look inside the driver side rear quarter behind the rear wheel to determine which procedure is appropriate for each vehicle.

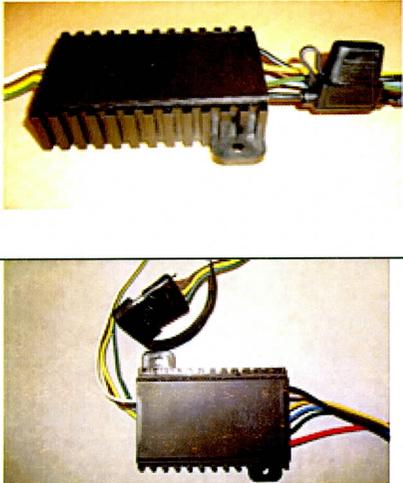
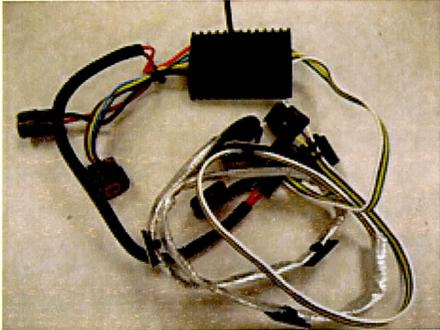
Previous	New
Part #	U8612 2B001/U8612 2B000	U8612 2B002
Santa Fe Direct to Factory Connectors

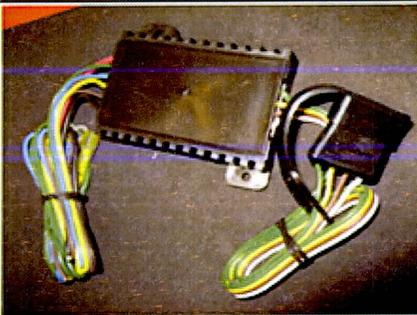
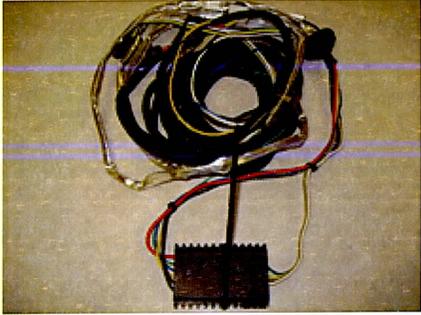
Part #	U8614 2B001/U8614 2B000	U8614 2B002
Santa Fe Direct to Battery

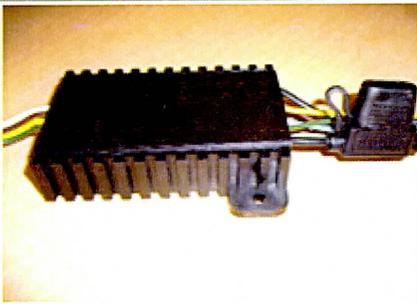
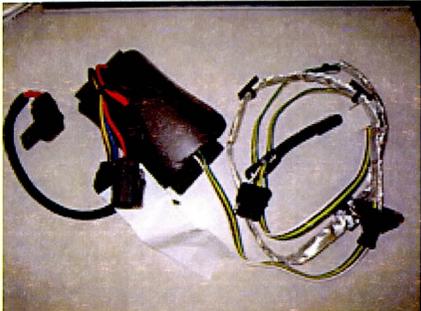
Part #	U8612 3J000/U8612 3J001 (Bare Module)	U8612 3J002 (Foam Covered Module)
Veracruz Direct to Factory Connectors

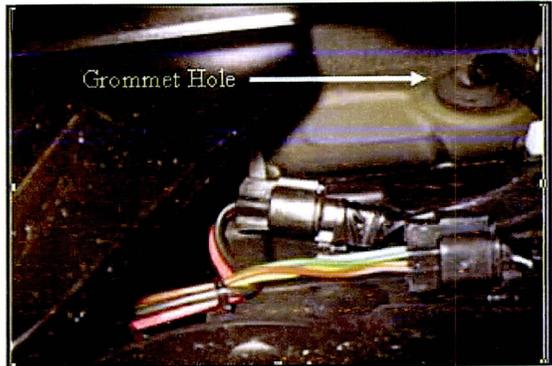
Carefully disconnect the two trailer hitch harness connectors located on the driver's side, behind the rear wheel next to the muffler.

After disconnecting the trailer harness, push the grommet, factory wires and connectors through the grommet hole.

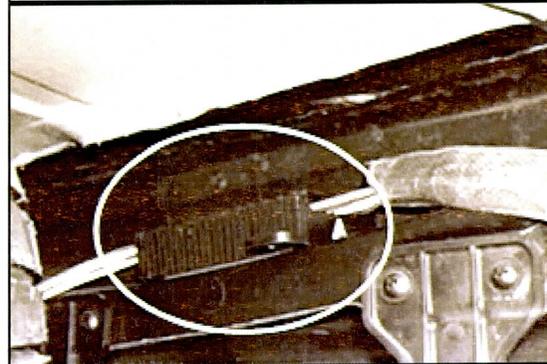
Remove the trailer hitch control module and harness by grasping the module by the hand and gently rotating it back and forth until the adhesive separates from the bumper reinforcement.

NOTE: Removed modules/harnesses MUST be returned to the WTC. Do not damage the module. Do not cut the attached wire harness.

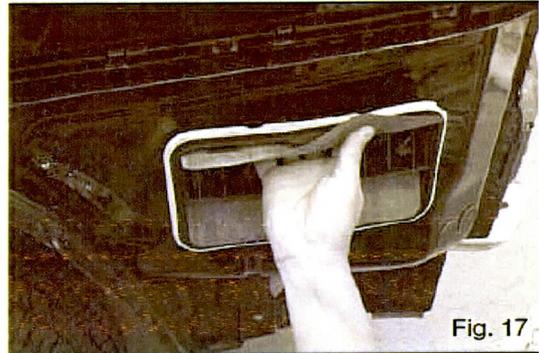
On left (driver's) rear side of vehicle, remove the Pressure Relief Vent (PRV) by lifting up the top flap and use fingers to unhook the locking tabs on the top of the vent.

CAUTION: Take care not to damage the PRV locking tabs.

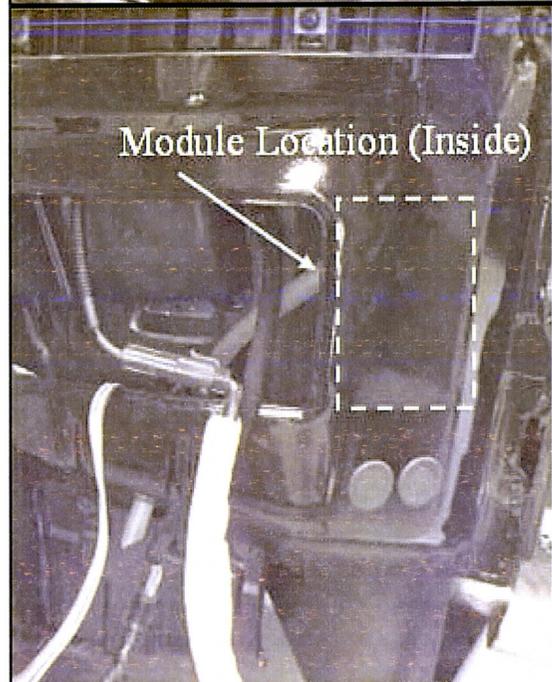
Before placing the new control module in the new location, connect the 2 connectors previously pushed through the grommet hole inside the PRV cavity to the module inlet connectors.

Clean inner flat surface of 'D' pillar as shown in the picture with provided alcohol pad.

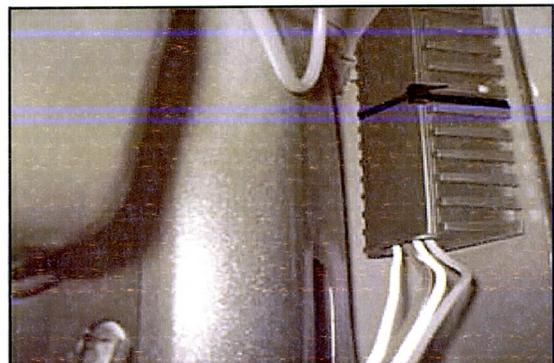
NOTE: Revised control module has a tie around the module and adhesive backing.

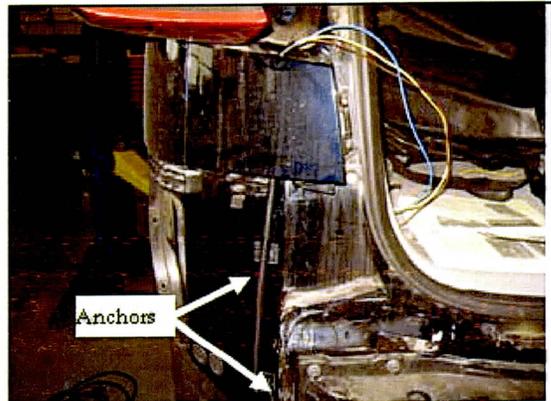
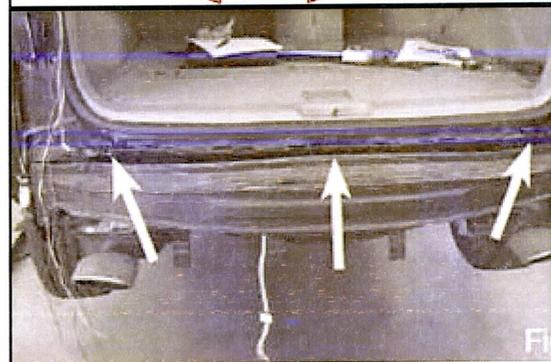
Secure the wire harness to the 3 anchors with wire ties.

Anchor orientation as shown in the picture

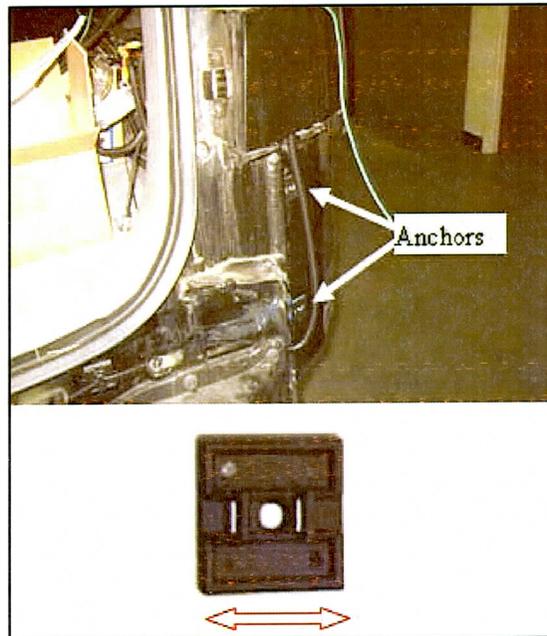
Apply 2 anchors in the location as shown. Prior to applying the anchors, clean the surface with provided alcohol pads.

Secure the wire harness to the anchors with supplied wire ties. Anchor orientation as shown in the picture.

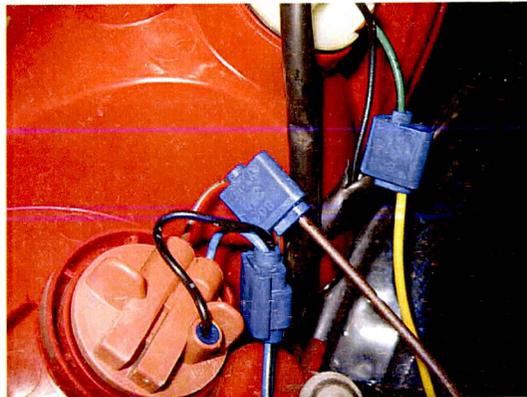
Attach the trailer hitch wiring harness to the rear light wiring cut in the prior steps. Splice the trailer hitch harness wires as listed in the chart below, using the grease filled wire taps provided.

Trailer Harness Wire Color	Cut Harness Wire Color	Function
Brown	Brown	Tail/Running Lights
Yellow	Yellow	Left Turn
Blue w/Black Stripe	Blue w/Black Stripe	Stop Lamps
Green	Green	Right Turn

WARNING: Using non grease filled connectors could lead to possible corrosion and light/harness malfunction.

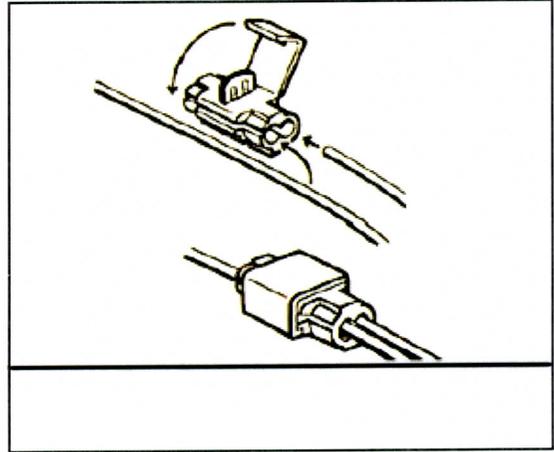
To properly secure the wire tap, open the cover completely and lay the original wire completely into the exposed channel. Insert the trailer harness module wire into the opening up to the stop. With both wires properly positioned inside the wire tap, use a pair of blunt nose pliers to seat the blade and pierce each wire in the wire tap. With the blade secured, close the cover of the wire tap, allowing it to lock in place.

NOTE: Failure to properly secure the wire tap may lead to intermittent operation of the harness and potential electrical system damage.

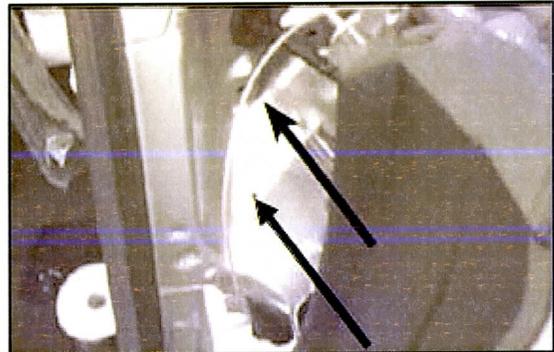
Position the wires within both tail light openings to avoid cutting or pinching the wires when the tail light assembly is secured.

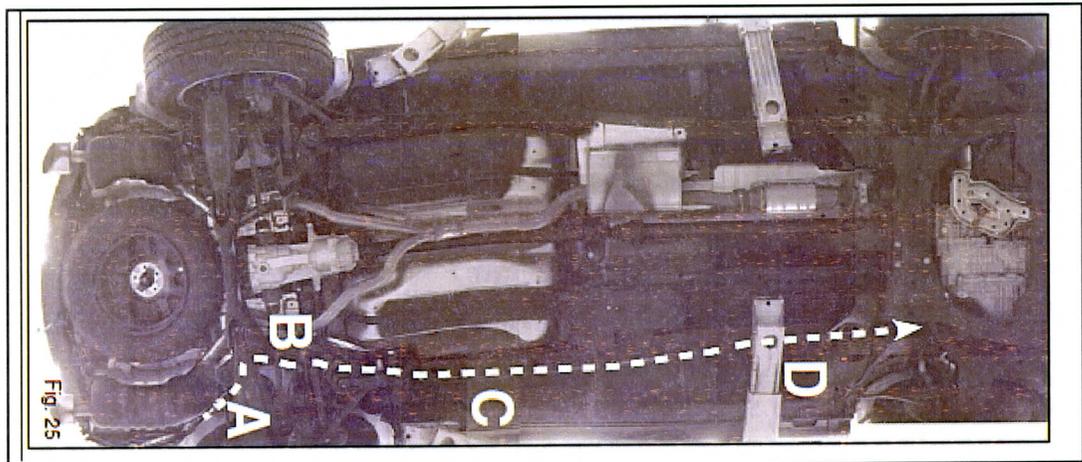
NOTE: Below is an overview of the Wire Path Installation - Module to Battery

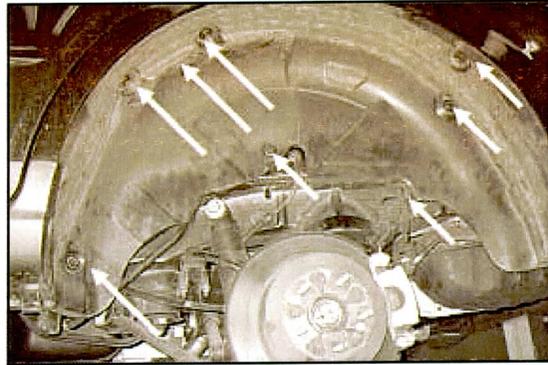
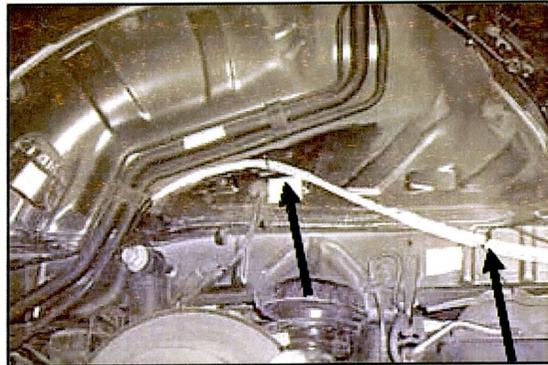
Use the red wire with coverings to route to fuse box in engine area. Route through wheel well as shown. **Wire Path Installation Location A.**

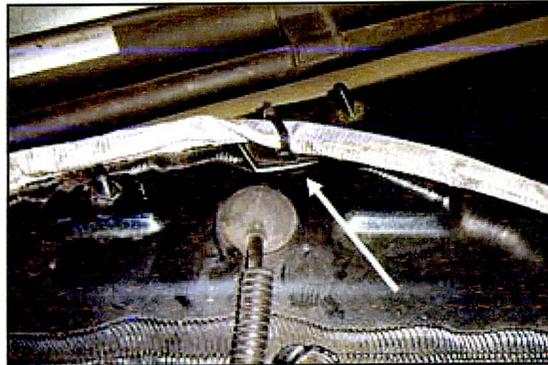
Secure the wire harness to the anchor point using the provided cable tie. **Wire Path Installation Location A.**

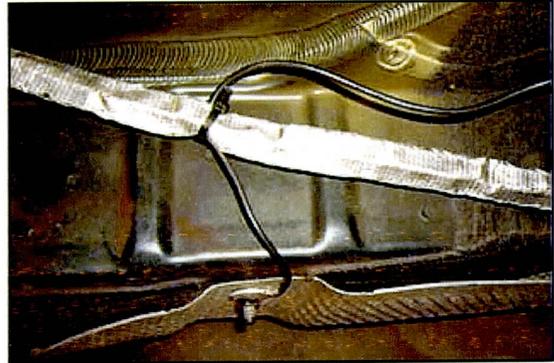
Position the ring terminal on the black module wire on the exposed stud and replace the nut. **Wire Path Installation Location A.**

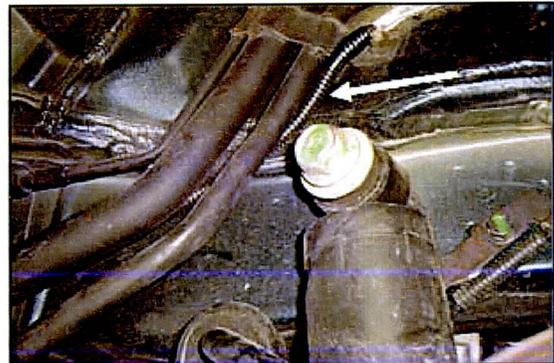
Route the harness above the exposed fuel pipe mounting bracket located just above the shock absorber mount bolt. **Wire Path Installation Location A.**

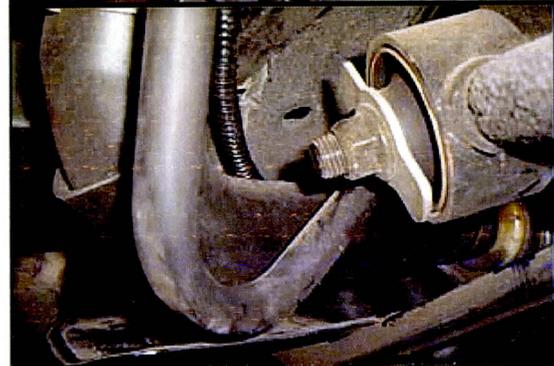
Continue routing the harness between the Emergency Brake cable and above the large fuel filler pipe. **Wire Path Installation Location B.**

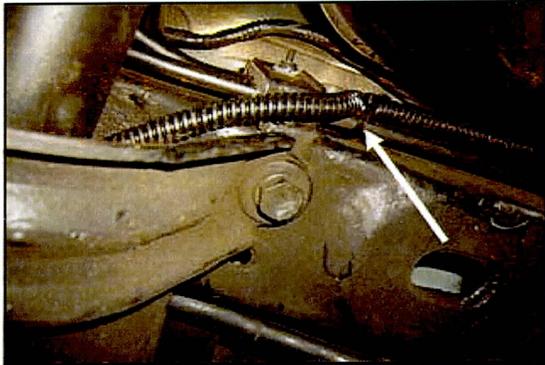
Secure the harness to the lower brake line using the provided cable tie. Locate tie in front of the brake line support bracket as shown. **Wire Path Installation Location B** indicated in photo.

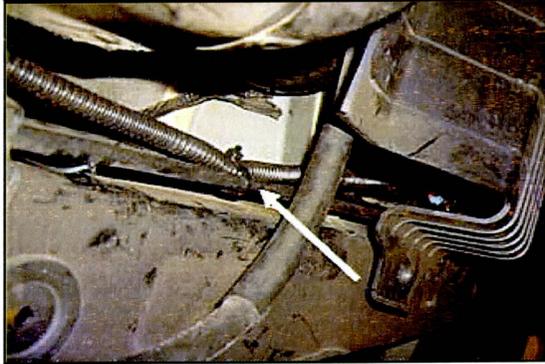
Route harness above the fuel pump plastic cover and secure using the provided cable tie to the lower brake line at corner of the pump cover. **Wire Path Installation Location C** indicated in photo.

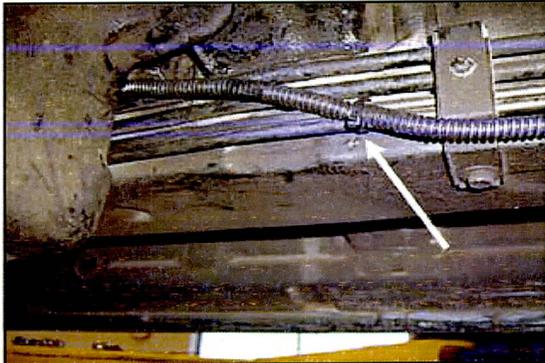
Continue to route the harness on the inside of the frame rail and secure to brake line using a provided cable tie just behind the bracket supporting the brake and fuel lines as illustrated. **Wire Path Installation Location C** indicated in photo.

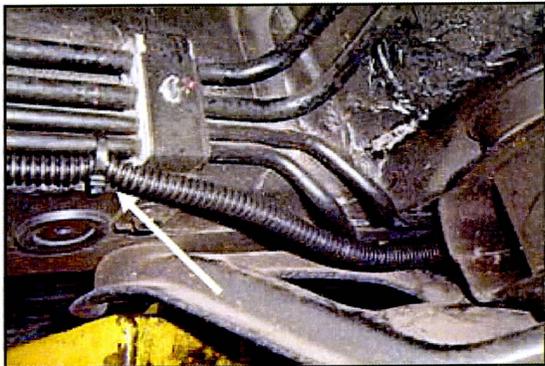
Route the harness along the brake line and secure using provided cable tie to the bracket supporting the brake and fuel lines. **Wire Path Installation Location D** indicated in photo.

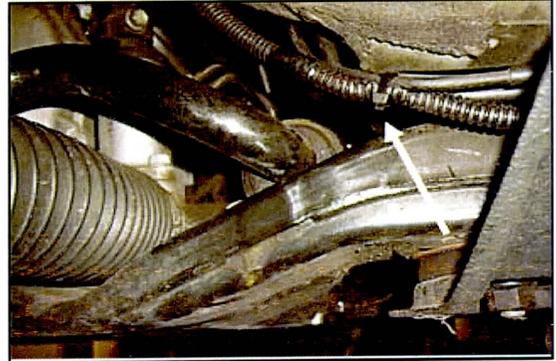
Continue to route the harness between the engine sub frame and under the frame rail, and secure with provided cable tie to lower brake line beside the sway bar. **Wire Path Installation Location D** indicated in photo.

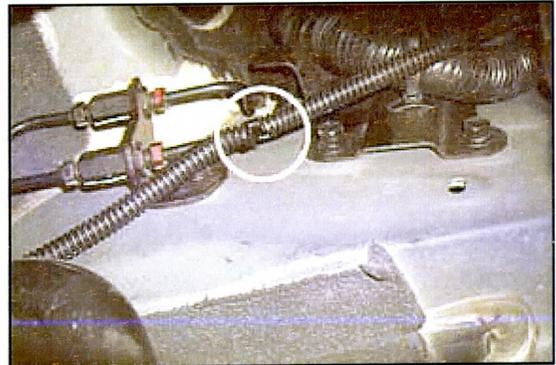
Route harness upwards along the brake line into engine compartment and secure with provided cable tie at the brake line bracket as illustrated. **Wire Path Installation Location D** indicated in photo.

CAUTION: Make sure the harness does NOT contact or interfere with the steering column boot.

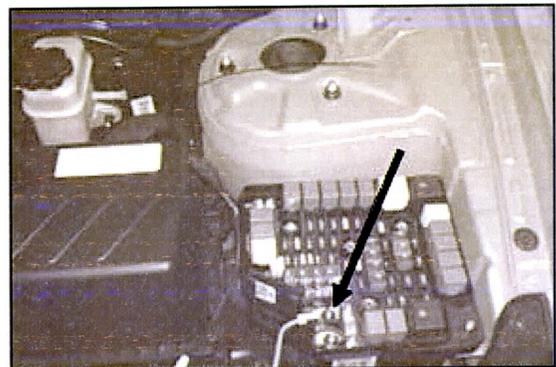
At the front of the vehicle with the in-line 15 amp fuse REMOVED, attach the ring terminal on the end of the Red 12 gauge power wire to the inboard stud in the power distribution center using a 10 mm socket. Tighten securely to ensure a proper connection. Replace the fuse box cover. **Wire Path in Engine Compartment** indicated in photo.

CAUTION: Failure to properly tighten this fastener may result in intermittent operation and or damage to the vehicle's electrical system and or the trailer wiring harness.

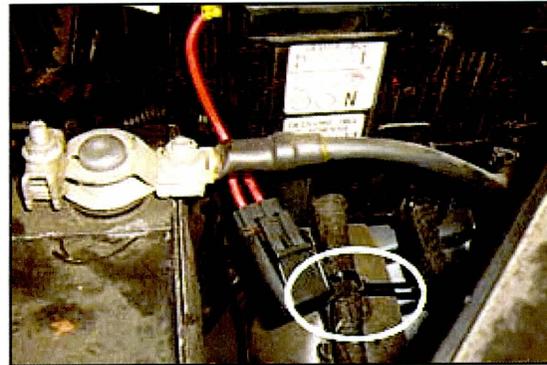
Secure the harness fuse holder cover bracket to the wire harness in front of the battery using the provided cable tie as illustrated. **Wire Path in Engine Compartment shown in photo.**

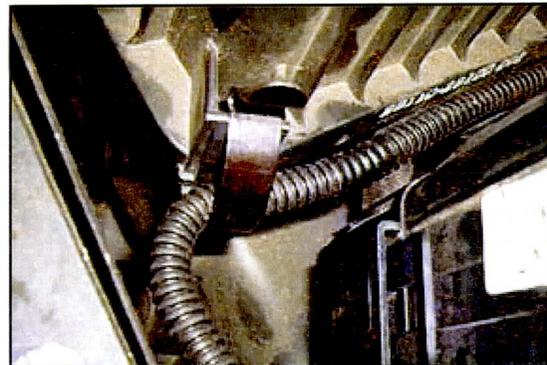
Route the harness through the two air filter securing clips as illustrated. **Wire Path in Engine Compartment shown in photo.**

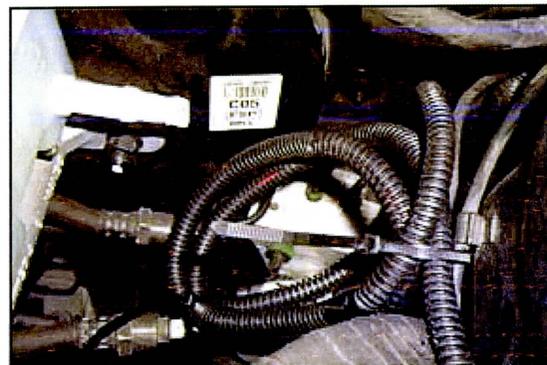
Bundle up the excess wire and secure to the brake line using provided cable tie as illustrated. **Wire Path in Engine Compartment shown in photo.**

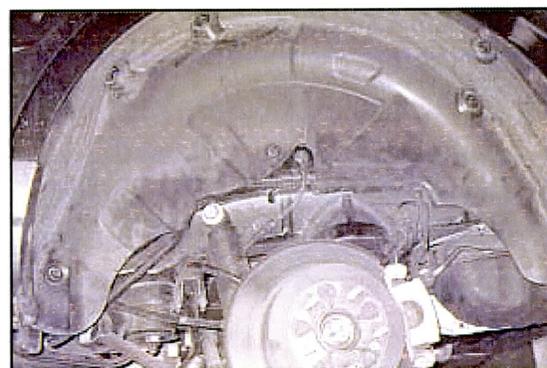
Replace the left rear wheel assembly. Torque the lug nuts to 89-108 Nm, (9-11 Kgf-m, 65-79 lb-ft).

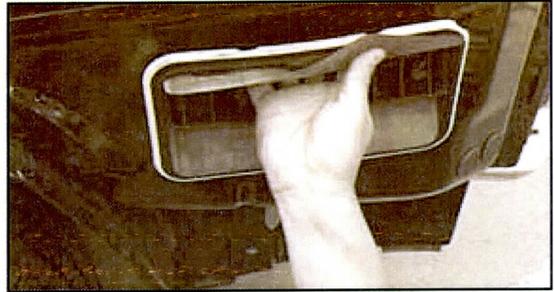
Replace the Pressure Relief Vent cover to its proper position, ensuring that the rubber flaps are pointing down.

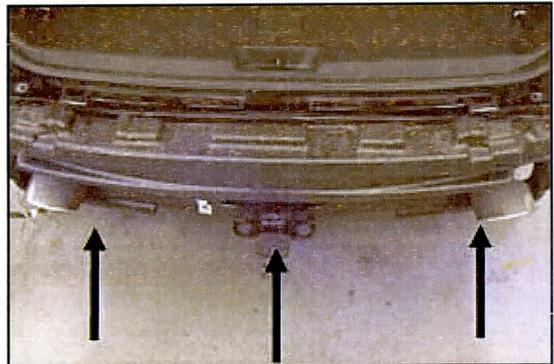
Reseat the foam bumper backing onto the composite bumper reinforcement structure, using a small piece of tape on each end of the foam to hold in position during reassembly.

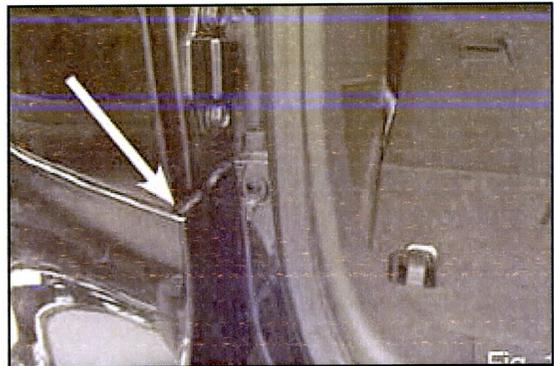
Adjust the bumper cover left and right, aligning with the body panel just below the tail lights. (driver side shown)

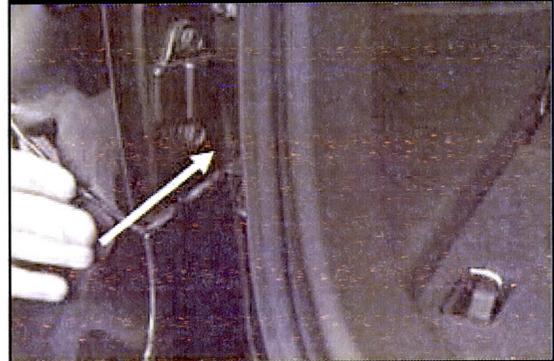
Replace the two shoulder screws (one per side) securing the bumper cover to the rear body near the tail lights.

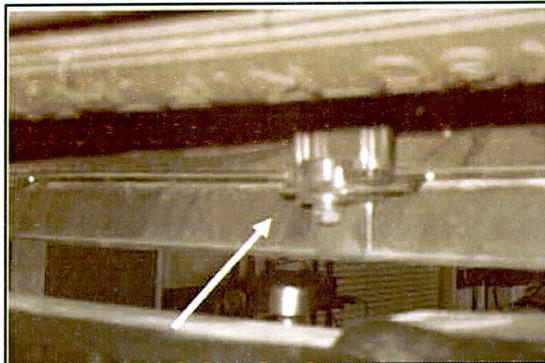
Replace the four bolts securing the bumper brackets to the bumper cover.

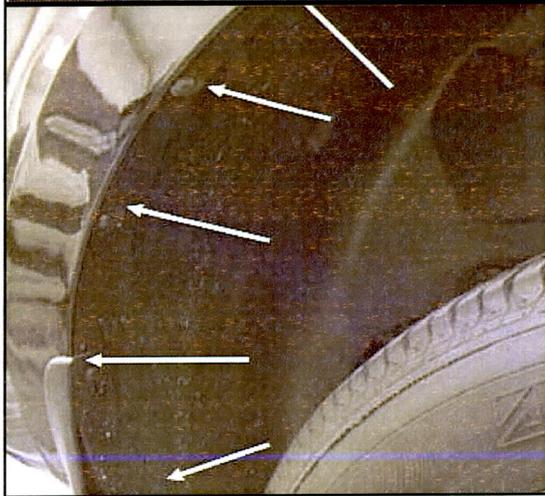
Replace the five Phillips head screws securing the bumper cover to the wheel openings on each side of the vehicle.

NOTE: If equipped, install the mud guards during this step, using the bottom two screws. An additional fastener is located below the mud guard, inserted vertically.

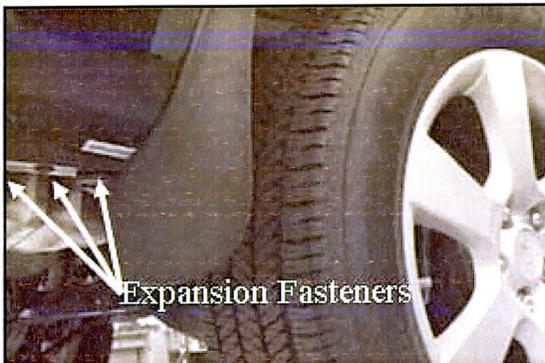
Replace the six (three per side) expansion fasteners, securing the bumper cover to the lower body panels near the mud guards.

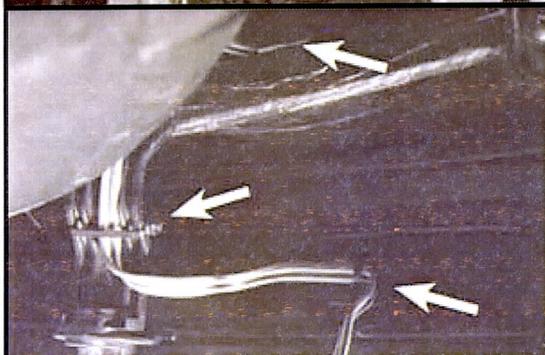
Continue routing the trailer wiring harness 4-pin connector across the top of the bumper reinforcement and down along the bumper support bracket.

Clean the bumper support in the illustrated positions with a provided alcohol wipe. Pull the backing from the last two cable anchors and mount to the bumper support as illustrated.

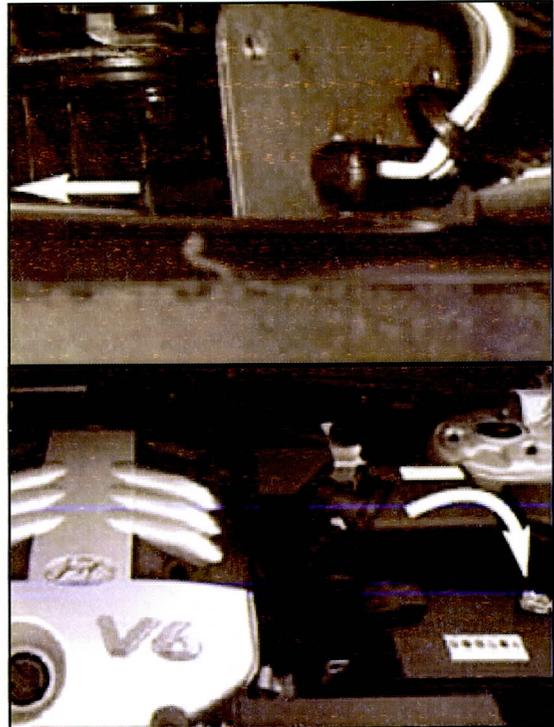
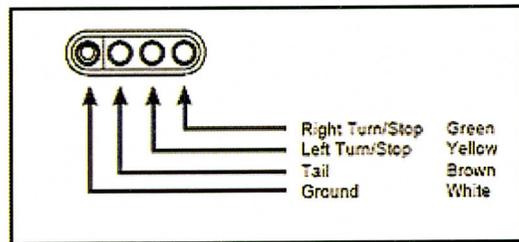
Check the 4 wire connector per the flow chart in the installation instructions for correct operation.

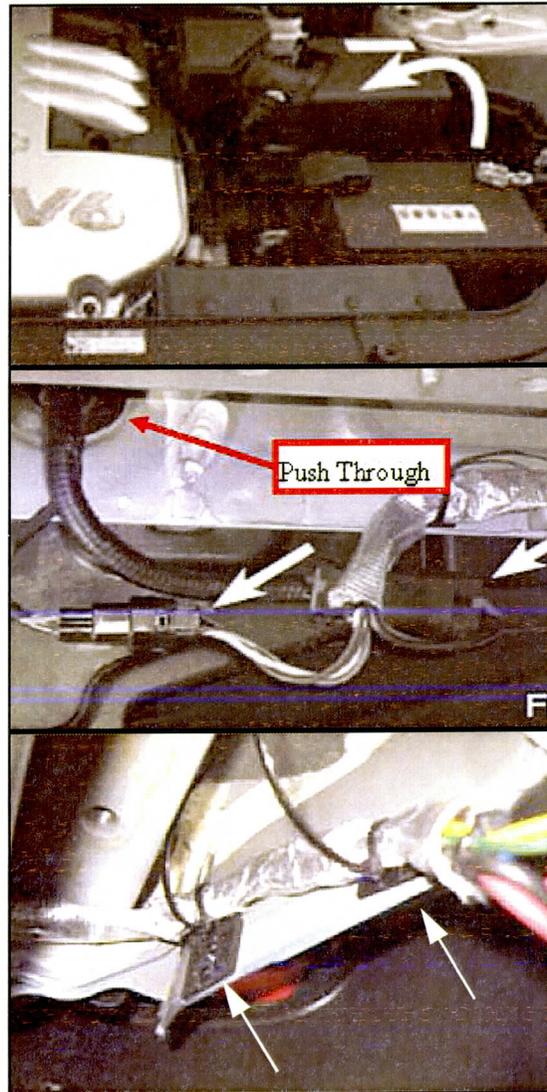
Disconnect the 2 connectors on the trailer hitch wiring harness located on the right (passenger) side, behind the rear wheel next to the muffler. At this location, push the grommet and connectors through the hole in the inside body panel.

Remove the underbody trailer hitch wiring harness and all anchors with a flat head screw driver by prying from behind the anchors.

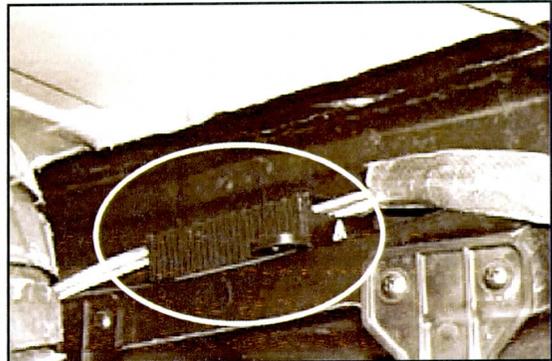
Remove the trailer hitch control module and harness by grasping the module by hand and gently rotating it back and forth until the adhesive separates from the bumper reinforcement.

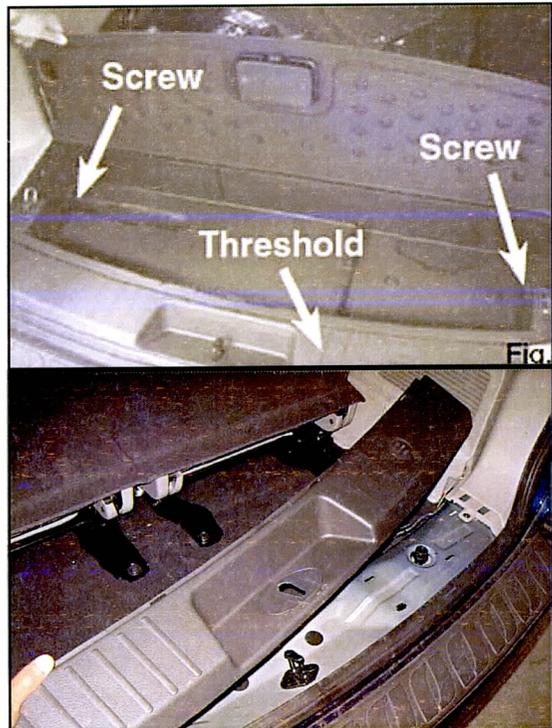
With cargo door open, remove the tool tray by unscrewing the 3 screws securing the tray. One screw on left side, one in the middle, one under the jack assembly foam liner.

Use a trim tool and pry up the sill panel to remove.

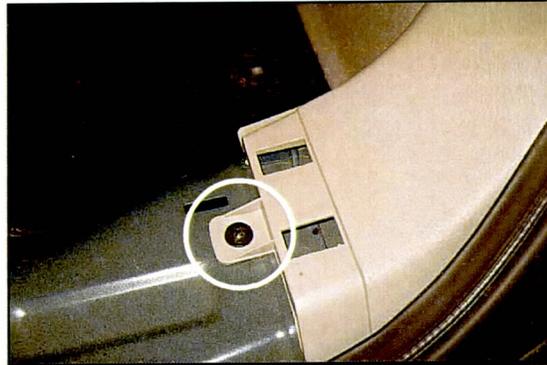
Remove Phillips head screw securing the lower corner of the side interior panel on the passenger side near the sill plate.

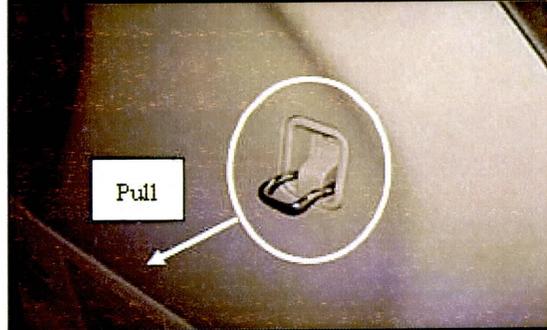
Pull panel apart by using this cargo anchor.

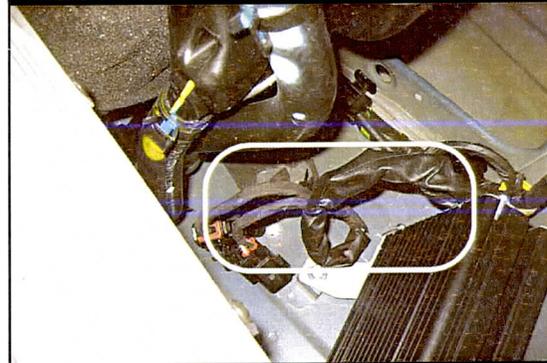
Reach into opening and locate the vehicle harness connectors.

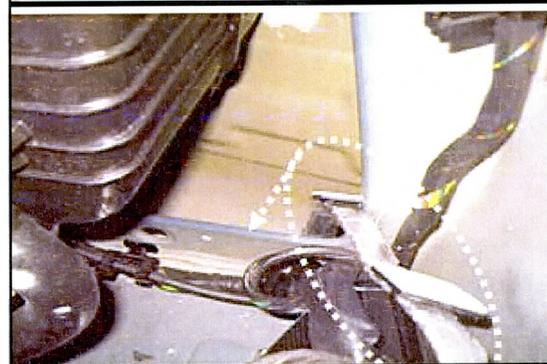
Route the trailer hitch module's 4 pin connector out the bottom of the vehicle through the grommet hole. Push the grommet located on the 4 pin connector harness all the way through the hole.

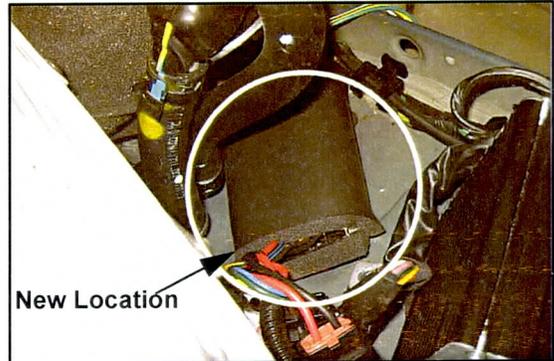
Connect the new trailer hitch module's connectors to the vehicle tow hitch connectors. Press connectors firmly together until the locking tabs engage. Use the provided alcohol wipes to clean the flat surface as shown, before applying the module into its location. Remove the tape backing and stick to surface.

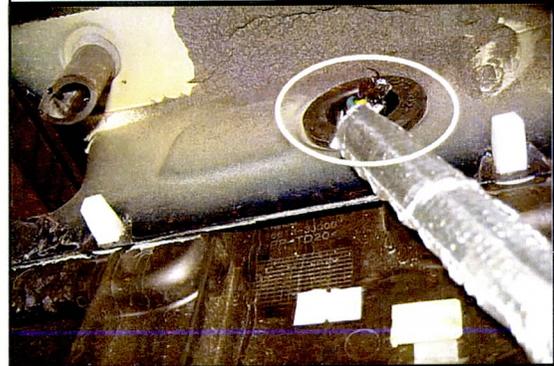
From underneath the vehicle, seat the grommet found on the 4 pin connector harness into the opening. Confirm that the grommet seals to body.

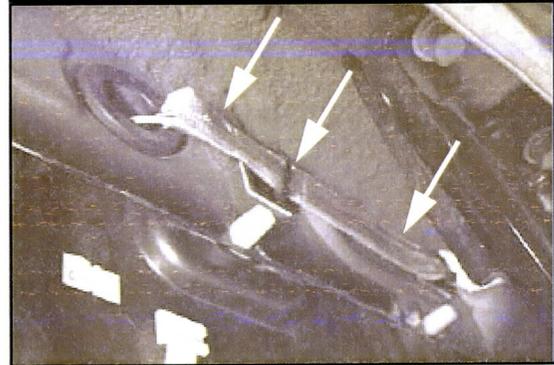
Route the 4 pin trailer connector harness rearward toward the right (passenger) side muffler hanger, staying above the lower bracket bolt.

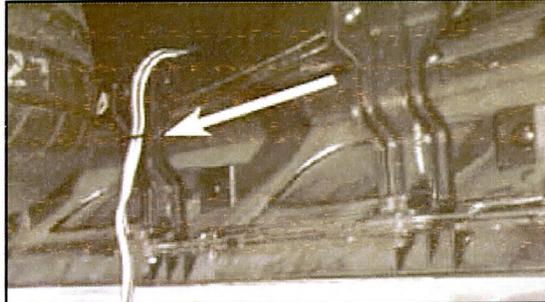
Secure the cable to the bumper support bracket using a supplied wire tie.

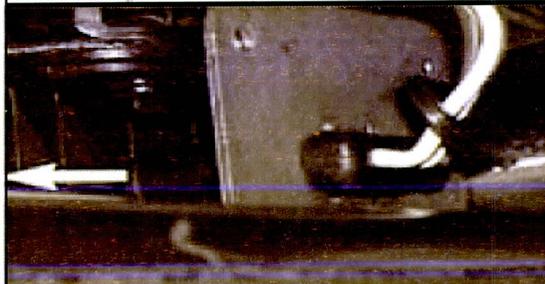
Remove the dust cover and carefully push the 4 pin connector through the connector mounting bracket from under the vehicle until it snaps in place.

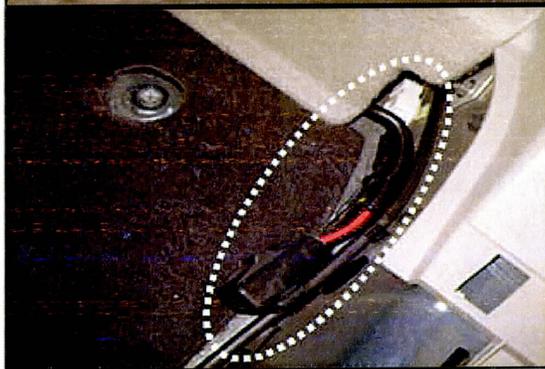
Secure the fuse holder to the existing vehicle wiring using a cable tie to allow it to be accessed from underneath the tool tray.

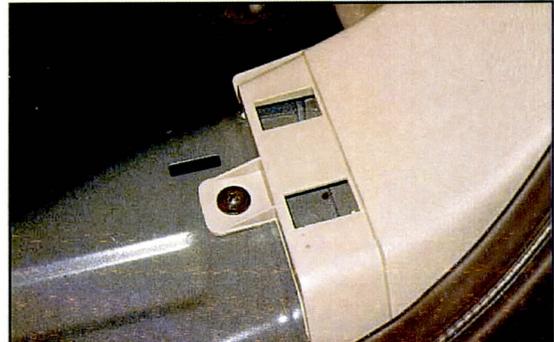
Return the right side interior trim to its original position. Replace the Phillips head screw to the lower corner of the trim panel.

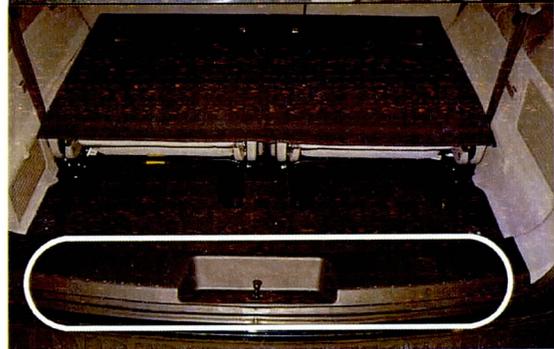
Press the sill panel firmly into its original position. Use a trim panel tool to ensure the weather seal is not pinched under the sill panel.

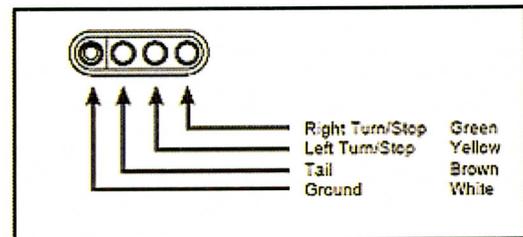
Check the 4 pin connector per the flow chart in the installation instructions for correct operation.
