## OEM SAFETY DEFECT NOTIFICATION:

Over the past several months we have had reports of cracks and resulting propane gas leaks in a small number of brass swivel nuts on the pressure tap component of model 322/323. Based on these initial incident reports, Norcold proceeded to gather additional components from used vehicles for analytical purposes to assess potential for further incident occurrences. Based on our findings, we believe the potential exists under some circumstances for similar incidents of cracking and resulting gas leakage conditions.

When the serial number for models 322 and 323 is lower than 734882, replace the Swivel Nut/Pressure Tap and Burner Tube [F] shown in Figure 1 with Service Kit # 621189.

## Service Kit Installation (models 322 and 323)

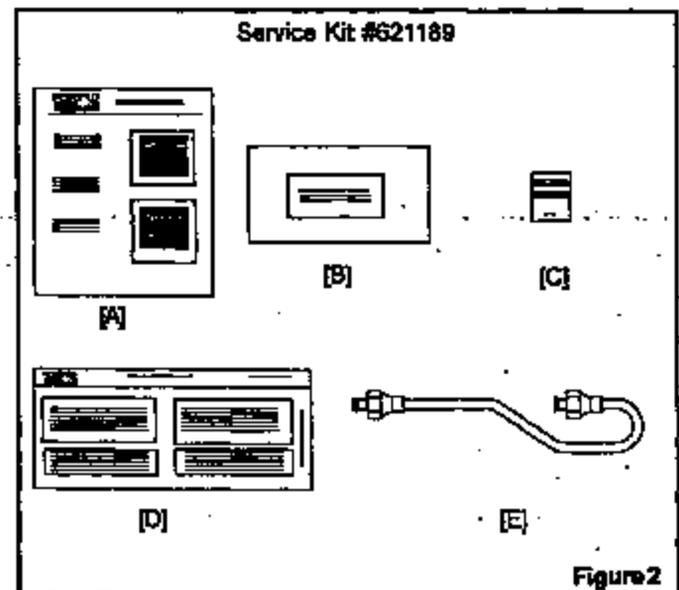
### Service Kit # 621189 Includes - Figure 2:

- A. 621192 - Service Kit Instructions
- B. 621180 - Pre-Addressed/Postage Paid Return Envelope.
- C. 621175 - Rework Label
- D. 619789 - Claim Form
- E. 621176 - Burner Tube

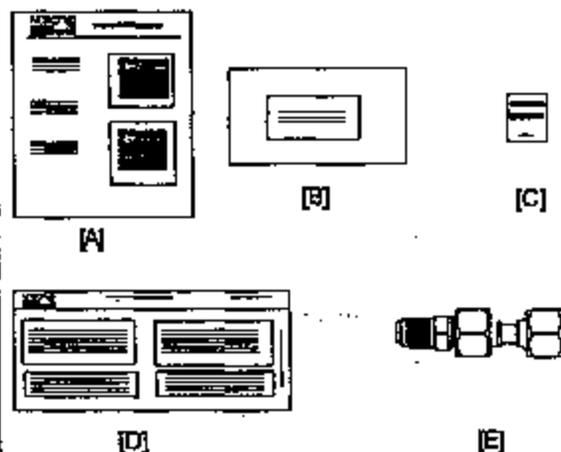
Figure 2

- A. 621193 - Service Kit Instructions
- E. 621180 - Pre-Addressed/Postage Paid Return Envelope
- C. 621175 - Rework Label
- D. 619759 - Claim Form
- E. 621187 - Flared Union/Swivel Connector Assembly

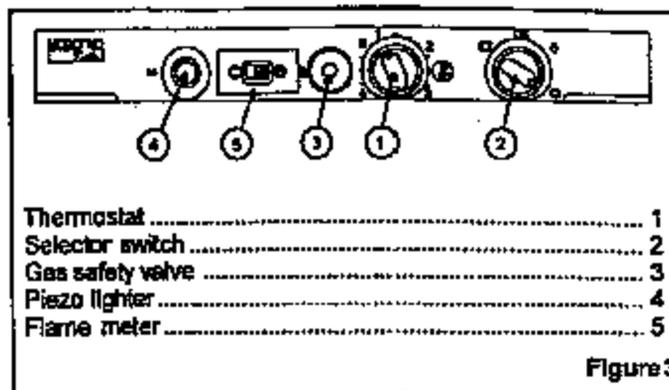
Figure 3

14. When a flame is present and the flame meter [5] moves into the green area, release the safety valve.
15. Leak test all brass connections. Use only a *commercial leak test solution*.
16. Turn the energy selector switch [2] to OFF, unless consumer preference is for continued operation.

Thermostat .....	1
Selector switch .....	2
Gas safety valve .....	3
Piezo lighter .....	4
Flame meter .....	5

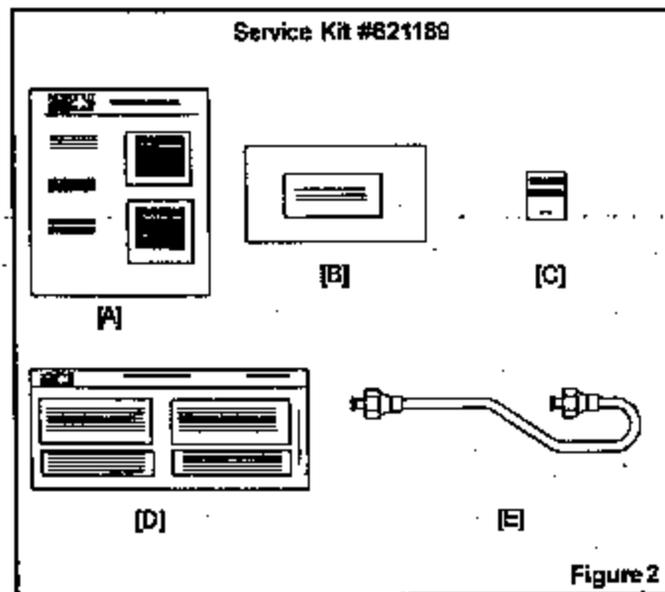
Figure 2

- A. 621192 - Service Kit Instructions
- B. 621180 - Pre-Addressed/Postage Paid Return Envelope.
- C. 621175 - Rework Label
- D. 619769 - Claim Form
- E. 621176 - Burner Tube

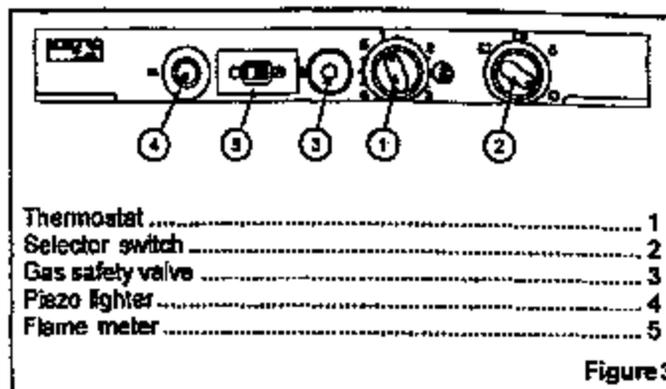
Figure 3

14. When a flame is present and the flame meter [5] moves into the green area, release the safety valve.
15. Leak test all brass connections. Use only a *commercial leak test solution*.
16. Turn the energy selector switch [2] to OFF, unless consumer preference is for continued operation.

Thermostat .....	1
Selector switch .....	2
Gas safety valve .....	3
Piezo lighter .....	4
Flame meter .....	5

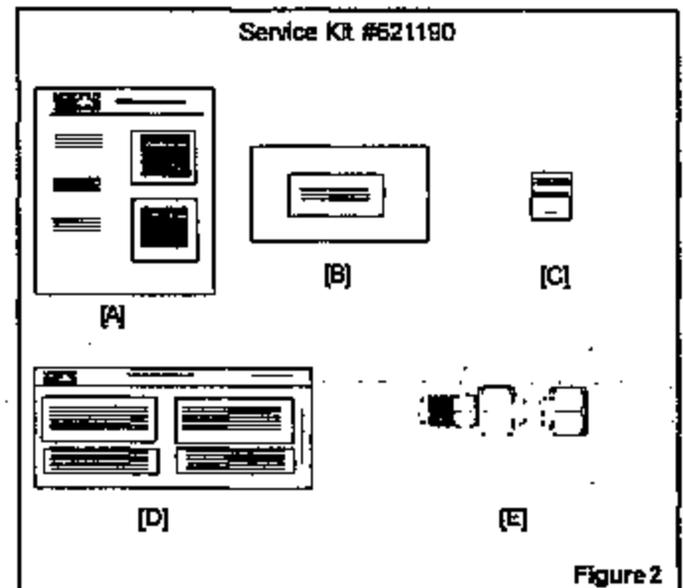
- A. 621193 - Service Kit Instructions
- B. 621180 - Pre-Addressed/Postage Paid Return Envelope
- C. 621175 - Rework Label
- D. 619769 - Claim Form
- E. 621187 - Flared Union/Swivel Connector Assembly.

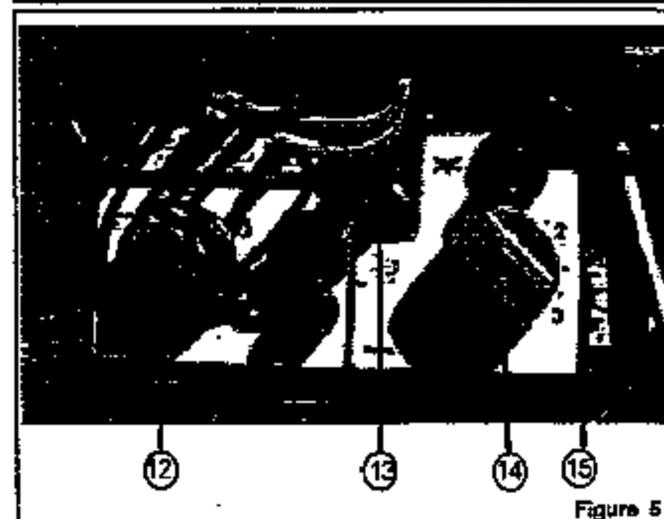
Figure 5

14. Open burner box door [6] and look for flame.
15. When the flame ignites, release the safety valve. If flame does not ignite, wait 5 minutes and repeat steps 11-13.
16. Leak test all brass connections. Use only a **commercial leak test solution**.
17. Turn the selector switch [12] to OFF, unless consumer preference is for continued operation.
