Safety Recall Circular

Code: 20P6

**Subject: 2008 R32
Fuel Tank Ventilation Valve**

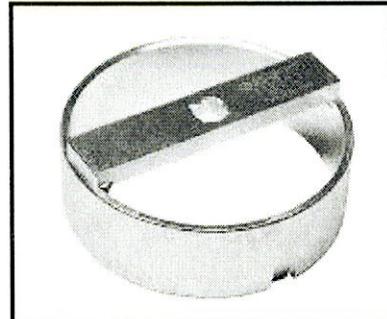
<ul style="list-style-type: none">• T10202 Wrench

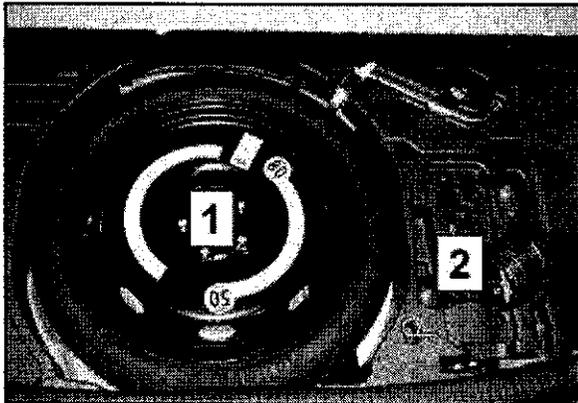
- Open rear hatch and lift floor mat
- ⇐ Remove spare tire -1- and foam block -2-

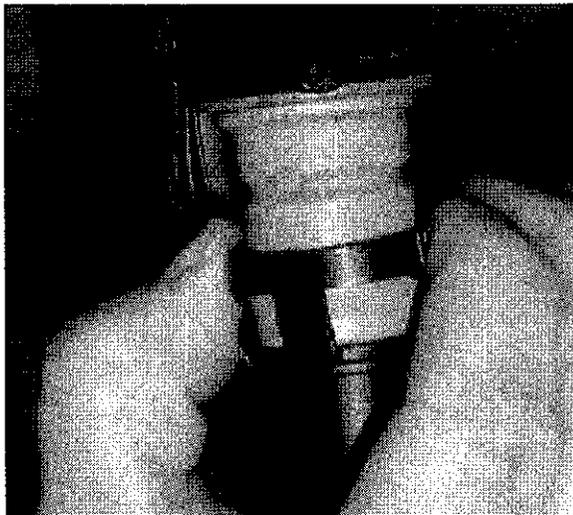
- Wrap cloth around connection at bottom of filler neck
- ⇐ Disconnect connector at top of filler neck by pushing in on two black holding rings -as pictured- and pulling downward

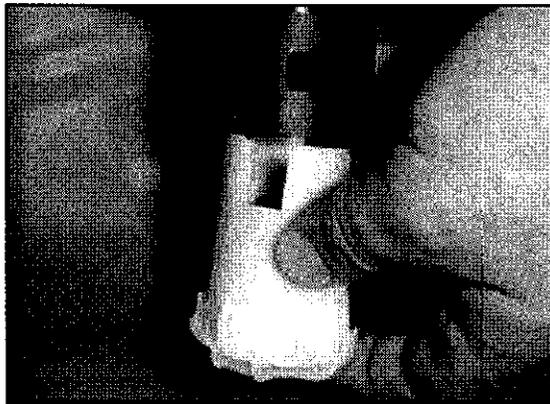
⇐ Carefully slide new valve assembly into position keeping alignment of cage (white piece) to housing (black piece) parallel to each other

Note: If alignment is not kept straight, fingers of the cage will prevent valve from functioning properly

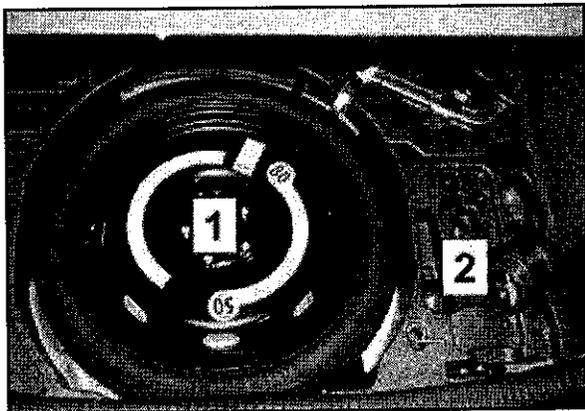
- ⇐ Replace spare tire -1- and foam block -2-
- Replace wheel lock key
- Close rear hatch
