**Subject: Document Submission for Revised Recall Campaign
09V-093 (Volkswagen Code 20P6/S2)**

Subject: Revision to Safety Recall 20P6/S2
2008 MY R32 (5th Generation)
United States Only

Code: 20P6
**Subject: 2008 R32
Fuel Tank Ventilation Valve**
REVISED

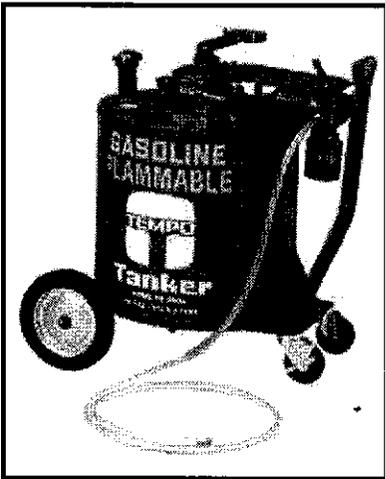
<ul style="list-style-type: none">• FM3000GH Fuel Storage Cart Non-Leaded (or equivalent)

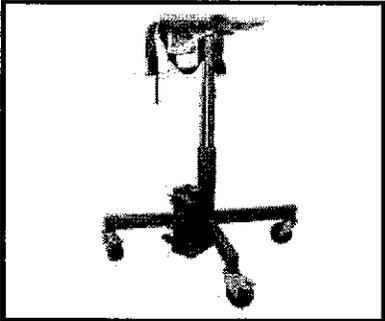
<ul style="list-style-type: none">• V.A.G 1383A Engine/Transmission Jack (or equivalent)

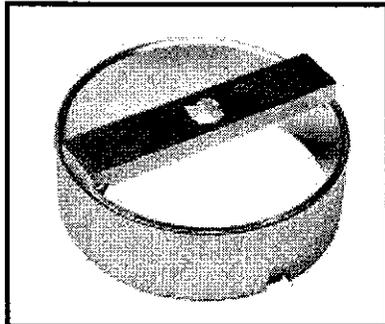
<ul style="list-style-type: none">• T10202 Wrench

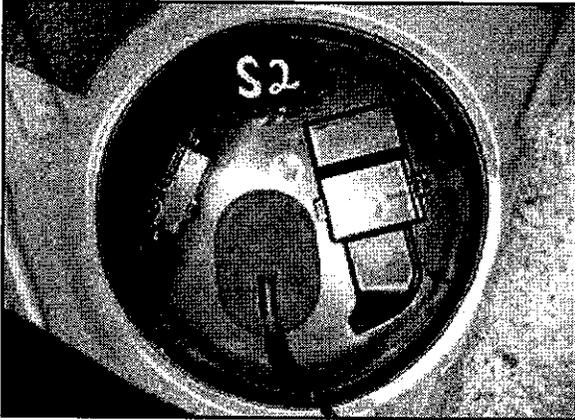
- Pull fabric covering fuel pump and inspect for "S2" marking on fuel pump cover
- If "S2" marking is found, campaign has been done – **WORK IS COMPLETE**
- If "S2" marking is not found, continue to **Section B-**

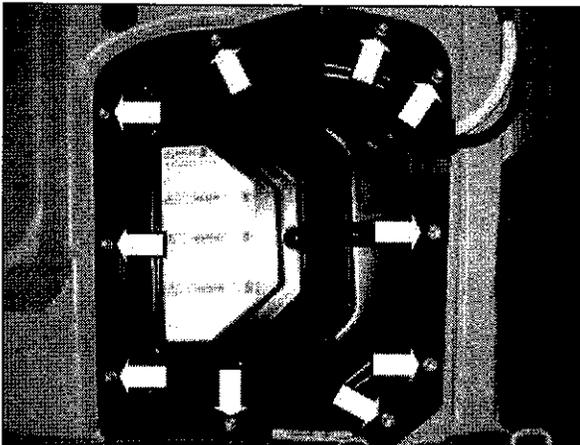
- ⇐ Remove ten bolts -arrows- for battery cover and remove battery cover

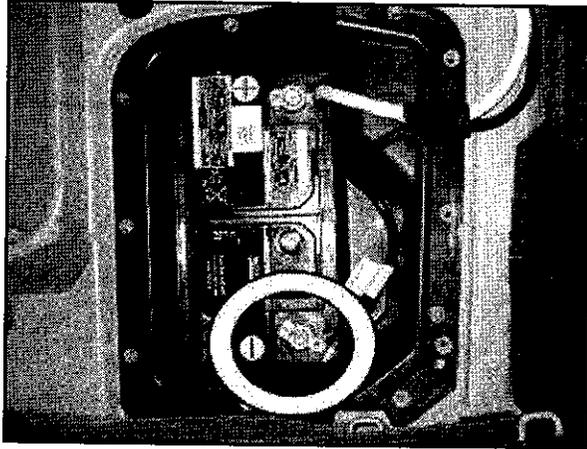
- Remove foam block covering battery (not pictured)
- ⇐ Disconnect negative battery ground cable -circle-
- Raise vehicle on hoist

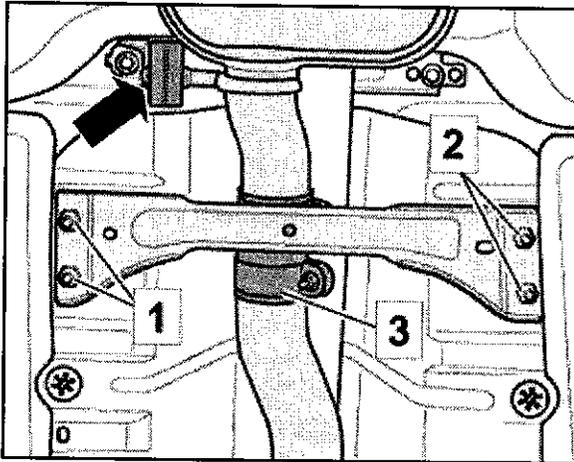
- ⇐ Remove underbody crossmember by removing nuts -1- and -2-
- ⇐ Remove two nuts for clamping sleeve -3- and slide clamp forward
- ⇐ Separate exhaust from retaining loop -arrow-

i Tip: Do not bend the flex joints in front of the exhaust pipe more than 20 degrees or they may be damaged

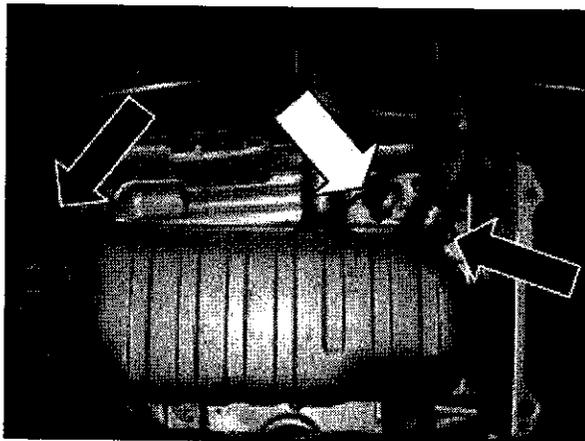
- ⇐ Disconnect vacuum line from exhaust flap vacuum actuator -white arrow-
- ⇐ With aid of another technician or using the V.A.G 1383A Engine/Transmission Jack (or equivalent), remove bolts for rear exhaust hangers -black arrows- and remove center and rear exhaust as an assembly

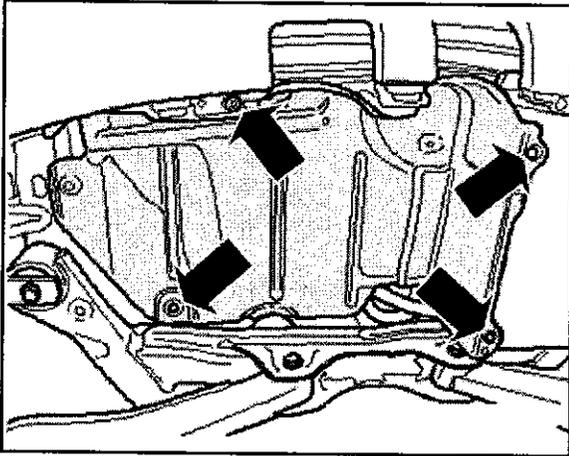
⇐ Remove heat shield for rear exhaust
-arrows-

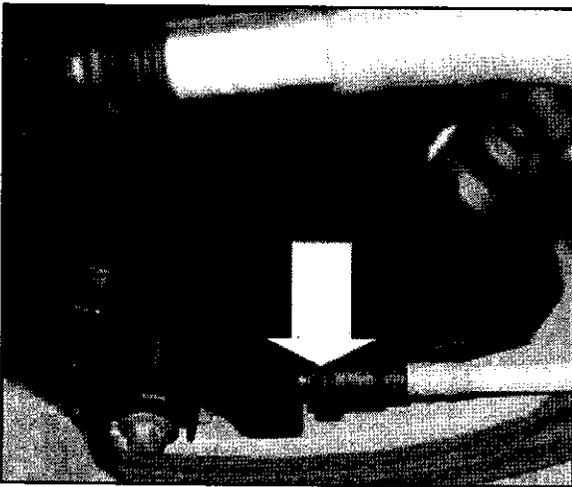
⇐ Disconnect small line - arrow- from EVAP
canister

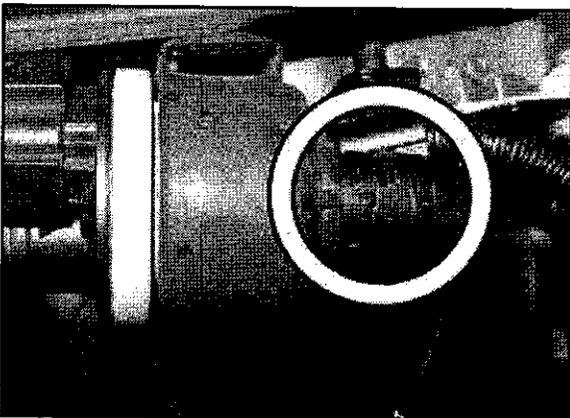
⇐ Disconnect clamp -circle- from EVAP canister
purge valve N-80

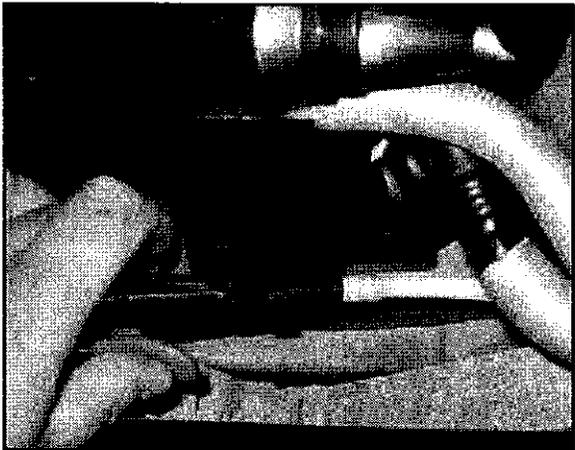
Note: Liquid fuel may be present

Wrap cloth around end of line prior to purging, if liquid fuel is suspected

- Raise vehicle on hoist
- Using dry compressed shop air, purge any debris, fuel or contaminants from line leading to EVAP canister purge valve N-80

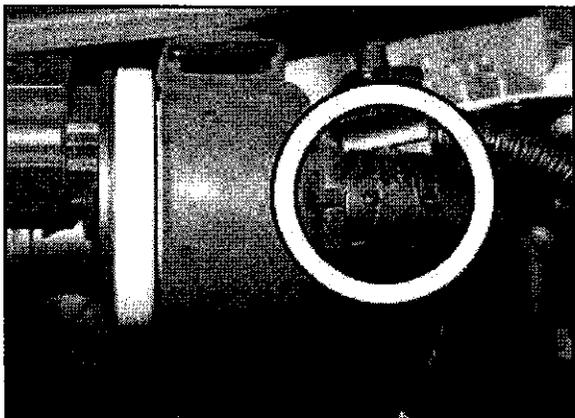
⇐ Reconnect line to EVAP canister purge valve N-80 and install new spring clip -circle- with part number (N 907 683 01)

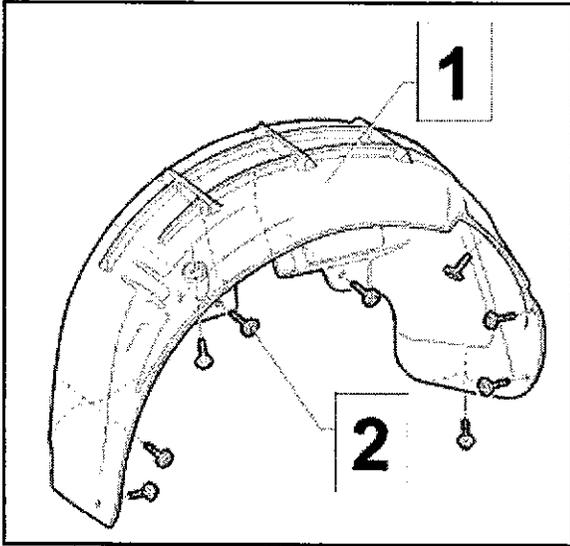
- Remove right rear (passenger side) wheel (illustration shows left rear)
- ⇐ Remove screws -2- (qty. 9)
- Remove right rear (passenger side) wheel housing liner -1-

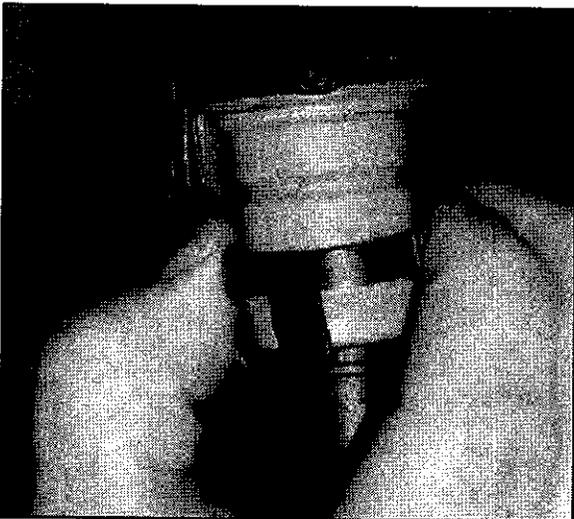
Note: Do not use shop air on line -arrow-, as line leads to fuel tank and it can result in damage to fuel tank
Damage to fuel tank is not covered under this action

- Wrap cloth around connection at bottom of filler neck

⇐ Disconnect connector at top of filler neck by pushing in on two black holding rings -as pictured- and pulling downward

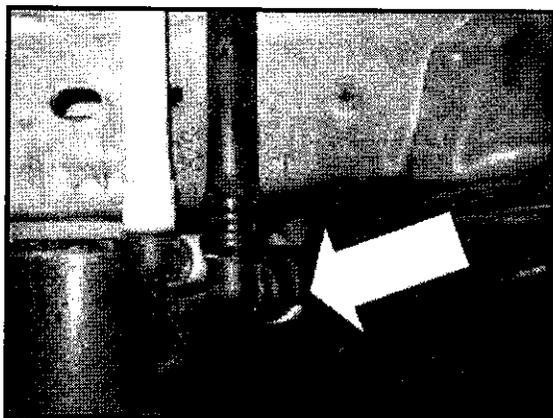
← Disconnect black line to LDP at connector
-arrow- at base of wheel housing

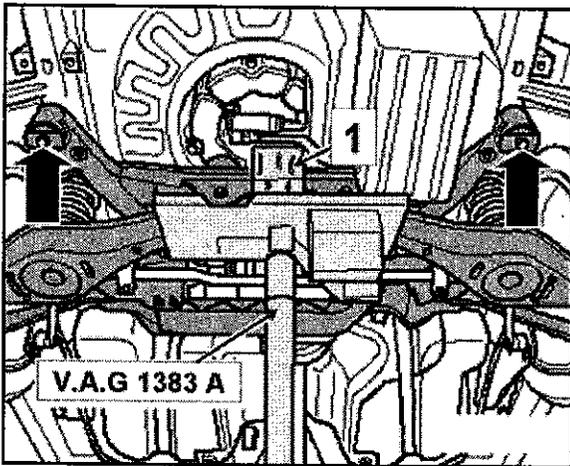
- Place engine/transmission jack V.A.G 1383A under rear axle
- ⇐ Place a block of wood -1- between engine/transmission jack V.A.G 1383A and sub frame
- ⇐ Remove rear bolts -arrows- at left and right of sub frame one at a time
- ⇐ Slowly lower sub frame using engine/transmission jack V.A.G 1383A until distance between sub frame and body achieves the dimension -a-

Tip: Dimension -a- 45 to 50 mm

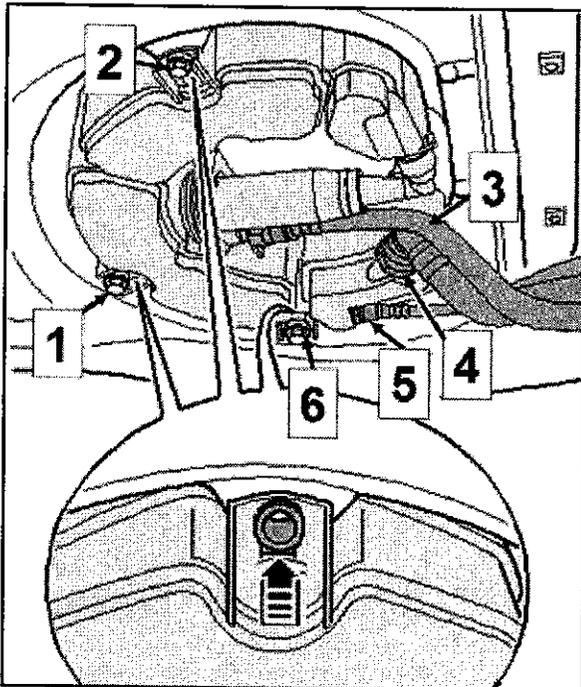
- ⇐ Install new EVAP canister into place and push retaining tabs in -direction of arrow-
- ⇐ Reinstall bolts -1-, -2- and -6- and torque to 8 Nm (6 lb-ft)
- ⇐ Reconnect vent lines -3-, -4- and -5- until they engage audibly with a “click”

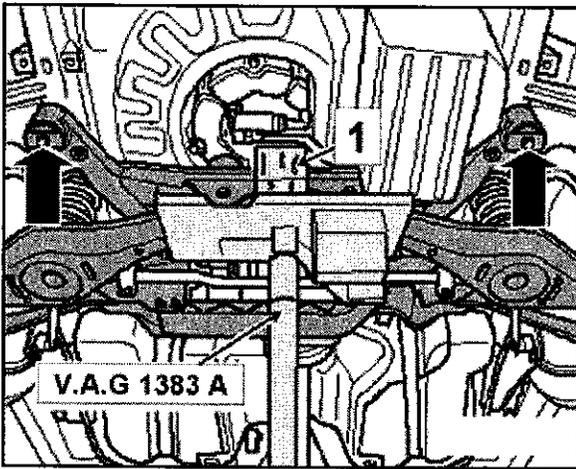
- Raise rear sub frame into place
- ⇐ Install new bolts -arrows- and torque to 90 Nm (66 lb-ft) + 90° additional turn
- Remove engine/transmission jack V.A.G 1383A and remove block of wood -1-

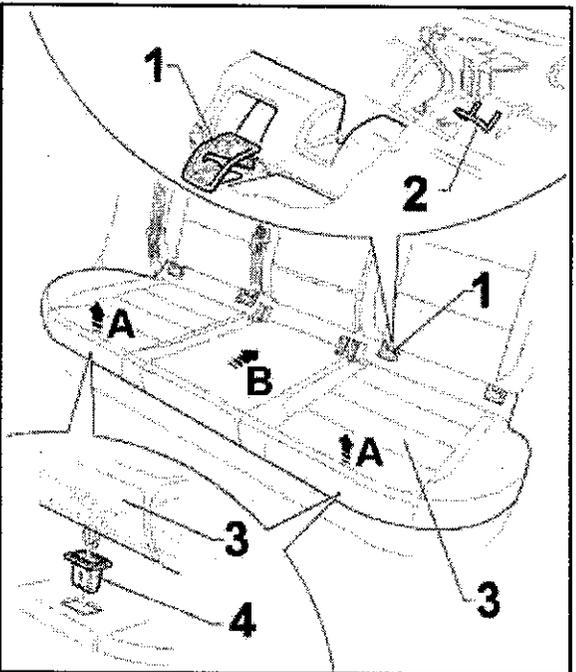
- ⇐ Unclip four guides -1- from child seat anchors -2-
- ⇐ In front area, pull seat bench -3- upward out of two mounts -4- arrows -A-
- ⇐ Push seat bench toward rear -arrow B-
- In rear area, pull seat bench upward
- Remove rear seat bench from vehicle

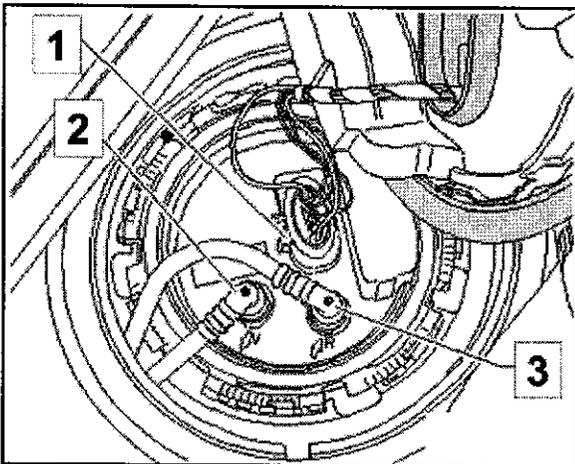
- ← Remove connector -1- and fuel lines -2- and -3- from the flange

Tip: Press in securing ring to disengage fuel lines

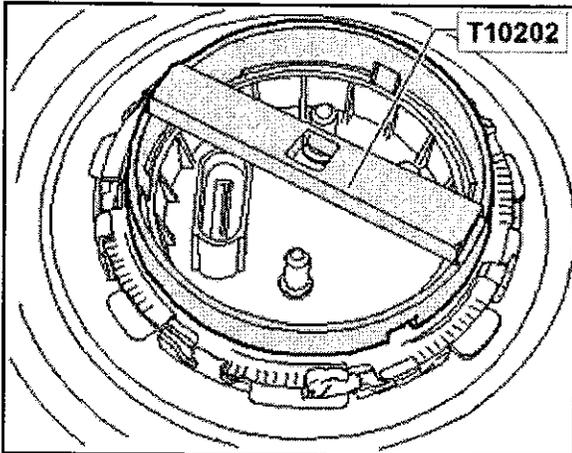
- Remove locking ring with wrench T10202
- Pull right sealing flange and fuel delivery unit seal out from opening in fuel tank and lay aside with lines still attached

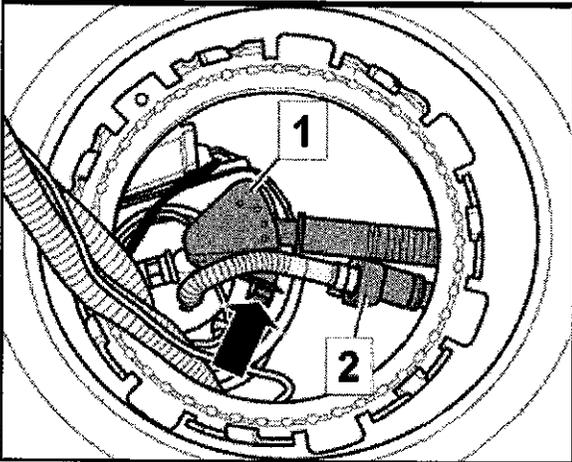
- ⇐ Through the fuel tank opening, separate the suction jet pump pipe -2- from the suction jet pump, by pressing the release button
- ⇐ Disconnect the fuel delivery line -1- by pressing the release -arrow-
- ⇐ Remove the fuel delivery unit

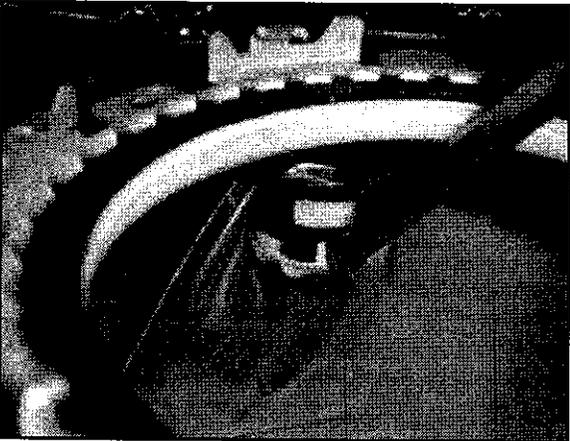
- NEW**
- ⇐ Place screwdriver in slot and against the fuel pump assembly ring (as pictured)
 - ⇐ Remove valve by striking down with moderate tapping force on the lower (white) part of valve

Note: STRIKE ONLY IN LOCATION SHOWN in picture
Damage to fuel tank will occur if different striking location is used

Note: DO NOT pry on the side of the valve. Prying on the side of the valve will result in damage to fuel tank

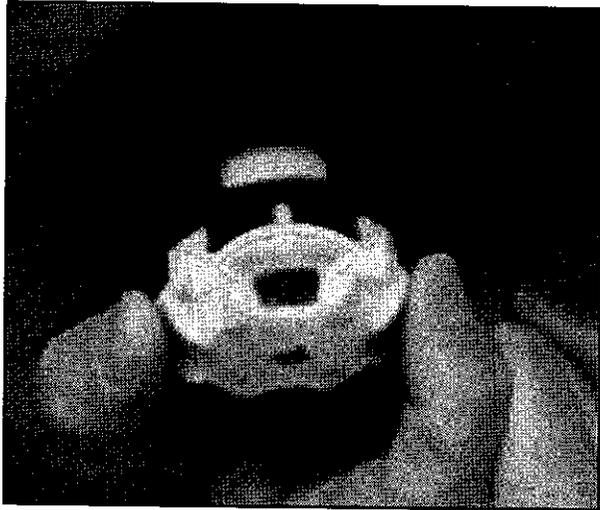
← Using only one or two fingers (as shown), and light side-to-side rotating motion, ensure valve assembly rotates easily in housing

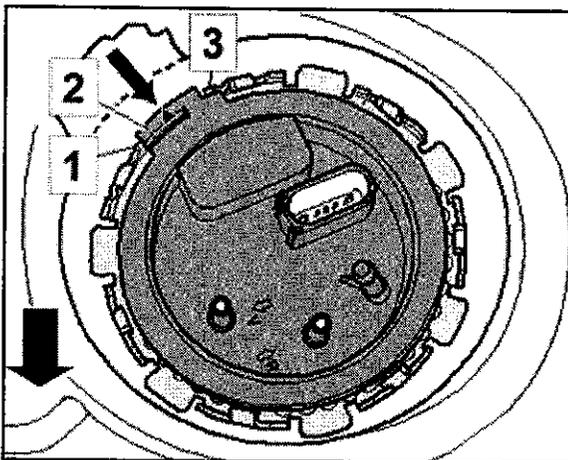
← The tab -2- on locking flange faces toward the arrow marking and must lie between tabs -1- and -3- on fuel tank

Tip: -arrow- points in direction of travel

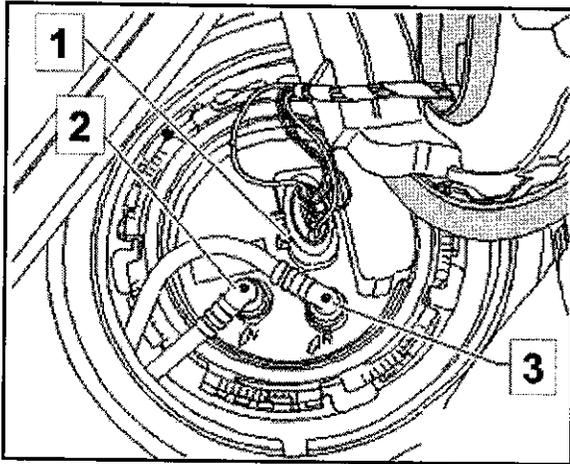
⇐ Reinstall connector -1- and fuel lines -2- and -3- onto the flange

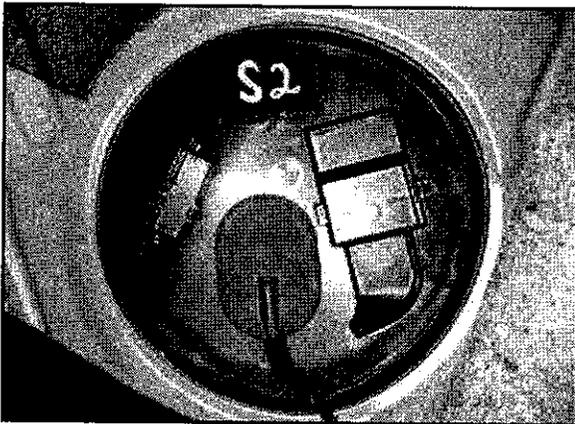
⇐ Use paint pen to mark "S2" on fuel pump cover as pictured

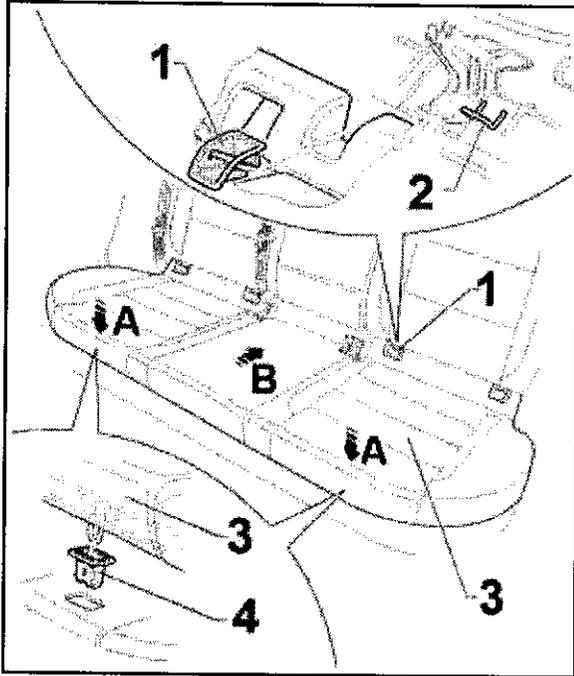
- Reinstall rear seat bench into vehicle
- ⇐ Push seat bench toward rear -arrow B-
- ⇐ In front area, push seat bench -3- downward into two mounts -4- arrows -A-
- ⇐ Reinstall four guide clips -1- onto child seat anchors -2-

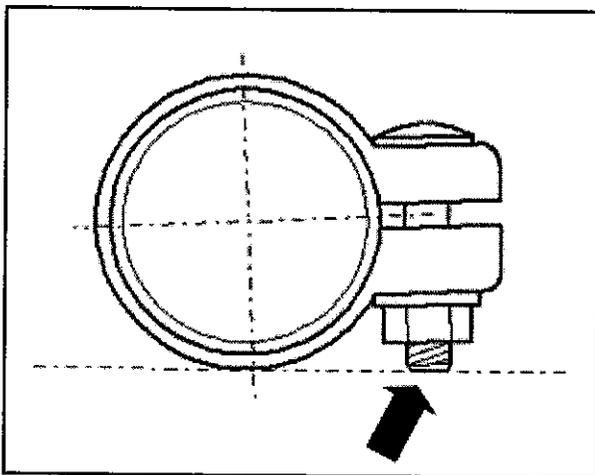
**Tip:** Pay attention to the clamping sleeve position. The ends of the bolts must not protrude beyond the lower edge of the clamping sleeve

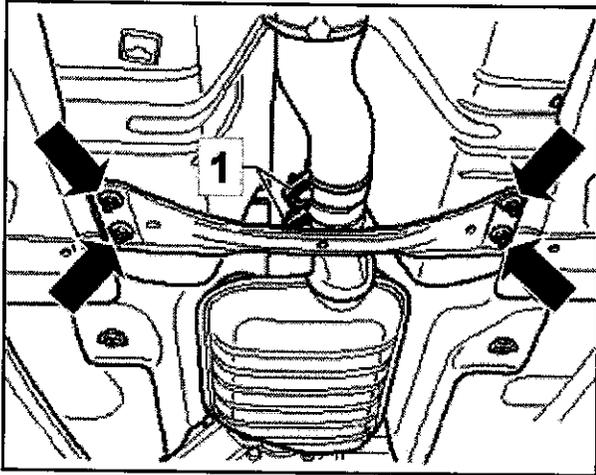
- ⇐ Slide exhaust assembly onto clamping sleeve
-1-
- ⇐ Reinstall crossmember and bolts -arrows-
- Tighten clamping sleeve connections to 25 Nm (18 lb-ft)
- Lower vehicle on hoist

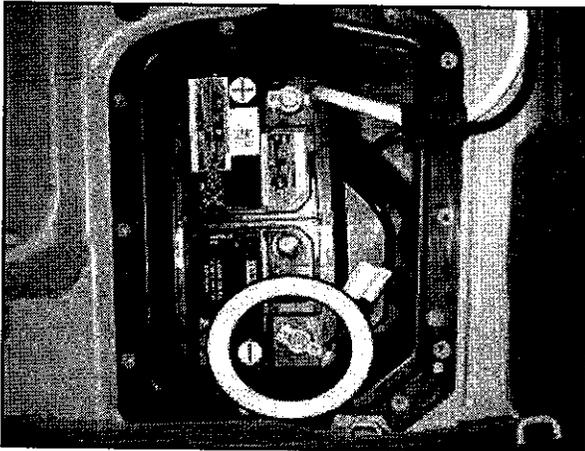
- ⇐ Reconnect negative battery Ground cable
-circle- and torque to 6 Nm (4 lb-ft)
- Reinstall foam block covering battery (not pictured)

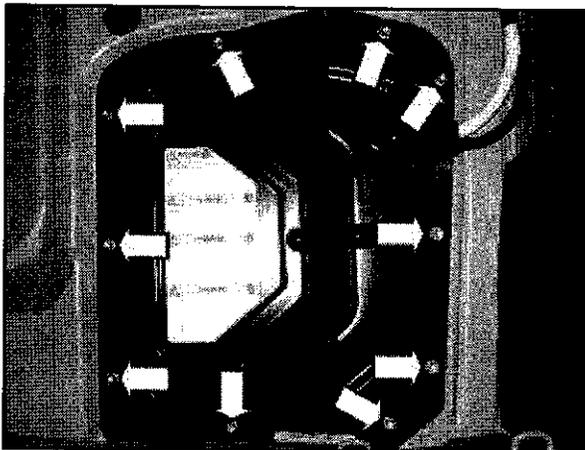
- ⇐ Reinstall battery cover with ten bolts -arrows- for battery cover and torque to 10 Nm (7 lb-ft)

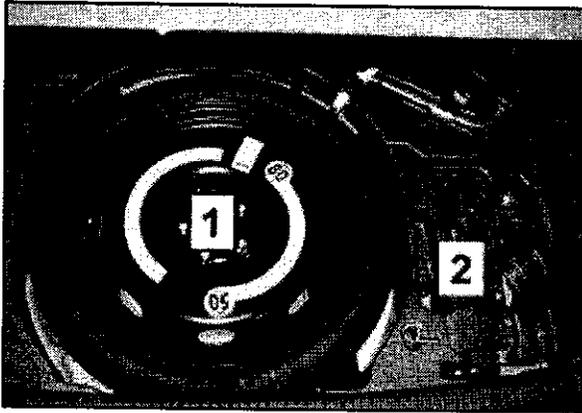
← Replace spare tire -1- and foam block -2-
