HYUNDAI Technical Service Bulletin

Group CAMPAIGN	
		Number 09-01-020	
Subject EF SONATA, XG300, XG350 - FRONT SUBFRAME CORROSION TREATMENT (CAMPAIGN 089)		Date JULY, 2009	
		Model SONATA / XG300 / XG350	
CIRCULATE TO:	<input type="checkbox"/> GENERAL MANAGER	<input checked="" type="checkbox"/> PARTS MANAGER	<input checked="" type="checkbox"/> TECHNICIAN
<input checked="" type="checkbox"/> SERVICE ADVISOR	<input checked="" type="checkbox"/> SERVICE MANAGER	<input checked="" type="checkbox"/> WARRANTY MGR	<input type="checkbox"/> SALES MANAGER

- Some 1999-2004 SONATA (EF) and 2001-2004 XG300/XG350 (XG) vehicles that are registered and operated in specified "salt belt" states may exhibit corrosion damage to the subframe assembly.
- Inspect the front subframes for corrosion damage. Measure the thickness of the subframe steel. If specified levels of corrosion damage have occurred as described in this bulletin, replace the front subframe with a new subframe that incorporates additional holes in the upper and lower panels. If a front subframe does not require replacement, add drainage holes and treat the subframe with rust-proofing material.

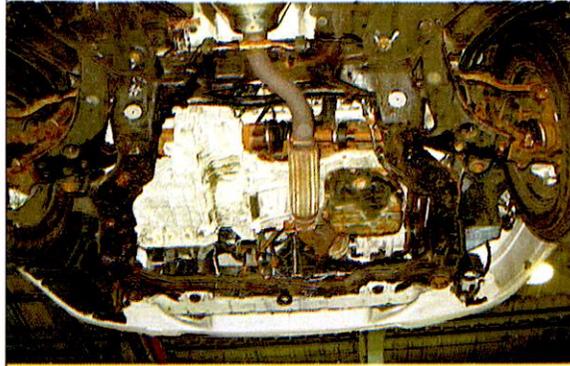
1. Lift up vehicle

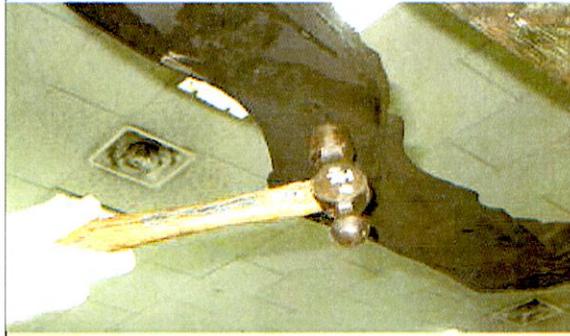
2. Lightly strike the subframe throughout with a hammer.

CAUTION: Be careful **DO NOT** strike the subframe too hard to prevent deformation damage.

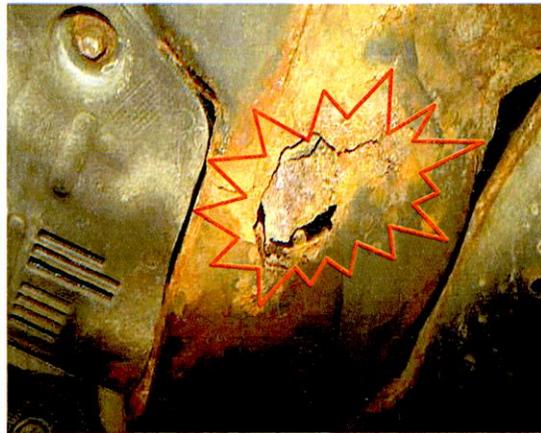
3. Inspect the subframe for corrosion perforation.

The photo on the right shows corrosion perforation.

CAUTION: Make sure to thoroughly inspect for corrosion perforation throughout the subframe including the sides.

NOTE: If any corrosion perforation is found, replace the subframe assembly with a new one. If not, proceed to the next step to further inspect the subframe for corrosion.

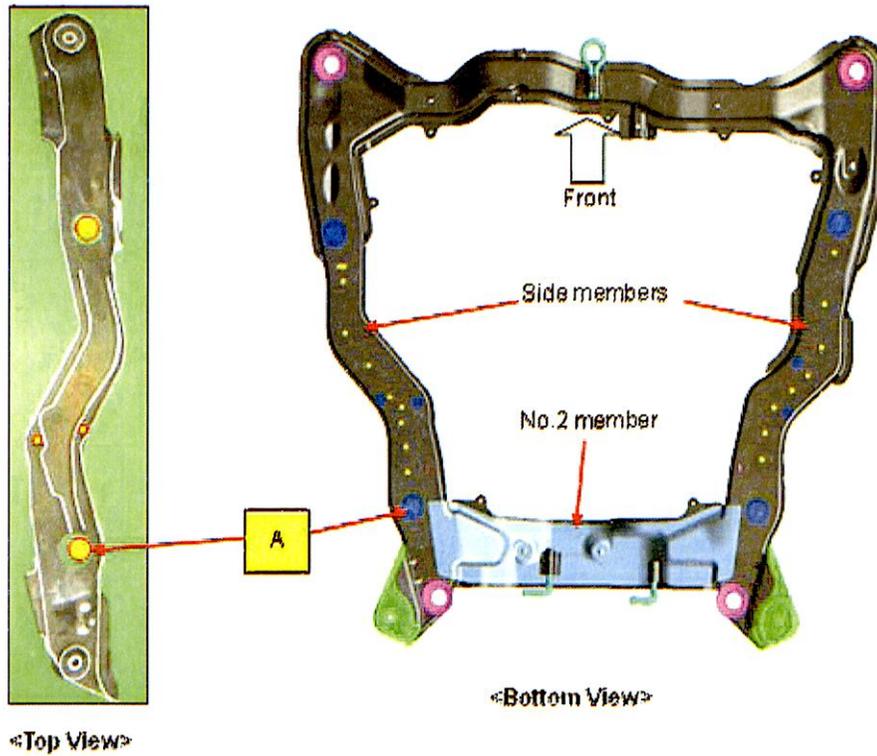
4. Drill a hole 40mm (A) in diameter on the rear of the right side member by following the detailed procedures below.

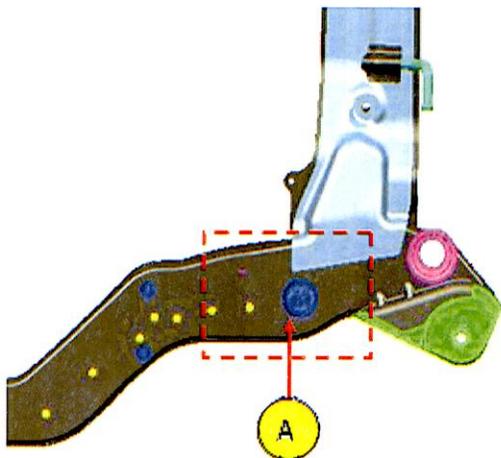
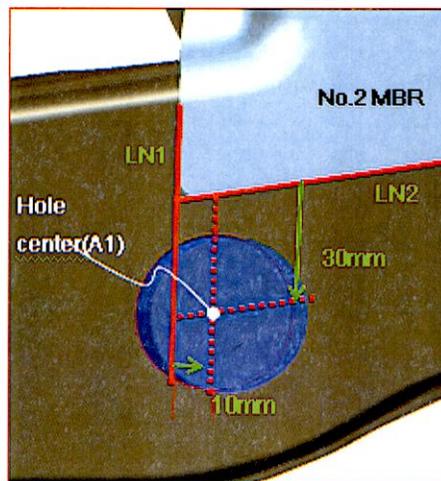
5. Put a marking point (A1) on the right side member as indicated in the photo.

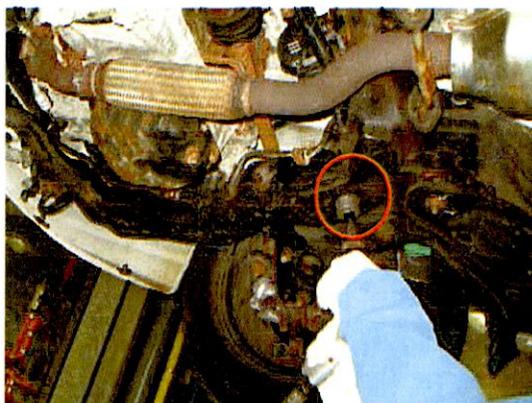
6. Center the 40mm hole saw on the mark and drill a hole in the right side member.

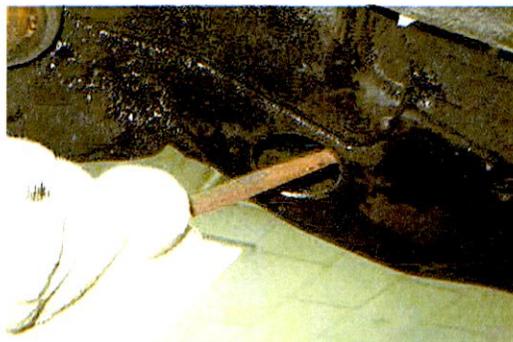
7. Use a file to remove burrs around the hole.

CAUTION: If the burrs are not fully removed, it may prevent the thickness gauge from being inserted over the edge of the drilled hole in step 8.

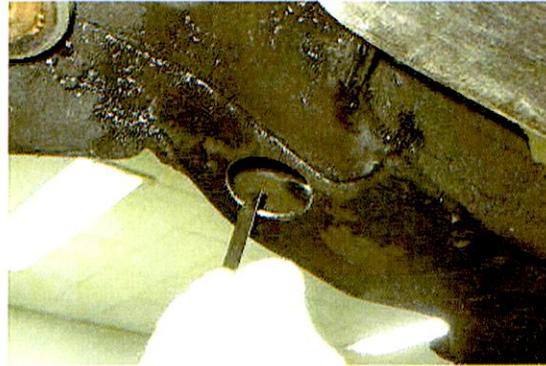
8. Insert the 1.5mm groove of the thickness gauge through the hole. Check the thickness of the subframe at as many points around the hole as possible.

9. If the subframe metal fits into the 1.5mm groove of the thickness gauge, replace the subframe assembly. Reference the SUBFRAME REPLACEMENT PARTS CHART on page 17. If the subframe metal does not fit into the thickness gauge, continue to the next step.

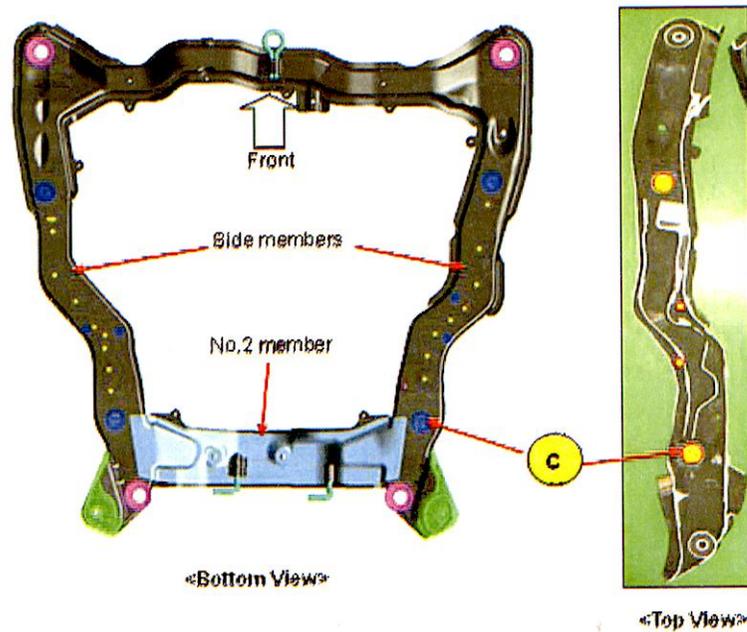
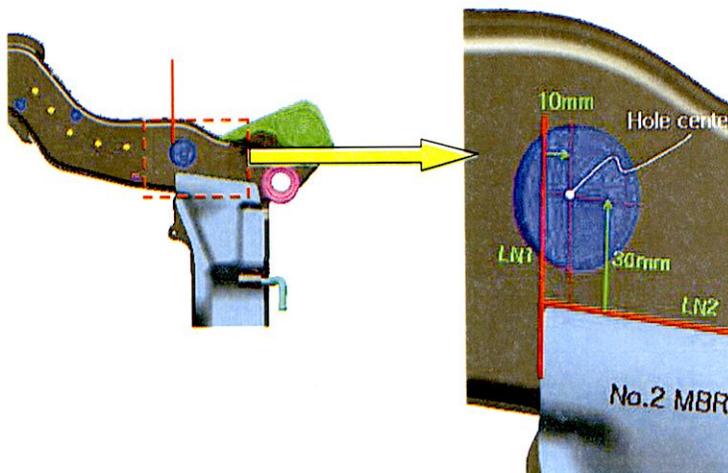
10. Drill a hole 40mm (C) in diameter on the rear of the left side member and check the thickness of the subframe metal of the left side member, as before.

11. If the subframe metal fits into the 1.5mm groove of the thickness gauge, replace the subframe assembly. Reference the SUBFRAME REPLACEMENT PARTS CHART on page 17. If the subframe metal does not fit into the thickness gauge, continue to the WAX APPLICATION FOR CORROSION PREVENTION procedure on page 24.

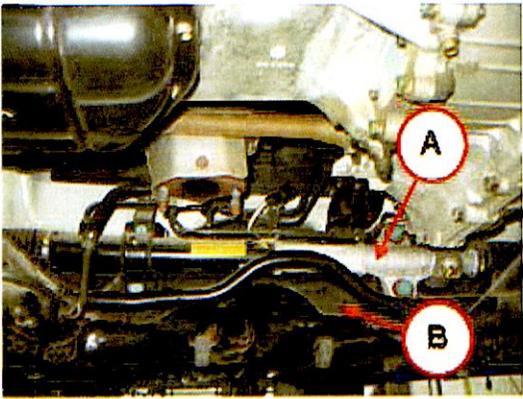
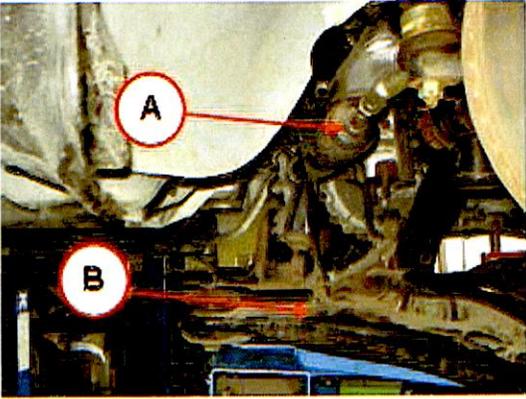
Original Procedure	Revised Procedure
<p>To replace the subframe (A), remove it simultaneously with the steering gearbox (B).</p>	<p>It is possible to remove the subframe (A) without detaching the steering gearbox (B) from the vehicle. DO NOT remove the steering gearbox for the subframe replacement.</p>

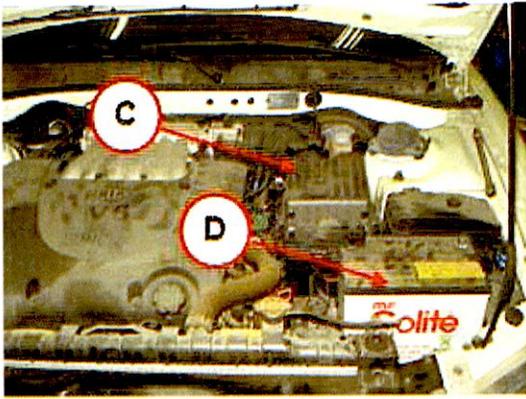
<ol style="list-style-type: none"> 1. Raise the hood. 2. Remove the battery (D). 3. Remove the air cleaner (C).

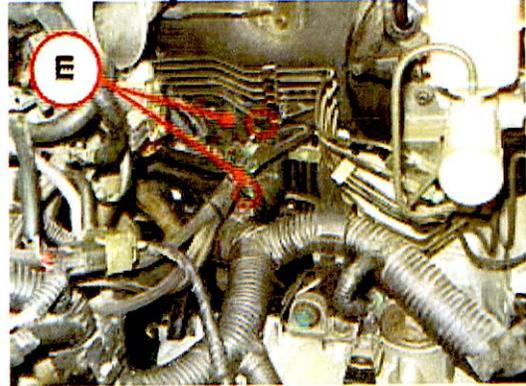
4. Remove the 2 main wiring harness mounting nuts (E) then slacken the wiring harness.

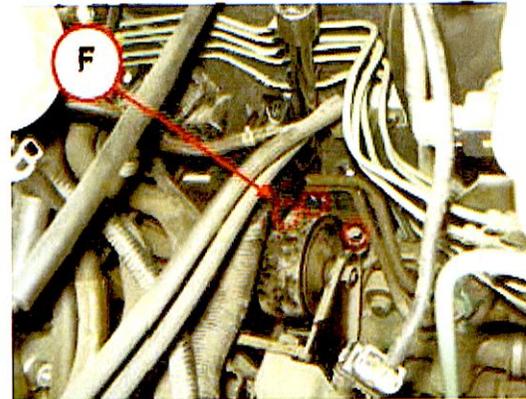
5. Remove the 3 rear roll stopper mounting bolts (F).

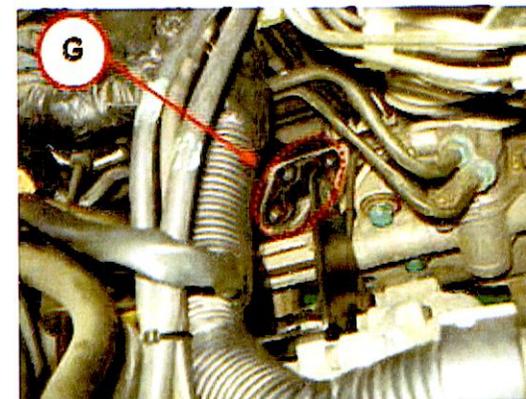
6. Photo of the location where the rear roll stopper mounting bolts had been installed (G).

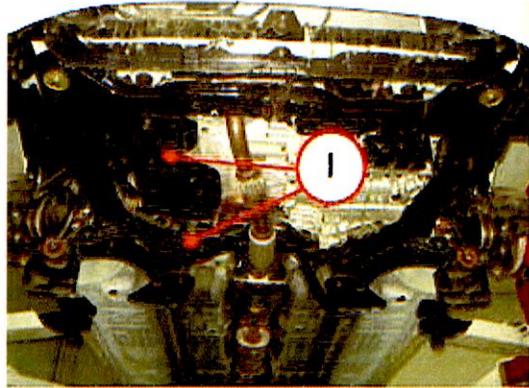
7. Lift the vehicle off the ground.
8. Remove the 2 right under covers (I).

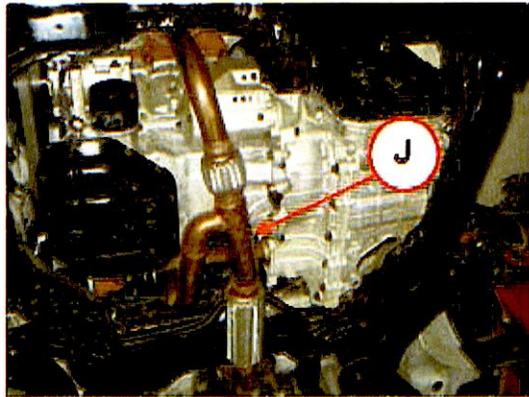
9. Remove the front exhaust pipe (J).

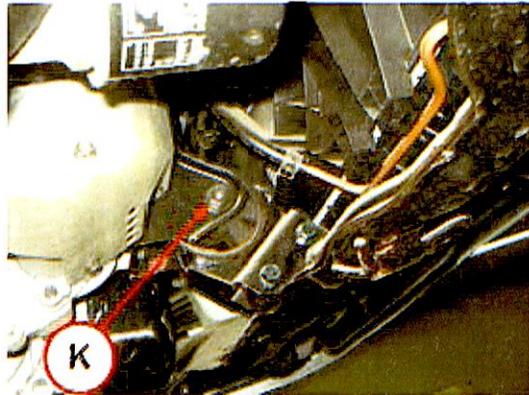
10. Remove the front roll stopper mounting bolt (K).

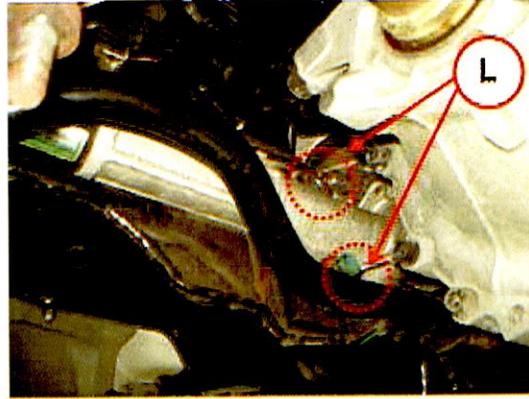
11. Remove the 2 steering gearbox mounting bolts (L) from the left side.

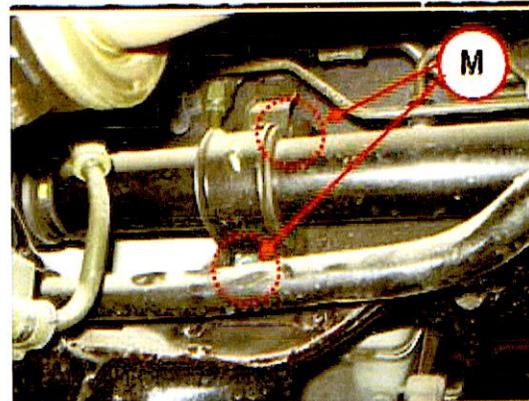
12. Remove the steering gearbox mounting bolts (M) from the right side.

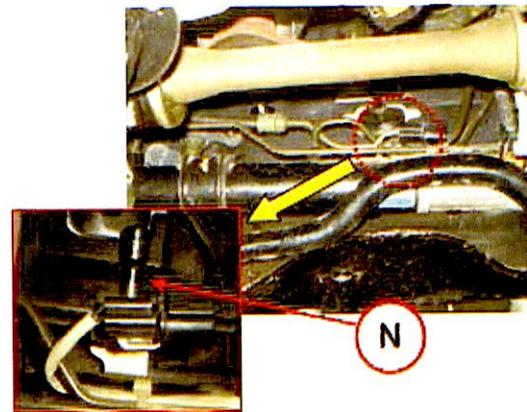
13. Remove the power steering pipe mounting bolt (N) from the top of the steering gearbox.

NOTE: The bolt can be difficult to see from under the vehicle.

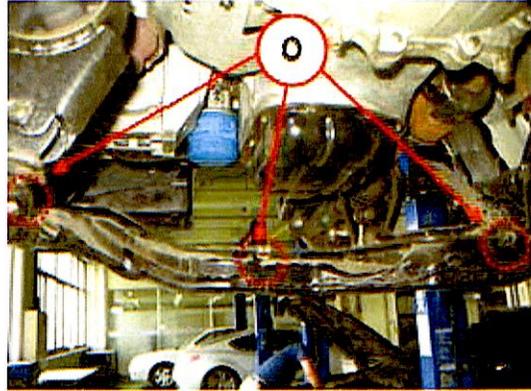
14. Remove the power steering pipe mounting bolts (O) between the steering pump and the steering gearbox.

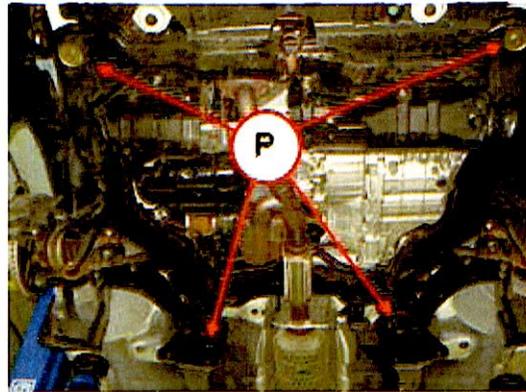
15. Remove the subframe brackets and mounting bolts (P).

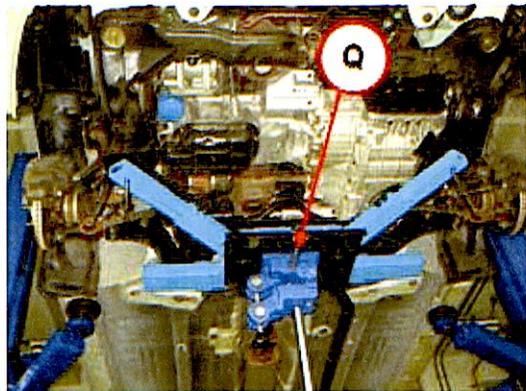
16. Support the subframe with a jack (Q).

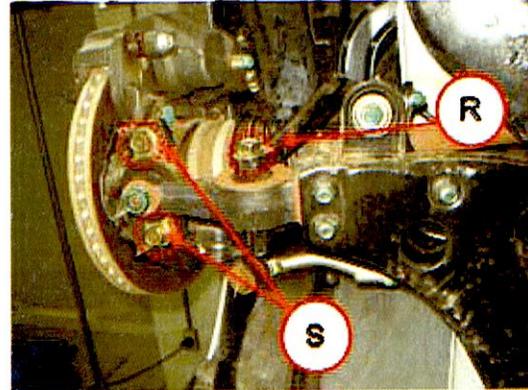
17. Remove the ball joint mounting bolt (R).
18. Remove the bolts (S) from the lower end of the strut assembly.
19. Repeat steps 17 and 18 on the other side.

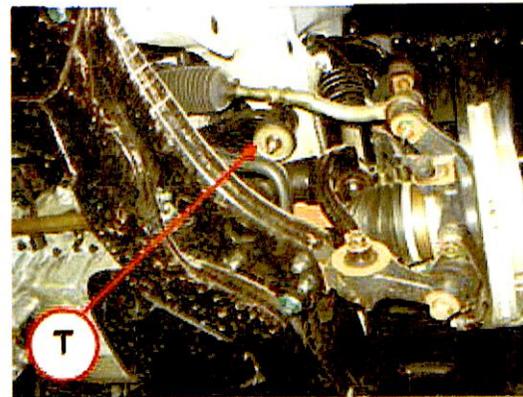
20. Remove the subframe center mounting nut (T).

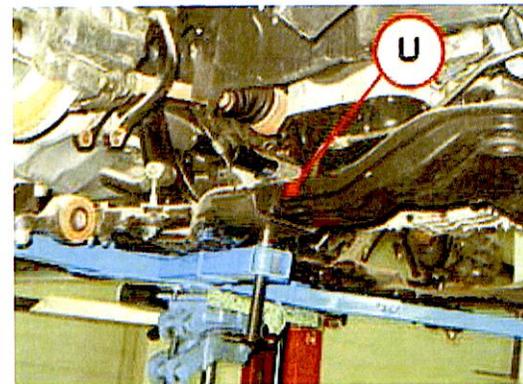
21. Detach the subframe (U) from the steering gearbox and then remove the subframe.
22. Install in reverse order of removal.

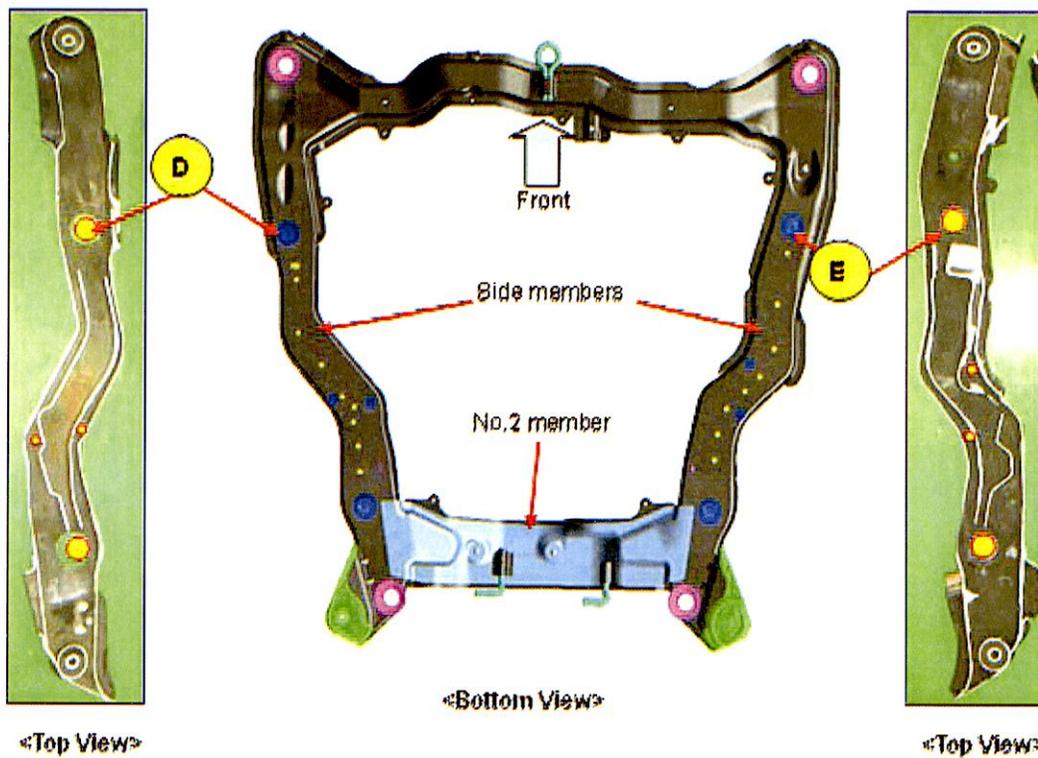
1. Drill 2 holes (D, E) 40mm in diameter on the front of the right and left side members by following the detailed procedures below.

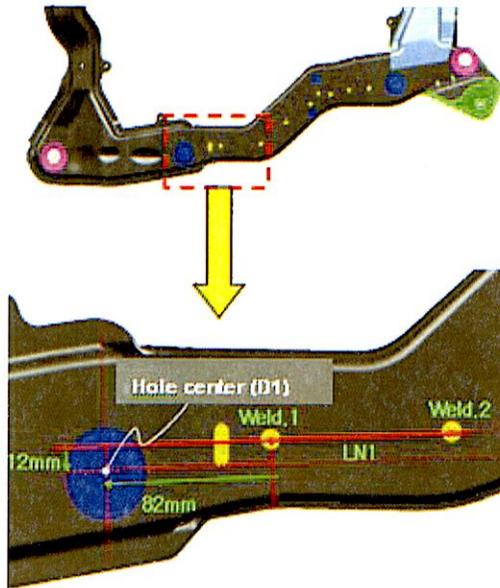
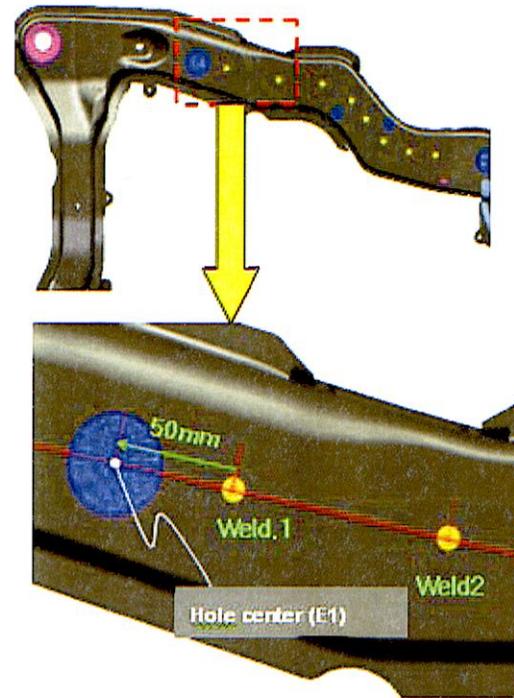
2. Put marking points (D1, E1) on both the right and left side members as indicated in the photo.

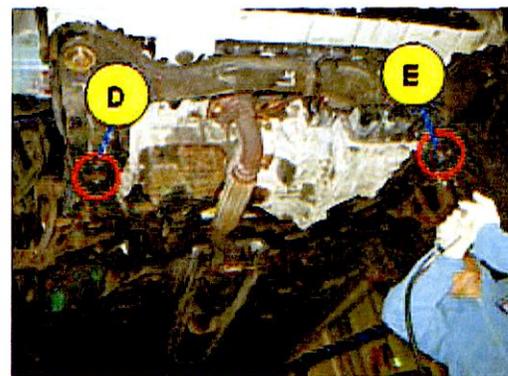
3. Center the 40mm hole saw on the mark and drill a hole in the right side member. Repeat this procedure for the left.

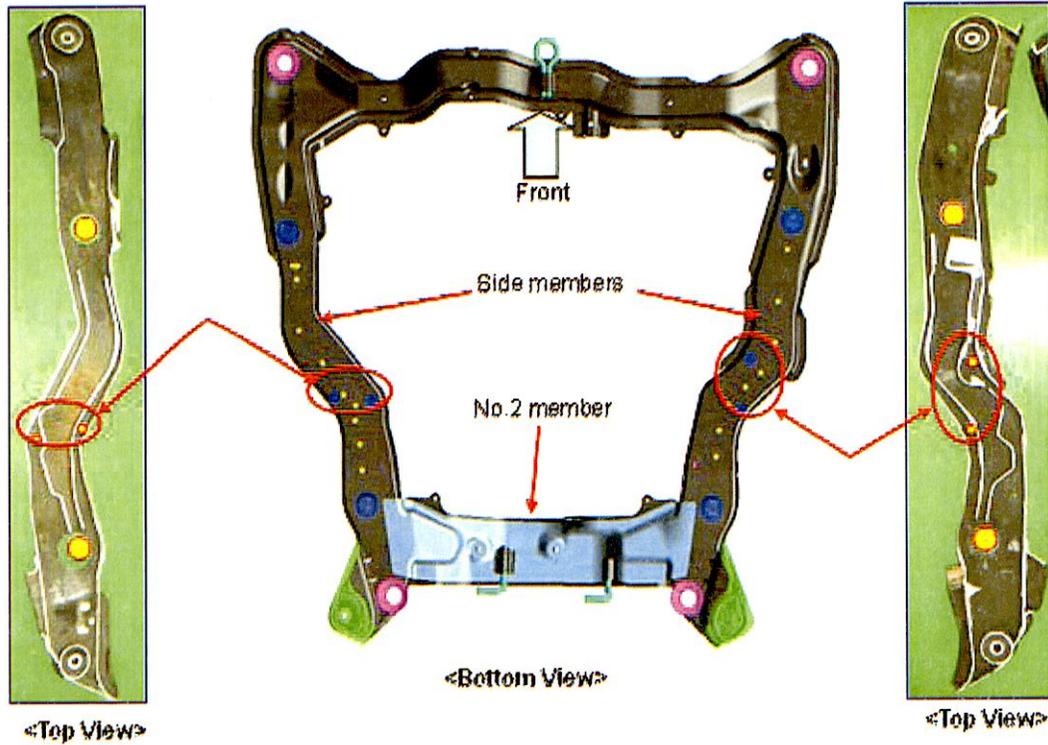
4. Drill four holes 8mm in diameter on the middle of the right and left side members by following the detailed procedures below.

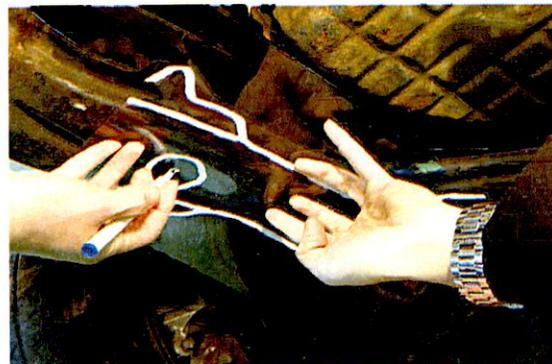
5. Align the hole jig with the right side member as shown in the photo at the right. Put two marks on the right side member. And repeat this procedure for the left.

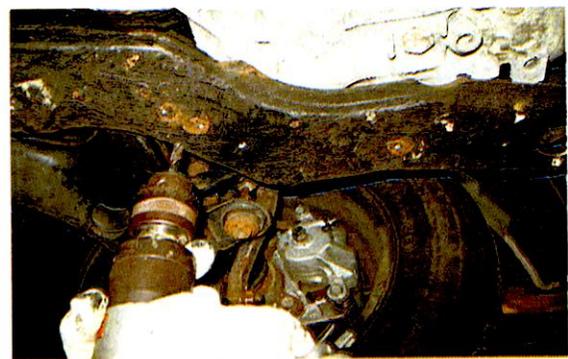
6. Center the 8mm drill bit on the marks and drill two holes in the right side member according to the template. Repeat this procedure for the left.

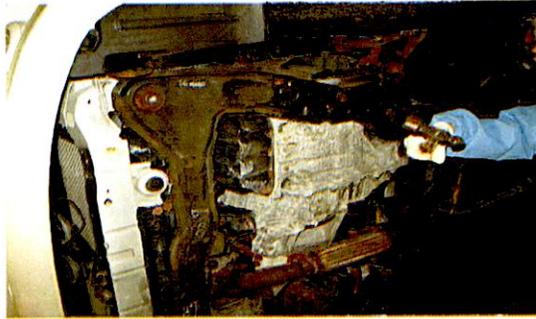
7. Remove fragments of rust from the inside of the subframe by following the detailed procedures below.
8. Strike the subframe throughout with a hammer.

CAUTION: Do NOT strike in the area of the four holes (F, G) 40 mm in diameter to avoid causing deformation damage.

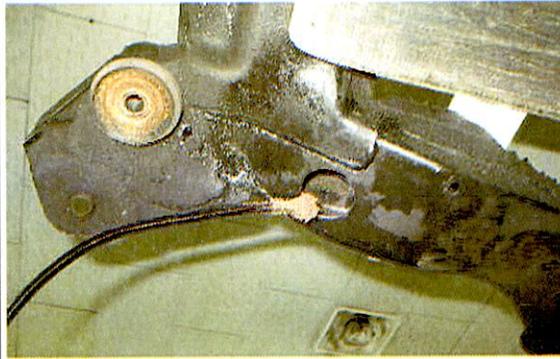
9. Insert a flexible magnet through the 40mm holes and remove any fragments of rust from inside the subframe.

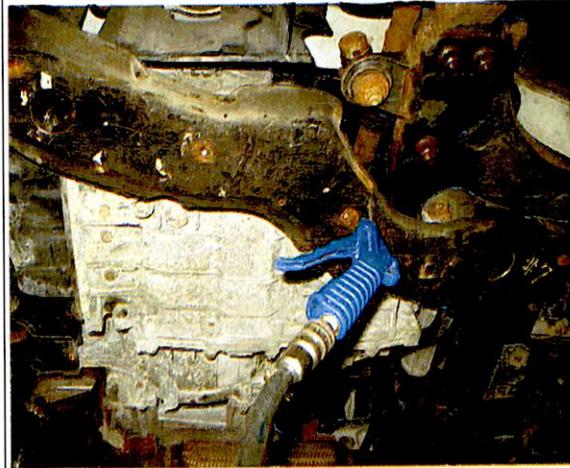
10. Insert the air gun inside of the subframe through holes in the right and left side members and blow rust from inside the subframe.

Use for front and rear holes ($\Phi 40$ holes) of side members - Nozzle is straight.

Use for center holes ($\Phi 8$ holes) of side members - Nozzle is bent.

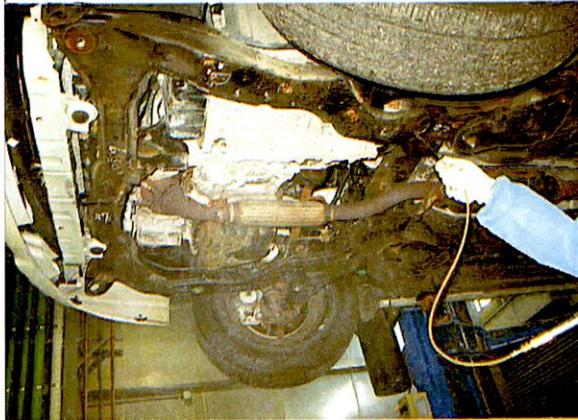
12. Pour one bottle (1 liter) of cavity wax into the injection gun reservoir. Spray cavity wax into the inside of the subframe through all the holes until wax drains through the holes.

NOTE: Use all the holes and keep spraying cavity wax until the cavity wax in the injection gun reservoir is exhausted. Make sure to use one bottle of cavity wax per vehicle.

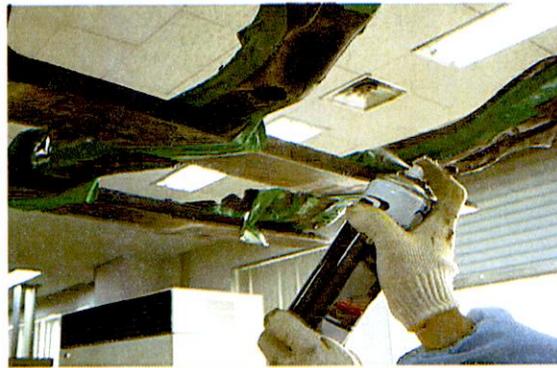
13. Spray undercoating on the subframe, especially around the holes.

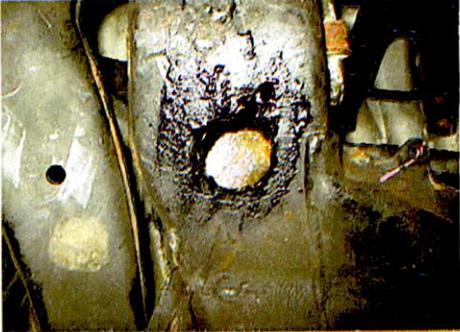
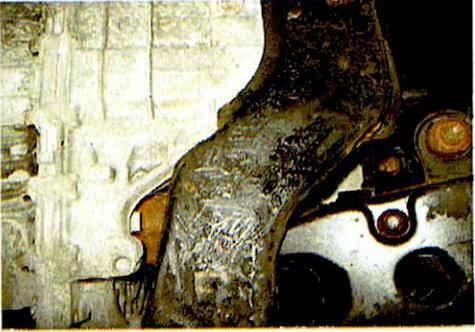
40mm hole	8mm hole

14. Cover all four 40mm holes with hole plugs.	Do not cover 8mm holes.
