<b>SAFETY RECALL RVXX0902 SEPTEMBER 2009</b>
--

**SAFETY DEFECT:** The sealer used on the wiper motor may crack and allow water and contaminants to enter the motor and form deposits at cavities located between the electrical traces.

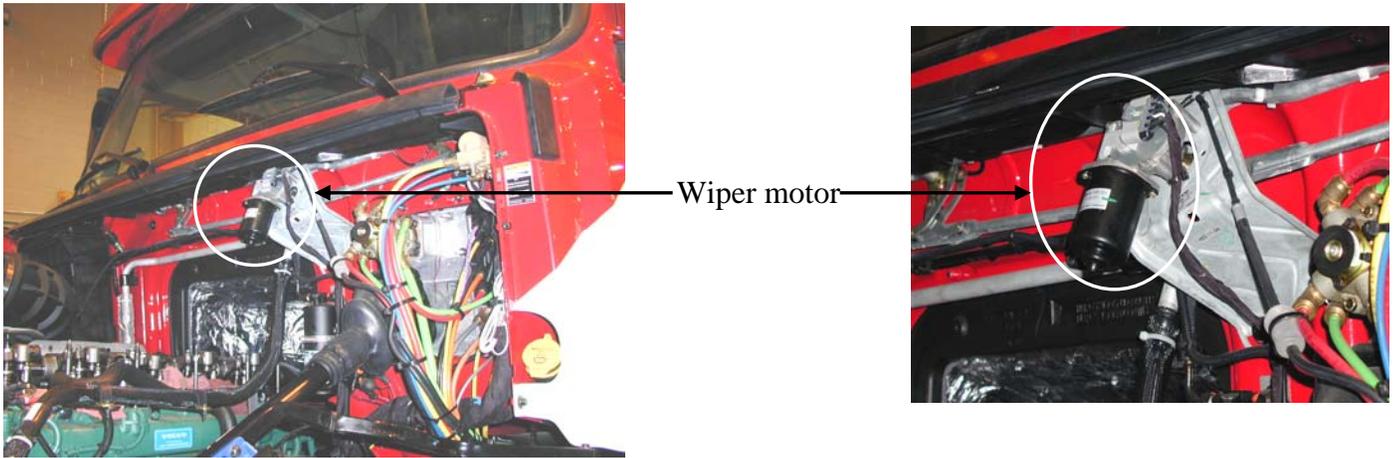
The windshield wiper motor is located under the hood on the upper bulkhead on the driver's side of the vehicle. The following image shows the location of the wiper motor:

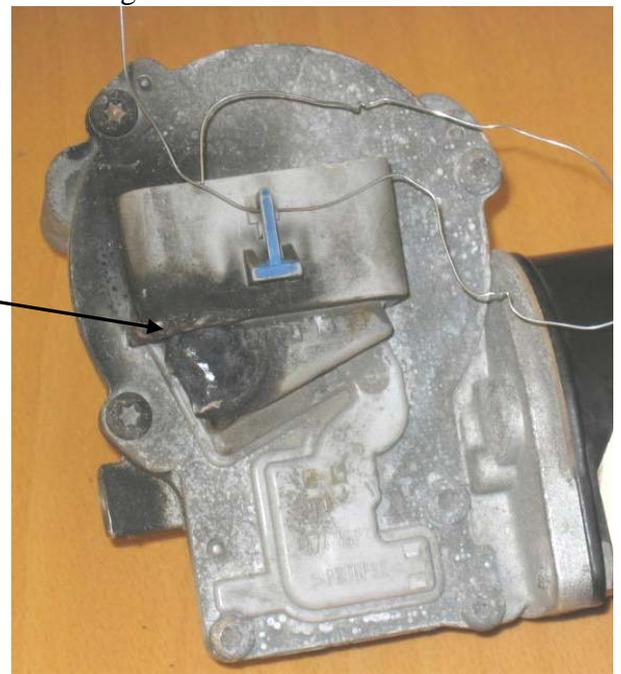
The two images below show connectors that exhibit signs of overheating:

Example of melted connector:  
(Plastic melted and charred)

**PRECAUTIONS YOU CAN TAKE:** Volvo **strongly recommends** that you inspect the wiper motor for evidence of overheating (melting or charring) (see photos on the last page of this document in the section titled "Inspection") during your daily pre and post trip vehicle inspections.

**If your motor shows signs of overheating, do not drive the vehicle; also remove the ignition key. You should contact Volvo's wiper motor recall support line (1-877-800 4945) for further help and instruction.**

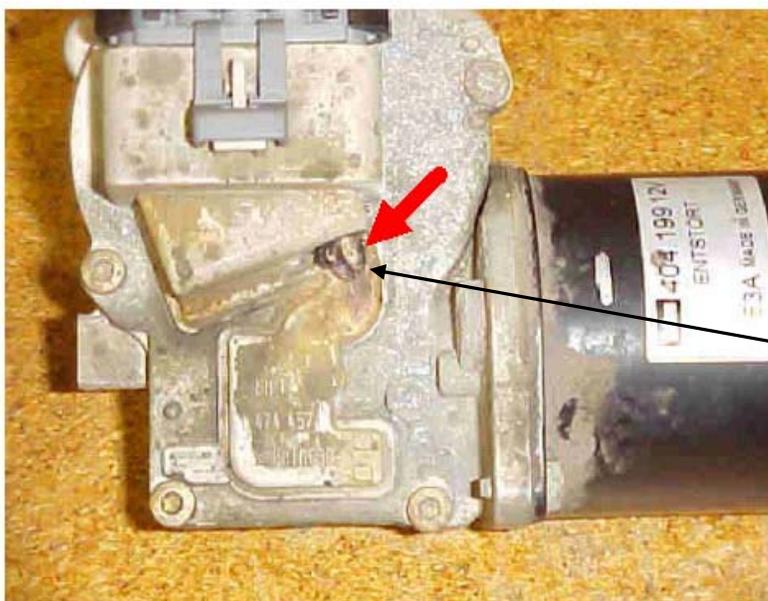
Example of melted connector (plastic deformed)
