SAFETY RECALL NOTICE

VOLVO

**SAFETY RECALL RVXX0902
DECEMBER 2009**

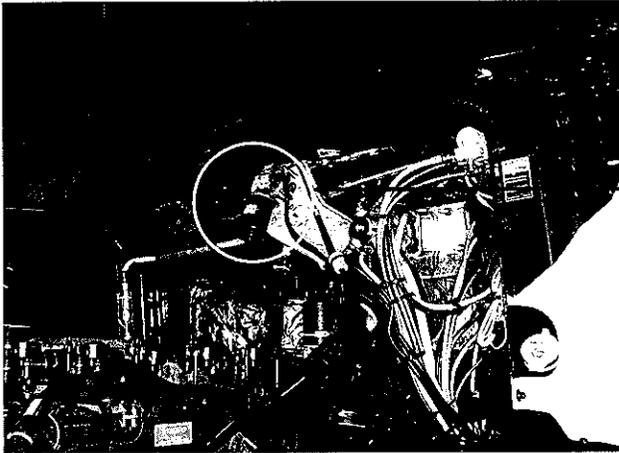
The windshield wiper motor is located under the hood on the upper bulkhead on the driver's side of the vehicle. The following image shows the location of the wiper motor:

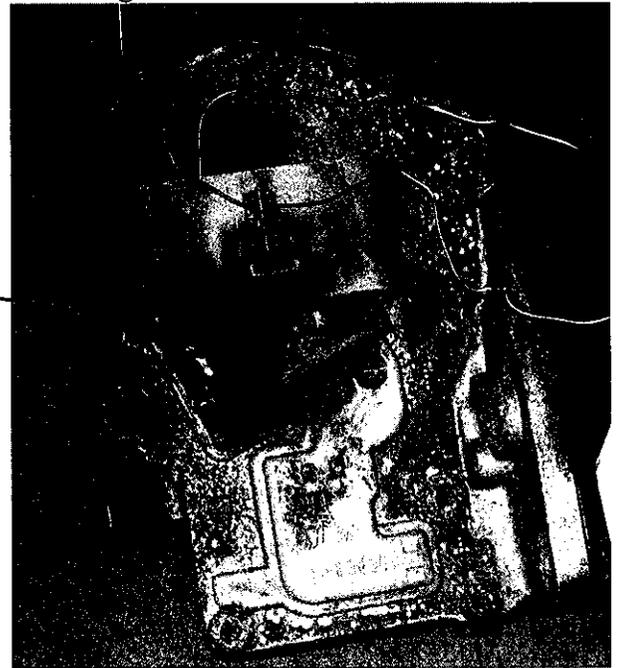
Example of melted connector:
(Plastic melted and charred)

PRECAUTIONS YOU CAN TAKE: Volvo **strongly recommends** that you inspect the wiper motor for evidence of overheating (melting or charring) (see photos on the last page of this document in the section titled "Inspection") during your daily pre and post trip vehicle inspections.

If your motor shows signs of overheating, do not drive the vehicle; also remove the ignition key. You should contact Volvo's wiper motor recall support line (1-877-800-4945) for further help and instruction.

You should contact the nearest Volvo Parts and Service Center and make an appointment. A new wiper motor will be installed at no charge to you. All Volvo Parts and Service Centers have been sent a bulletin covering all the details required to perform the safety recall.

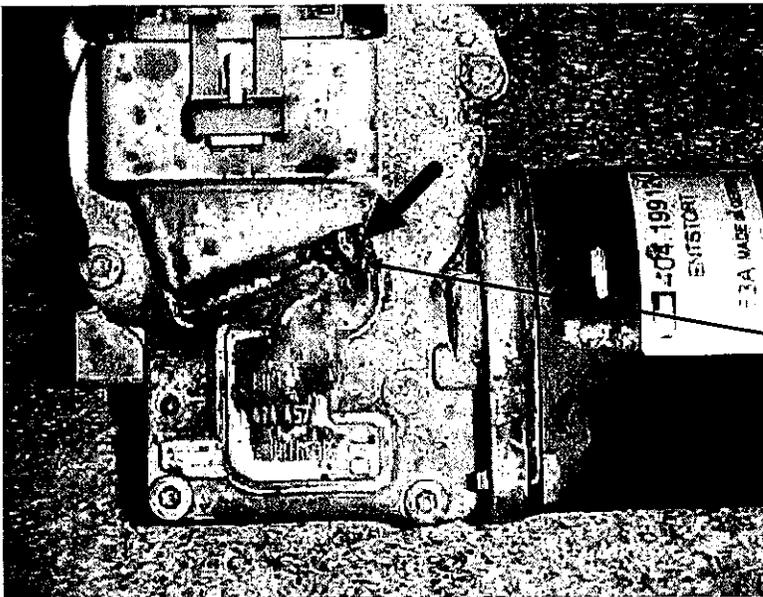
Example of melted connector (plastic deformed)
