## Safety Recall: Master Cylinder May Be Leaking

#### 2005 Odyssey

#### 2006 Odyssey

#### 2007 Odyssey

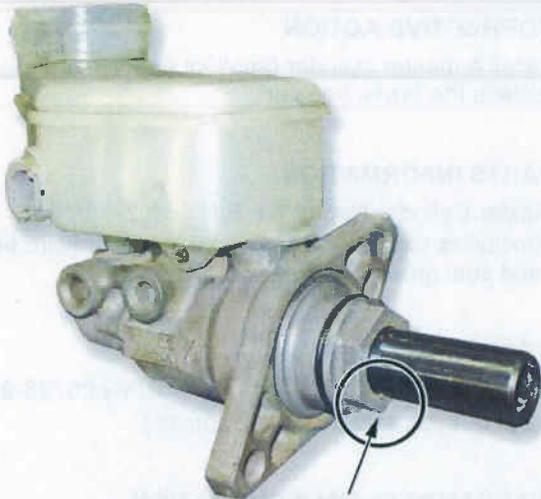
1. Remove the air cleaner and the air duct.
2. Remove the brake fluid from the master cylinder reservoir with a syringe.
3. Remove the master cylinder. Be careful not to bend or damage the brake lines.
4. Check for brake fluid leaking from the installed end of the master cylinder:
  - If there is a leak, go to step 5.
  - If there is no leak, go to step 6.

5. Replace the brake booster. Replacement includes checking the adjustment of the brake pedal height and the brake pedal position switch. Torque the brake booster mounting nuts to **13 N·m (9.4 lb-ft)**.

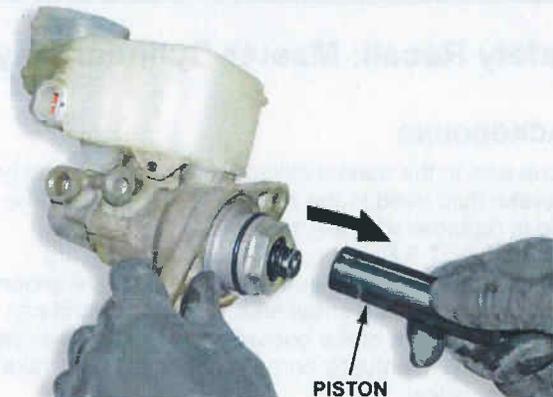
6. Place the master cylinder on clean shop towel on your work bench, then pull out the piston from the end of the master cylinder. A small amount of brake fluid will come out behind the piston; this is normal.

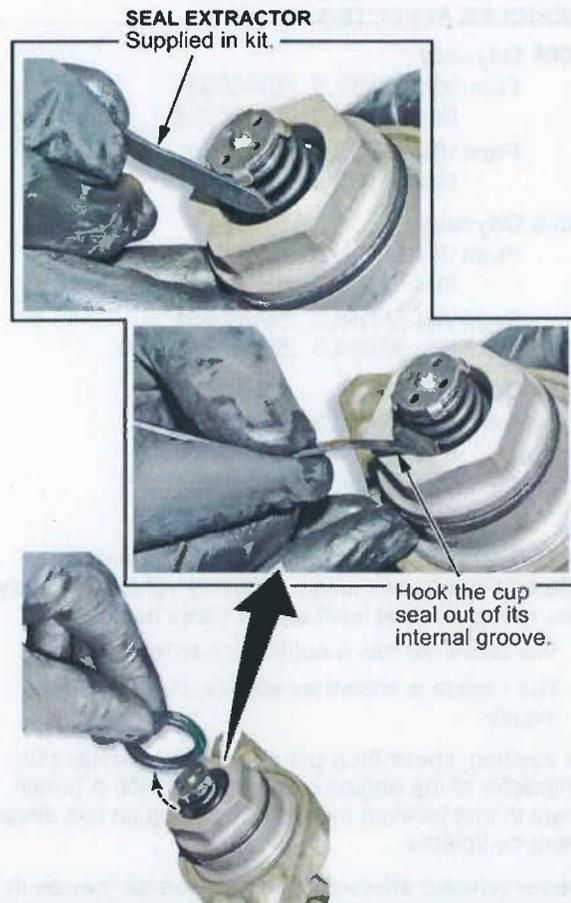
7. Remove the cup seal from the end of the master cylinder using the seal extractor (wire tie) from the kit.

NOTE: To avoid damaging the cup seal retention groove in the master cylinder, do not use a pick seal or any other metal tool to remove the cup seal.

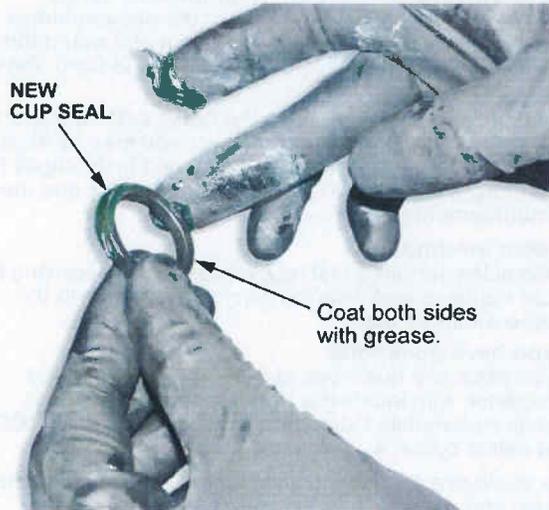
- Coat the new cup seal with the grease supplied in the kit.

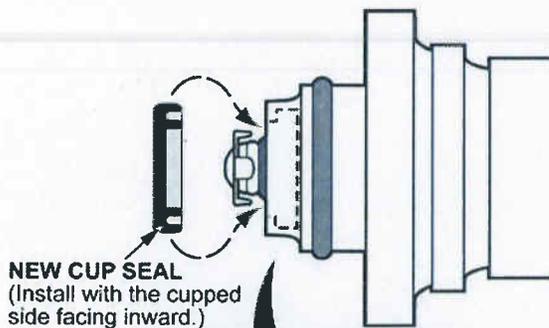
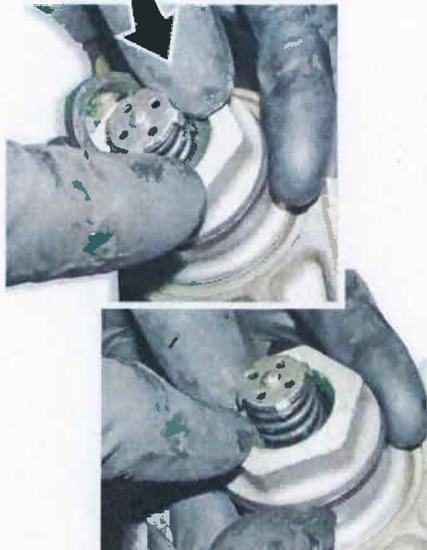
- Install the new cup seal, by hand, into the seal groove at the end of the master cylinder. Install the seal with its cupped side facing the master cylinder.

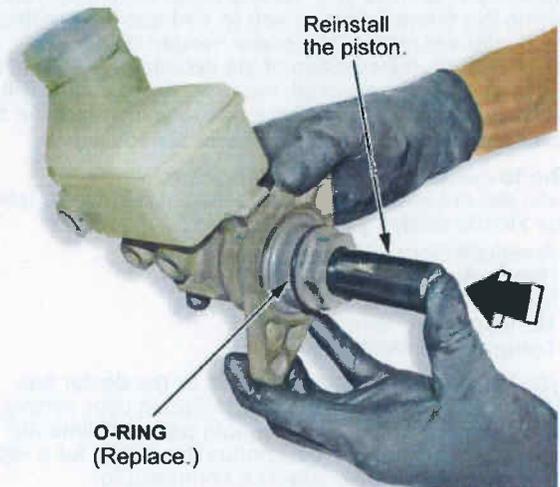
- Reinstall the piston into the end of the master cylinder.

- Reinstall the master cylinder.
  - Use a new O-ring coated with clean brake fluid.
  - Torque the mounting nuts to **13 N·m (9.4 lb-ft)**.
  - Torque the brake line nuts to **22 N·m (16 lb-ft)**.
- Reinstall the air duct and the air cleaner.
- Bleed the brake system.
- Center-punch a completion mark above the 15th character of the engine compartment VIN:
