Toyota Motor Sales, U.S.A., Inc.
19001 South Western Avenue
Torrance, CA 90501
(310) 468-4000

Subject: Safety Recall – A9E
Certain 1998 through 2010 Toyota Sienna 2WD Vehicles Equipped with a Spare Tire
Severe Corrosion of Spare Tire Carrier Cable
Remedy Procedure – Phase 2 (2007 – 2009 model year)

SPARE TIRE CARRIER CABLE REPAIR

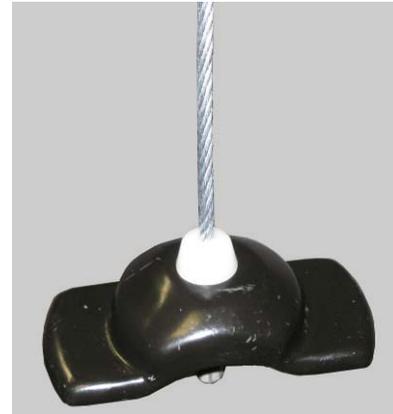
No Rust

- Install the floor seals: p/n 04000-41145 (2004-2009 only)
- Apply Noxudol twice to the cable to prevent corrosion.

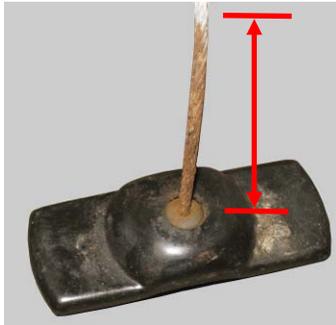
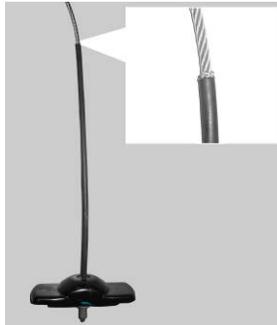
Greater than 8" of Rust Or Black Resin Cable

D. RUSTED CABLE CONDITION WITH MORE THAN 8" OF RUST or a BLACK RESIN CABLE

1998-2003 MY
<ol style="list-style-type: none"> Install a NEW spare tire carrier (p/n 51900-08010). Apply Noxudol twice to the new carrier. Reinstall spare tire.

2004-2009 MY
<ol style="list-style-type: none"> Install a NEW spare tire carrier (p/n 51900-08034). Install NEW floor seals. Reinstall spare tire.
