Toyota Motor Sales, U.S.A., Inc.
19001 South Western Avenue
Torrance, CA 90501
(310) 468-4000

Subject: Safety Recall – A9E
Certain 1998 through 2010 Toyota Sienna 2WD Vehicles Equipped with a Spare Tire
Severe Corrosion of Spare Tire Carrier Cable
Remedy Procedure – Phase 3 (Certain 2010 model year)

SPARE TIRE CARRIER CABLE REPAIR

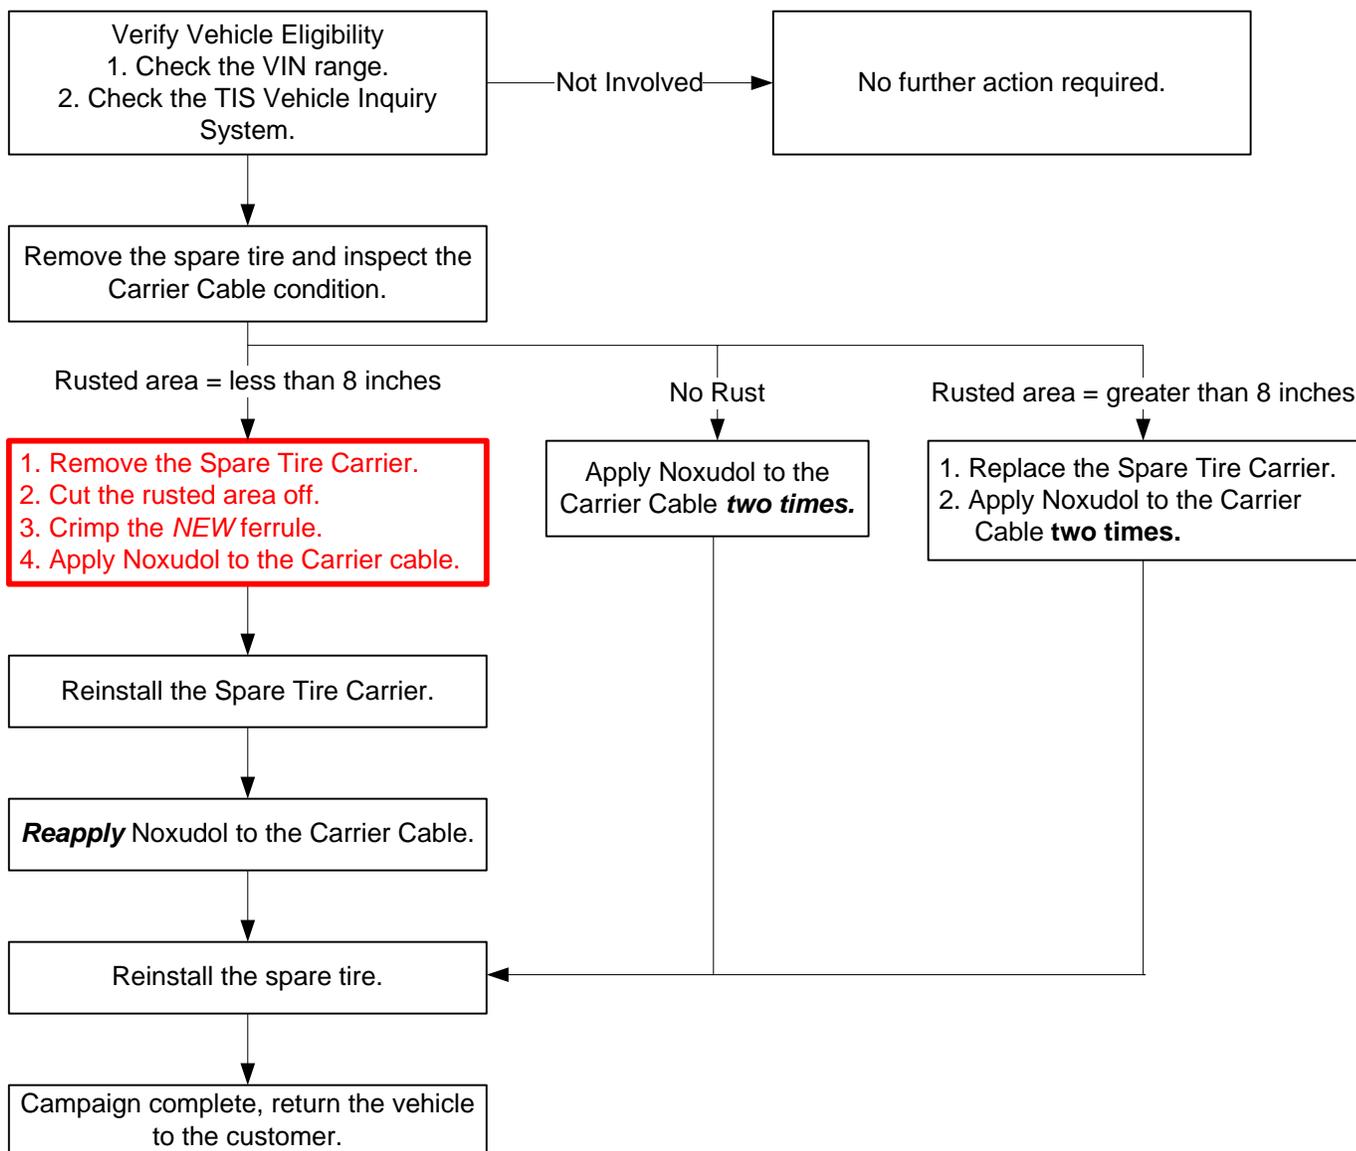
1998 – 2003 MY

I. OPERATION FLOW CHART

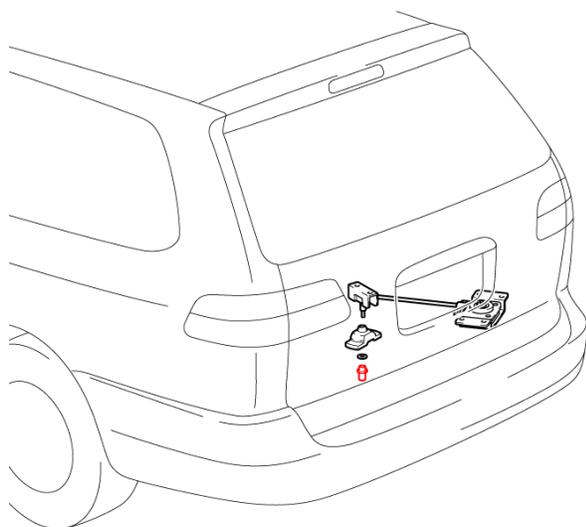
On certain 1998 through 2010 model year Sienna 2WD vehicles equipped with a spare tire, which are operated in cold climate areas with high road salt use; excessive corrosion may be exhibited on the end of the spare tire carrier cable. In the worst case, the spare tire stowed under the floor may become separated from the spare tire carrier.

1998 – 2003 MY
Carrier located between rear tires

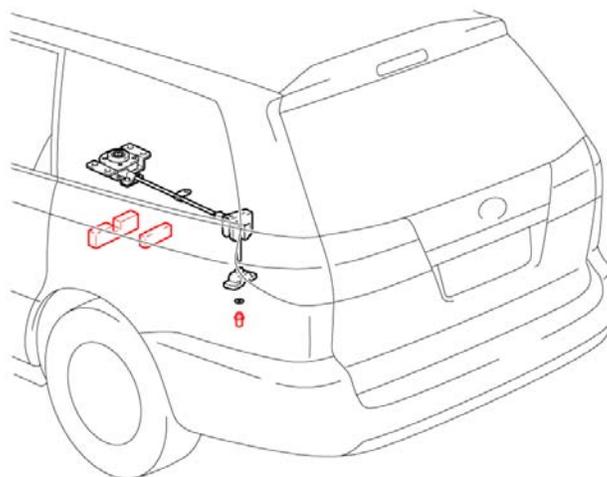
2004 – 2010 MY
Carrier located under the right side passenger sliding door

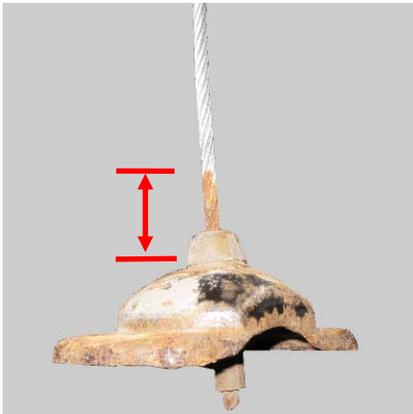
Less than 8" of Rust*
(measured from the lift plate up)

Spare Tire Carrier Cable Inspection Criteria.

- Cut and remove the rusted portion of the cable.
- Repair the cable using Sienna Kit #1 p/n 04000-40108 and a hydraulic press.
- Apply Noxudol twice to the cable to prevent corrosion.
- Install the floor seals: p/n 04000-41145 (2004-2010 only)

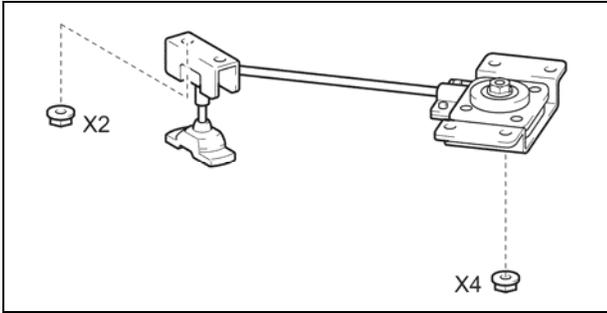
1. REMOVE THE SPARE TIRE CARRIER (1998-2003)

- a) Remove the 6 nuts and spare tire carrier.

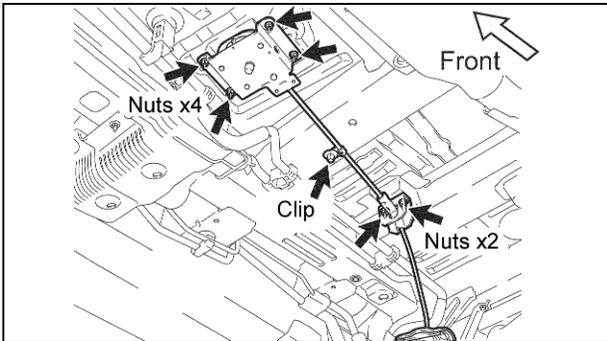
2. REMOVE THE SPARE TIRE CARRIER (2004-2010)

- a) Remove the clip, 6 nuts and spare tire carrier.

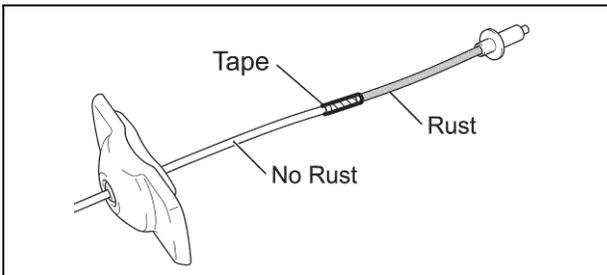
1. CUT THE CABLE

- a) Wrap tape around the edge of the rusted cable section 2 to 3 times.
- b) Cut the cable at the taped section.
- c) Remove the tape from the cut section.

NOTE: The cut section of the cable will be sharp.

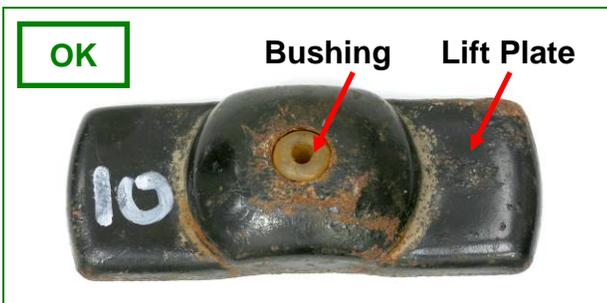
2. INSPECT THE LIFT PLATE AND BUSHING

- a) Replace the bushing and lift plate if any of the following are true.
 - Severe rusting on the lift plate
 - Damage to the bushing
 - No paint on the lift plate

Lift Plate Kit p/n 04000-40208

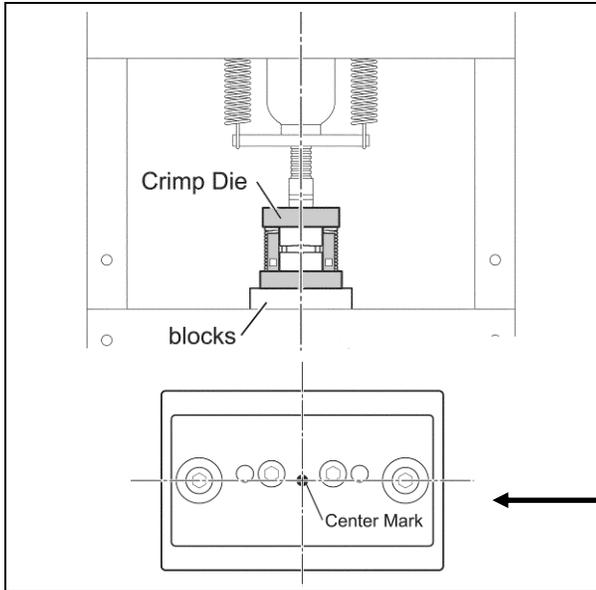
3. LEVEL AND CENTER THE HYDRAULIC PRESS AND DIE

- Confirm the hydraulic press and blocks are level. Level the press and blocks if necessary.
- Align the center mark on the crimp die to the center of the hydraulic press.

- The ferrule may fall off the cable due to improper crimping if the die is not centered on the press, and if the hydraulic press is not level.
- Always wear safety glasses when working with a press.

A hydraulic press must be used to crimp the ferrule. Any other tool will not exert enough pressure to properly secure the ferrule to the spare tire cable.

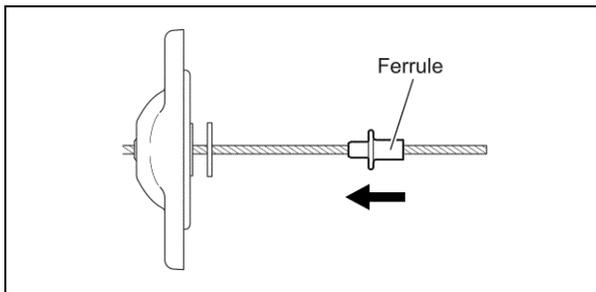
4. CRIMP THE FERRULE

- Slide on the **NEW** washer.
- Slide on the **NEW** ferrule in the correct orientation. (small end towards the lift plate)

NOTE: DO NOT install the ferrule backwards.

Ferrule Kit p/n 04000-40108

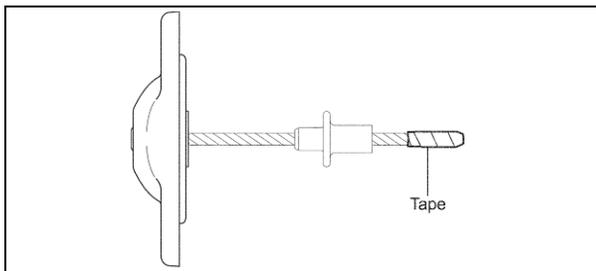
- Wrap tape around the cable end to prevent the ferrule from sliding off.

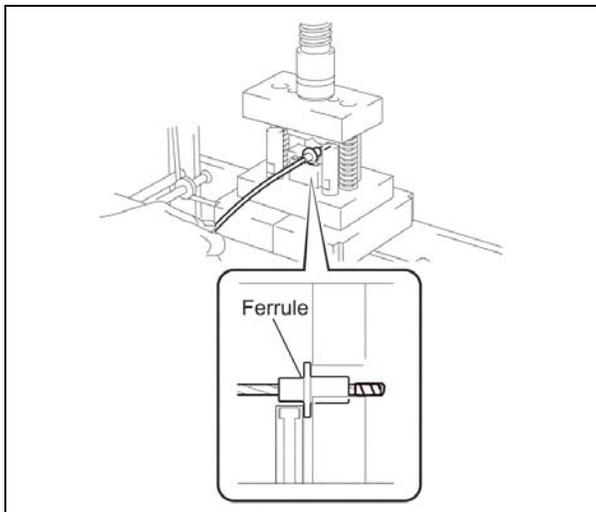
- Set the ferrule near the cable end on the crimp die.

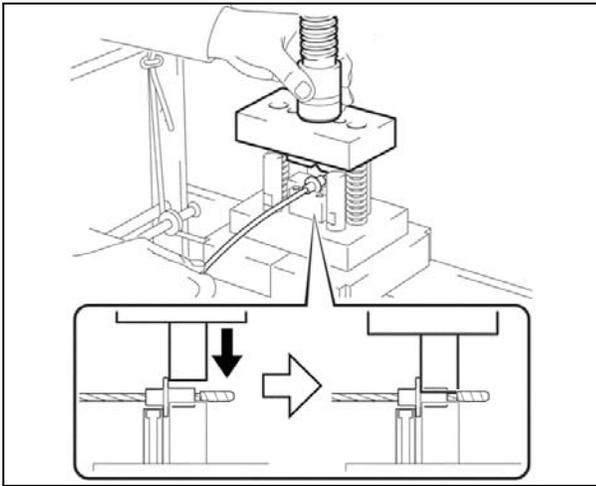
e) While holding the cable, carefully lower the hydraulic press until the crimp die contacts the top of the ferrule.

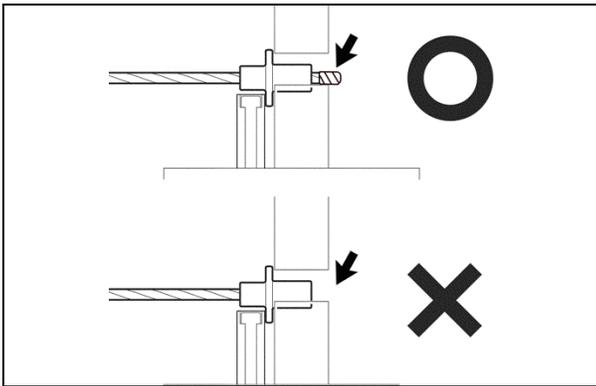
f) Verify the cable has not receded.

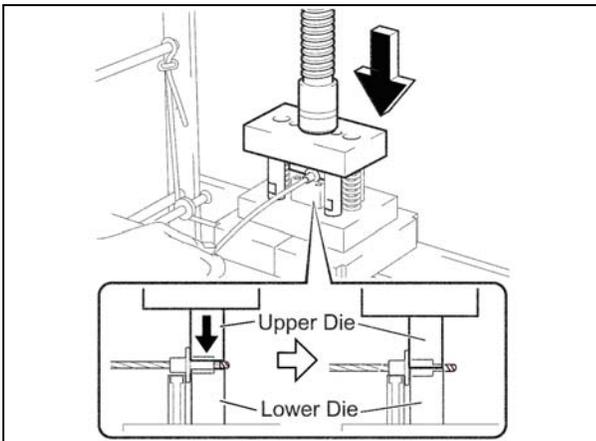
g) Hold the cable and crimp the ferrule.
 h) Monitor the pressure of the hydraulic press and crimp the ferrule just up to the point that the upper and lower sections of the die contact.

NOTE: Release the hydraulic pressure and stop work immediately if the press nears 17 tons (15.4 metric tons, 150 KN) regardless of the ferrule condition.

i) Release the press and remove the cable.

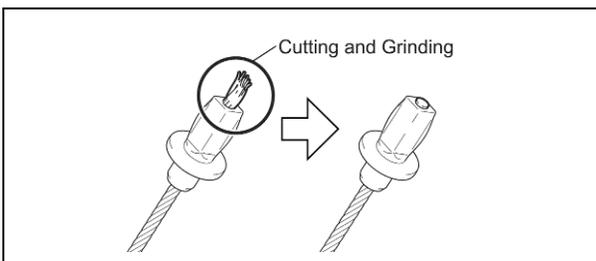
j) With a disk grinder, remove the cable end protruding from the ferrule.

NOTE:
 Do NOT damage the ferrule while grinding.

- k) Use the check gauge to measure **all** sides of the pressed ferrule. Make sure the crimped ferrule only fits into the first section of the check gauge.

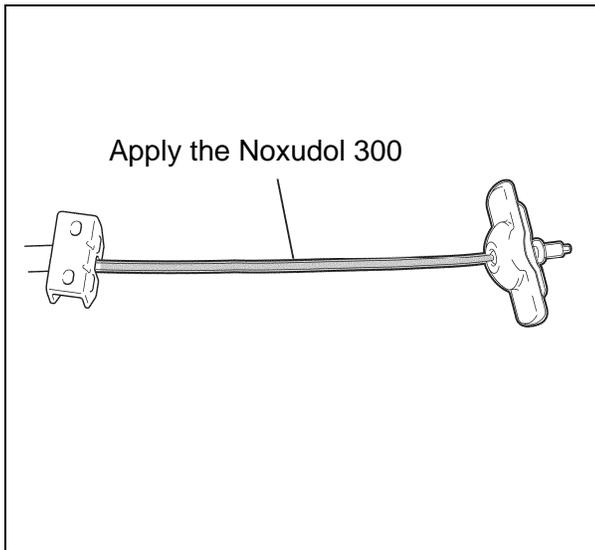
1. APPLY THE NOXUDOL 300 TO THE CABLE

- Take necessary measures to prevent overspray and/or drippage.
- Do not touch Noxudol 300 as the treated surfaces will remain tacky to the touch for a period of time.

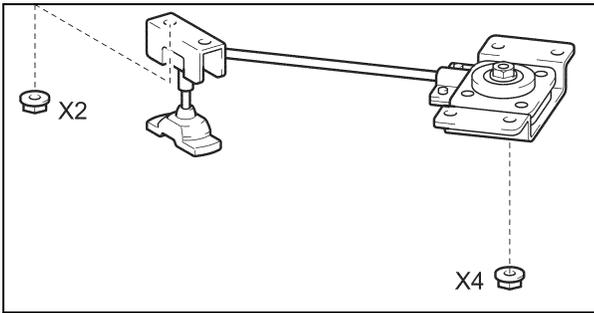
1. REINSTALL THE SPARE TIRE CARRIER (1998-2003)

- a) Install the spare tire carrier with the 6 **NEW** nuts.

Torque Specification:
5.4 N-m (55 kgf-cm, 48 in-lbf)

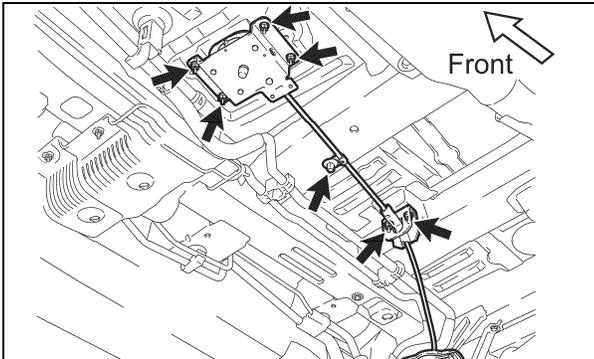
2. REINSTALL THE SPARE TIRE CARRIER (2004-2010)

- a) Install the spare tire carrier with the 6 **NEW** nuts and clip.

Torque Specification:
5.4 N-m (55 kgf-cm, 48 in-lbf)

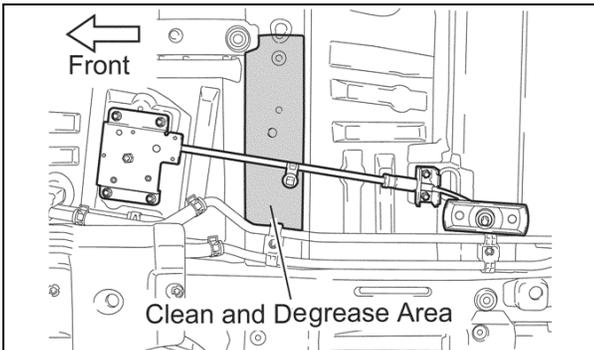
1. INSTALL THE FLOOR SEAL

- a) Clean and degrease the area illustrated on the vehicle under-carriage.

NOTE: If rust is present, remove the rust with a wire brush before cleaning and degreasing.

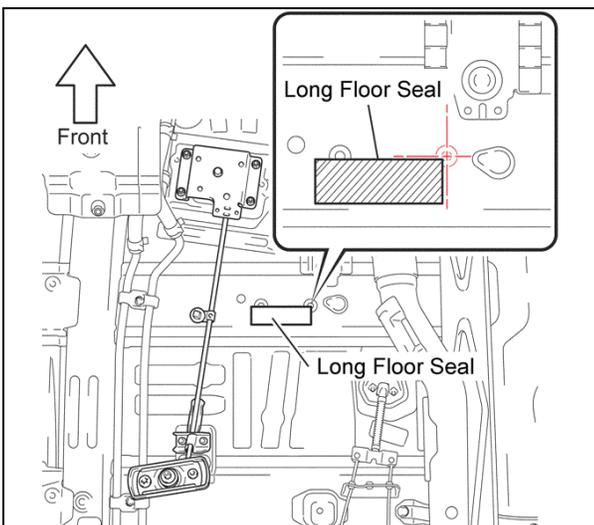
- b) Attach the long floor seal to the area shown.
c) Align the corner of the floor seal to the nub on the under-carriage (illustrated in red).

NOTE: When the floor seals are correctly installed, they prevent excessive splashed water from contacting the carrier cable.

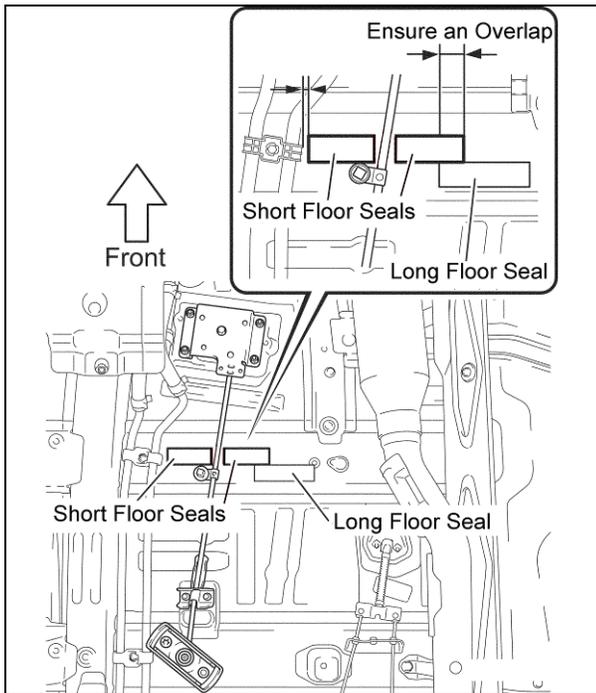
d) Attach two short floor seals to the areas shown.

NOTE: When the floor seals are correctly installed, they prevent excessive splashed water from contacting the carrier cable.

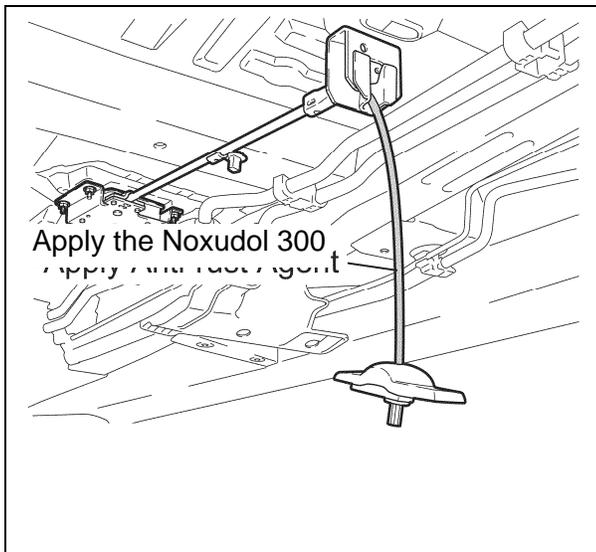
1. REAPPLY THE NOXUDOL 300 TO THE CABLE

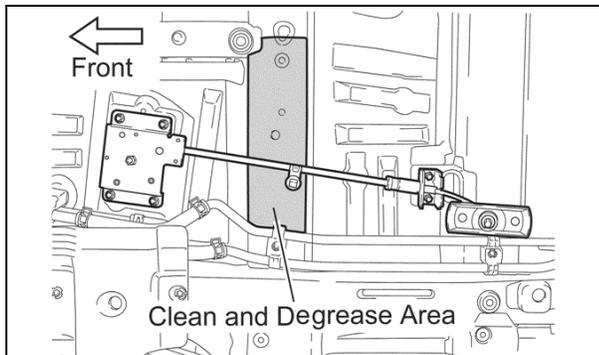
2. INSTALL THE FLOOR SEAL

- a) Clean and degrease the area illustrated on the vehicle under-carriage.

NOTE: If rust is present on the undercarriage, remove the rust with a wire brush before cleaning and degreasing.

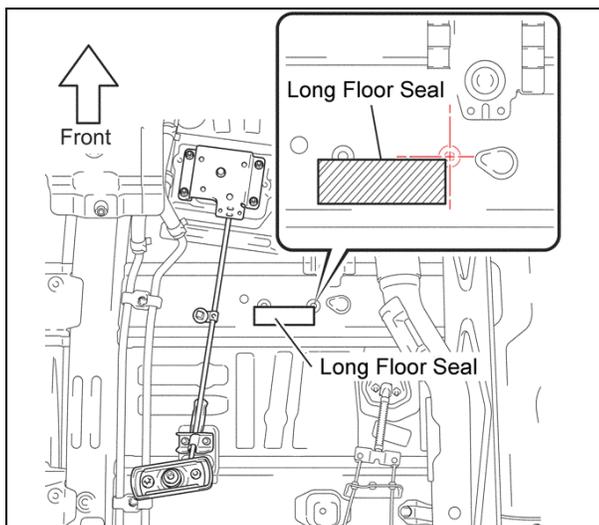
- b) Attach the long floor seal to the area shown.
- c) Align the corner of the floor seal to the nub on the under-carriage (illustrated in red).

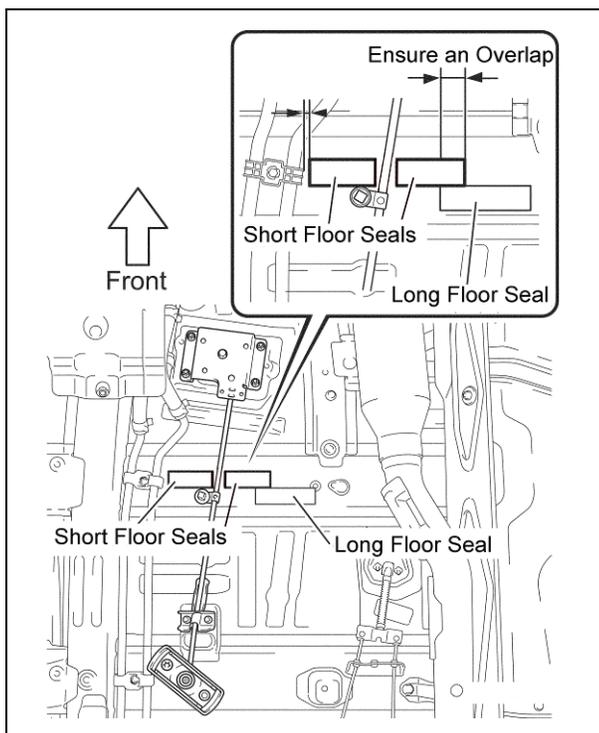
- d) Attach two short floor seals to the areas shown.

NOTE: When the floor seals are correctly installed, they prevent excessive splashed water from contacting the carrier cable.

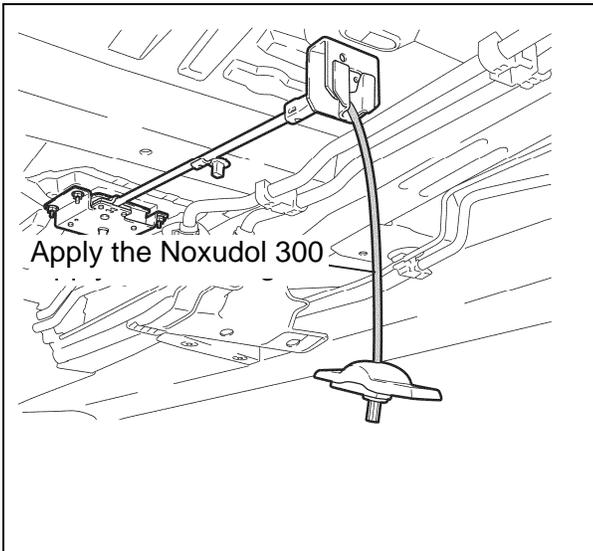
2. APPLY THE NOXUDOL 300 TO THE CABLE

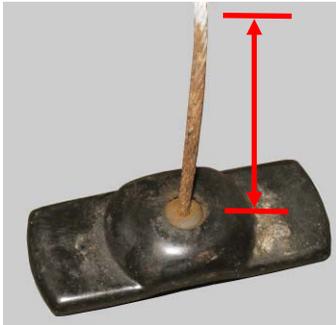
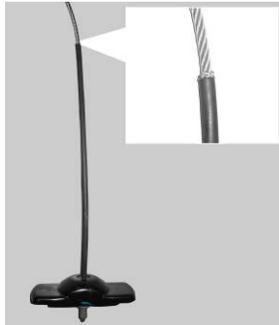
Greater than 8" of Rust Or Black Resin Cable

D. RUSTED CABLE CONDITION WITH MORE THAN 8" OF RUST or a BLACK RESIN CABLE

1998-2003 MY
1. Install a NEW spare tire carrier (p/n 51900-08010).
2. Apply Noxudol twice to the new carrier.
3. Reinstall spare tire.

2004-2010 MY
1. Install a NEW spare tire carrier (p/n 51900-08035).
2. Install NEW floor seals.
3. Reinstall spare tire.
