**BULLETIN NUMBER**  
13-28

**SUBJECT**  
Brake Assembly Cracking

## TIB 13-28; Brake Assembly Cracking

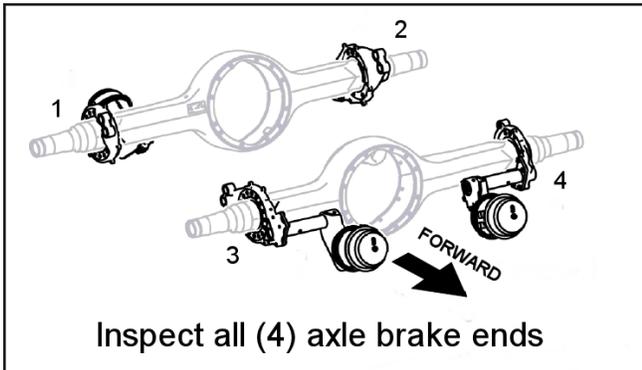
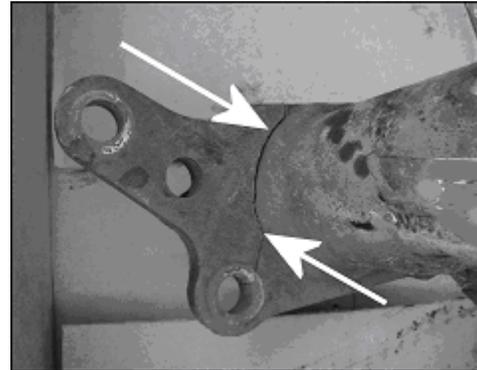
Cracks at the cam tube weld/flange

Replace cracked or fractured components. Standard procedures apply to replacing cracked or fractured brake assembly components and parts damaged as a result of brake assembly component fracture.

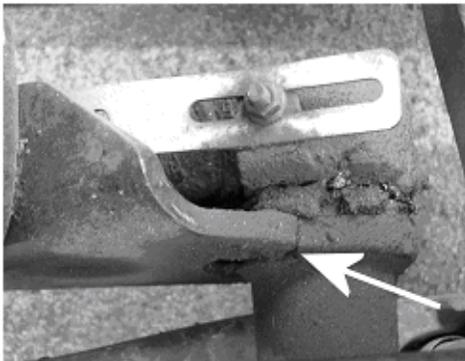
Cracks in brake air chamber bracket

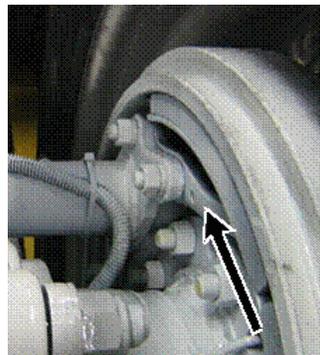
Cracks in the brake spider

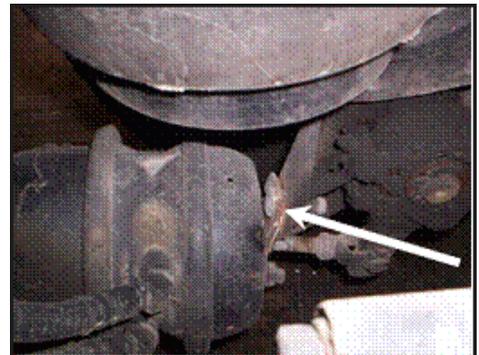
Cracks in the air brake chamber

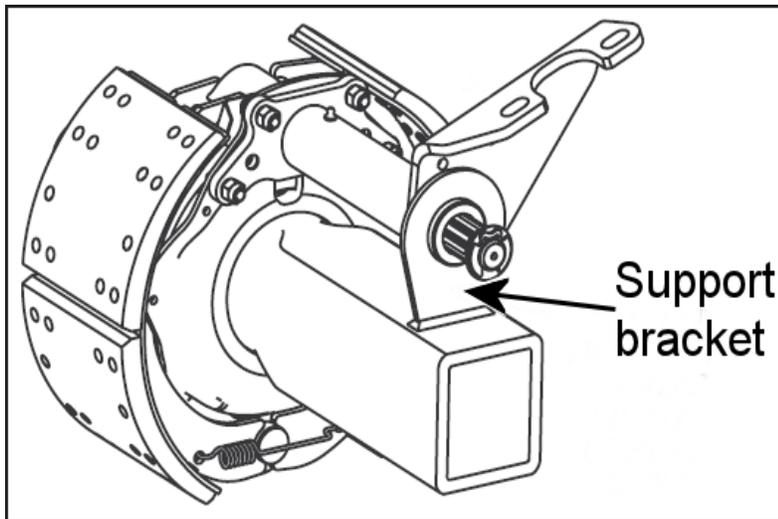
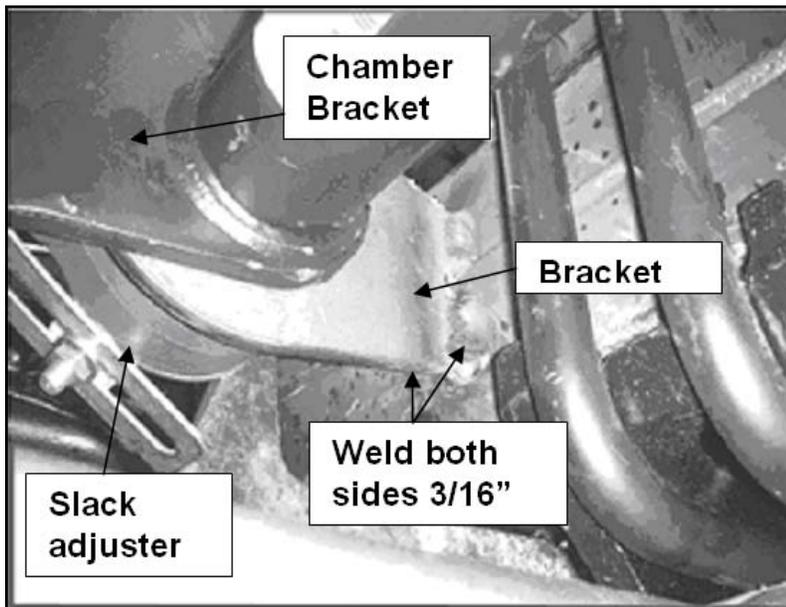
Following are illustrations of completed work.

Install supports on all rear axle ends that have brakes, whether there was a crack or fracture on that axle end or not. Use the following steps.

1. Properly chock wheels to prevent vehicle from rolling.
2. Remove wheel and tire.
3. Properly cage brake chamber per chamber manufacturer's instructions.
4. Disconnect the brake chamber from the slack adjuster
5. Remove the slack adjuster from the cam tube
6. Select the appropriate bracket, from the chart in PARTS section.
7. Slide the camshaft tube brace onto the camshaft tube. (See installation drawing C93-1178)
  - a. Push the brace as close to the brake air chamber mounting bracket as possible.
  - b. The brace hole will fit tight over the camshaft tube.
  - c. The small semi-circle notch in the bracket is designed to fit over the axle weld seam.
8. Weld the bracket to the axle housing.
  - a. Use approximately 3/16" weld size.
  - b. Weld the full length on both sides of the bracket.
  - c. Do not weld the bracket to the brake cam tube.

9. Prime and paint bracket and weld.
10. Reinstall slack adjuster then un-cage spring brake.
11. Reinstall wheel and tire.
12. Verify brakes are properly adjusted.

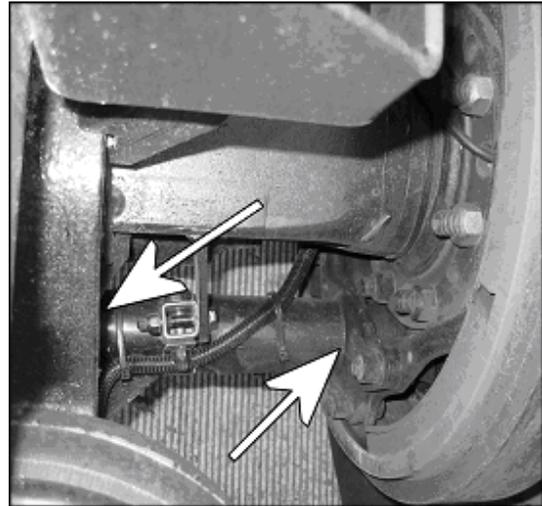
Top down view of brake cam tube

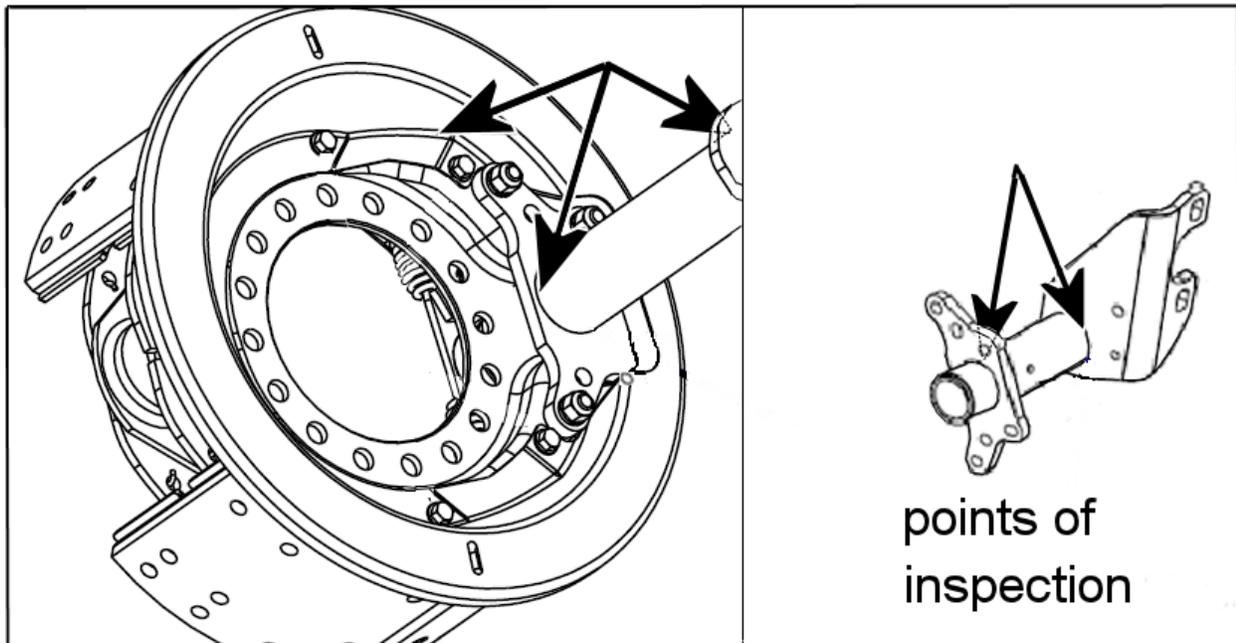
Detailed view of inspection area

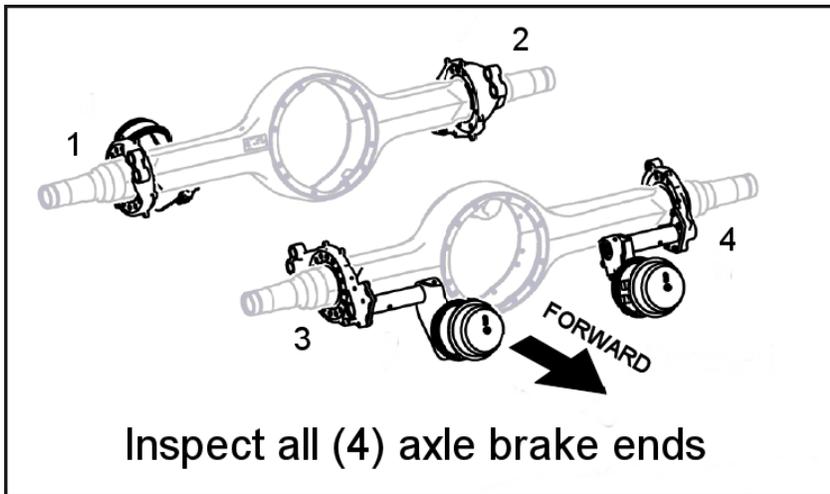
**What to look for:** cracks at cam tube or attached parts

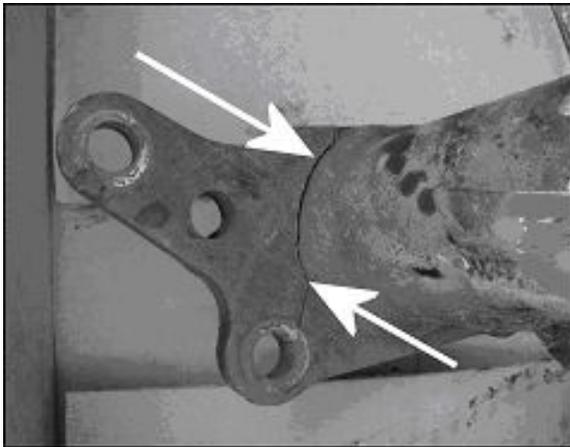
Cracks at the cam tube weld/flange

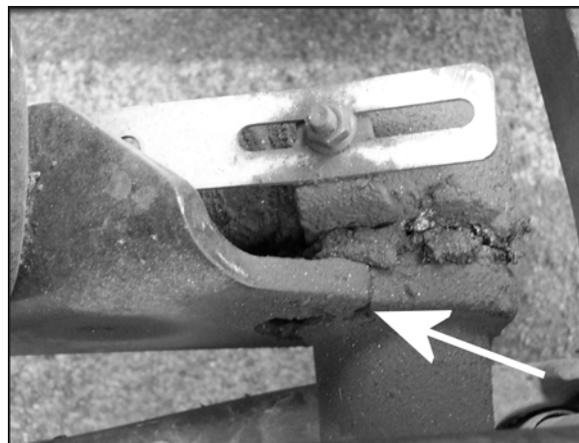
Cracks in brake air chamber bracket

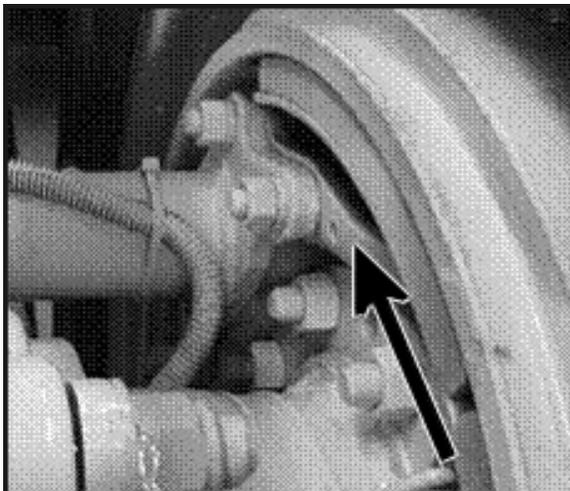
Cracks in the brake spider

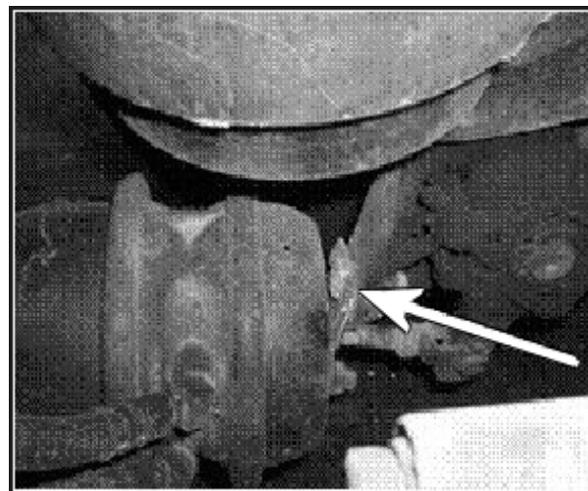
Cracks at the brake air chamber
