No. K4X00N/122

題目 F50, '02 Year Model, F.M.V.S.S. No.214 Self-Certification Test

Left side Impact (33.5mph)

題目 F50, 2003 Year Model, FMVSS No.214 Self-Certification Test

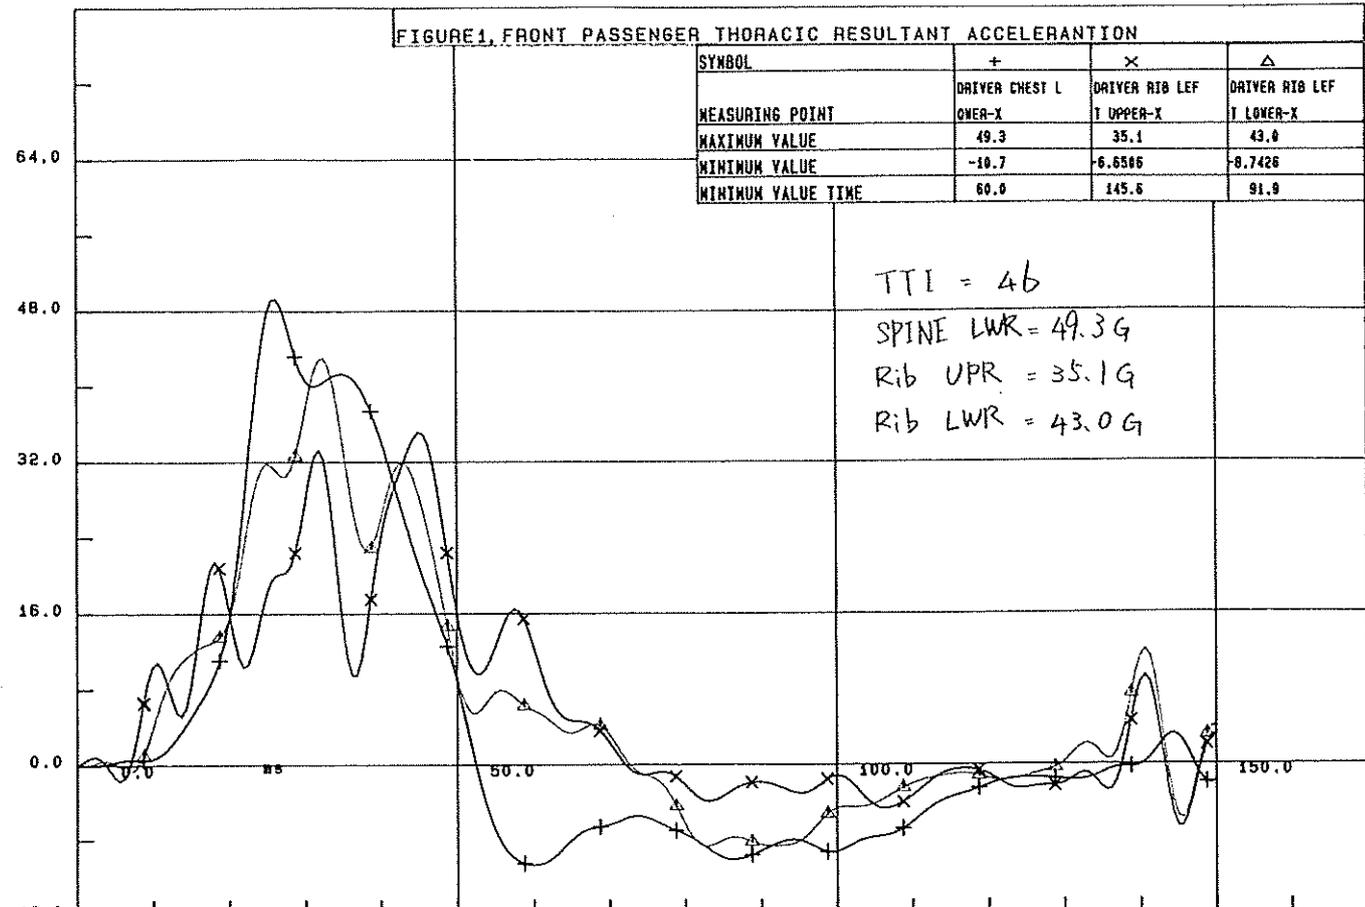
- 4.1 Detailed data of front passenger's injury criteria.  
See Figure 1~2.
- 4.2 Detailed data of Rear Passenger's injury criteria.  
See Figure 3~4.
- 4.3 Photographs of the test vehicle before and after.  
See Photo. 1~8.

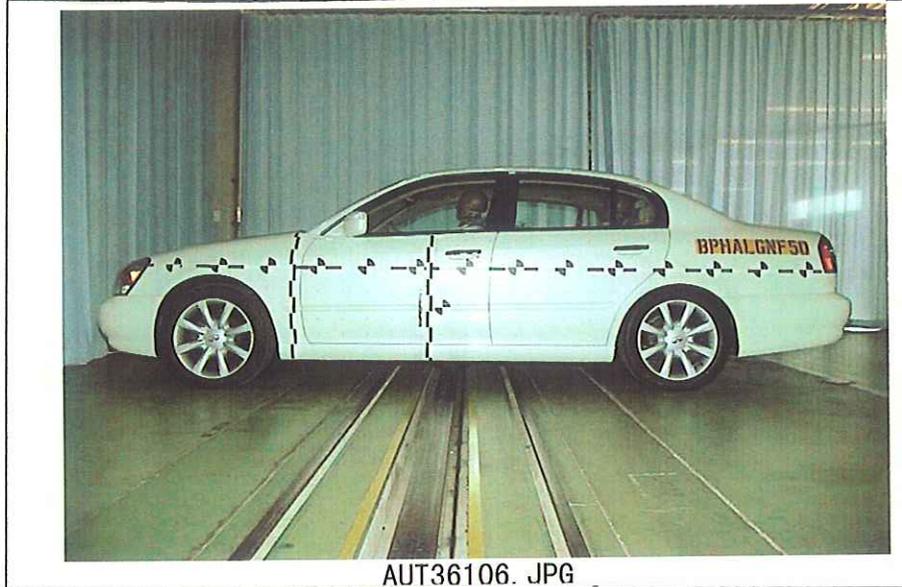
Photo. No.1                      PRETEST

SUBJECT :    Side    view

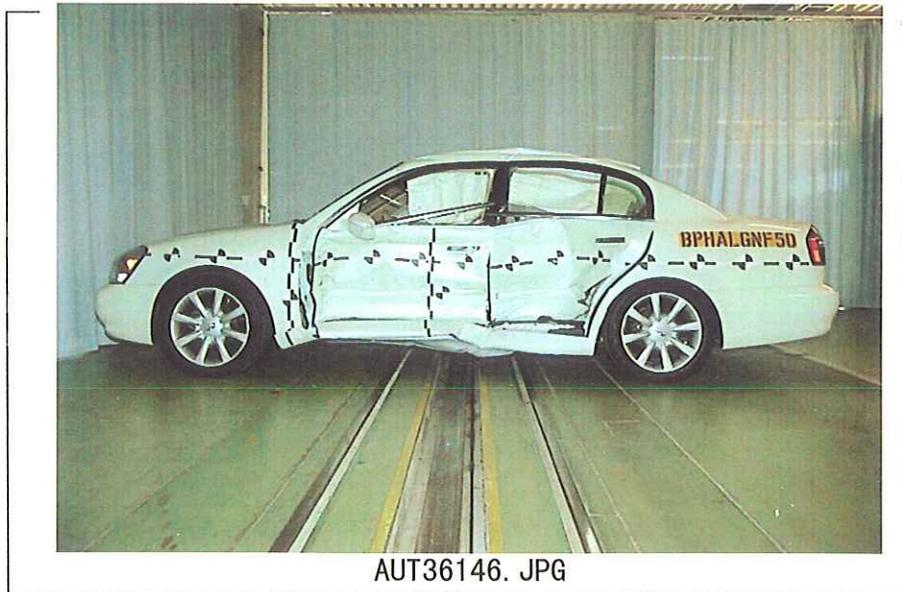
Photo. No.2                      POSTTEST

SUBJECT :    Side    view

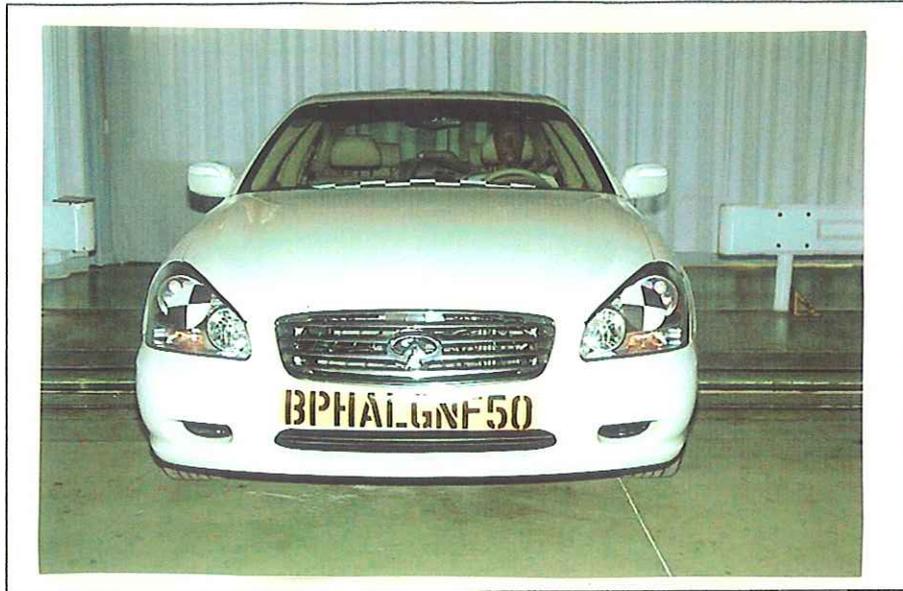
Photo. No.3                      PRETEST  
 SUBJECT : Front view

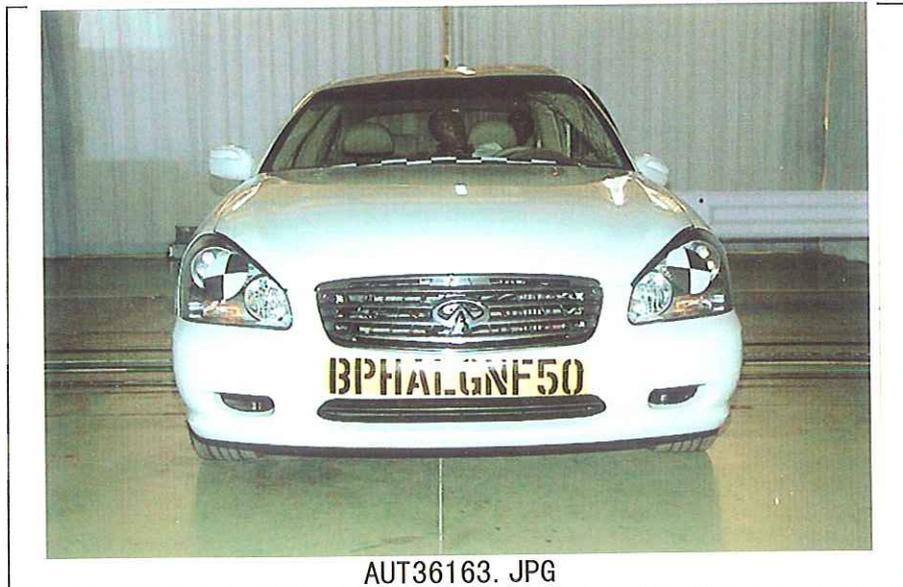
Photo. No.4                      POSTTEST  
 SUBJECT : Front view

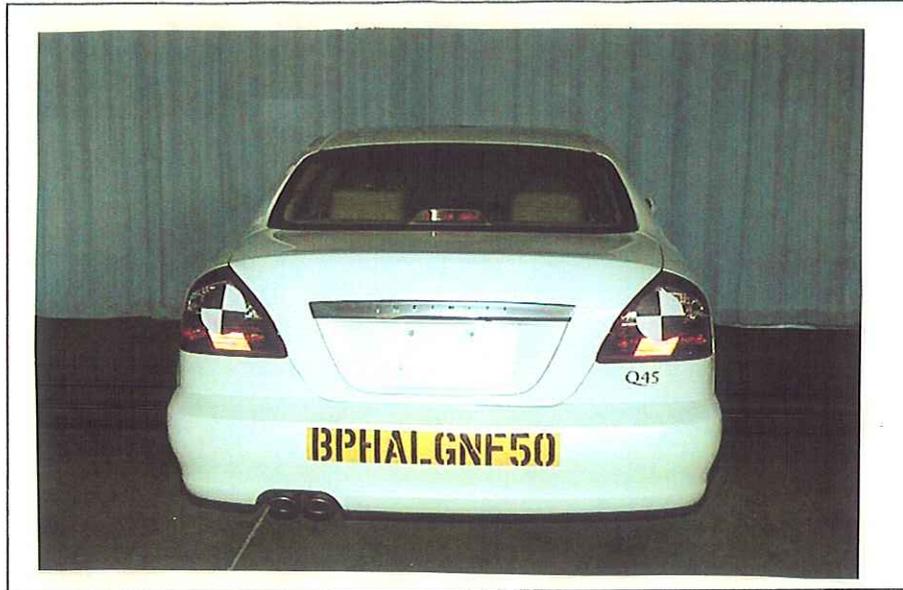
Photo. No.5                      PRETEST

SUBJECT :    Rear    view                      \_\_\_\_\_

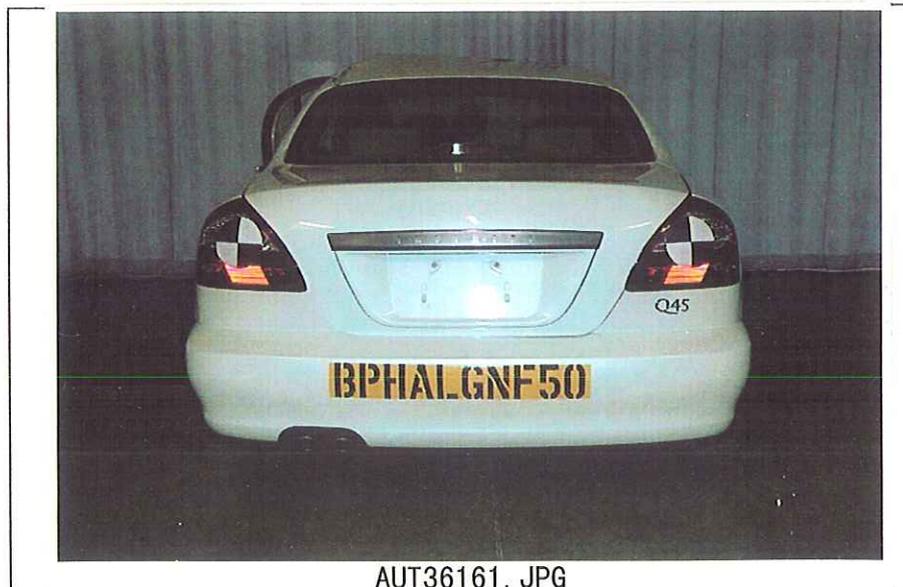
Photo. No.6                      POSTTEST

SUBJECT :    Rear    view                      \_\_\_\_\_

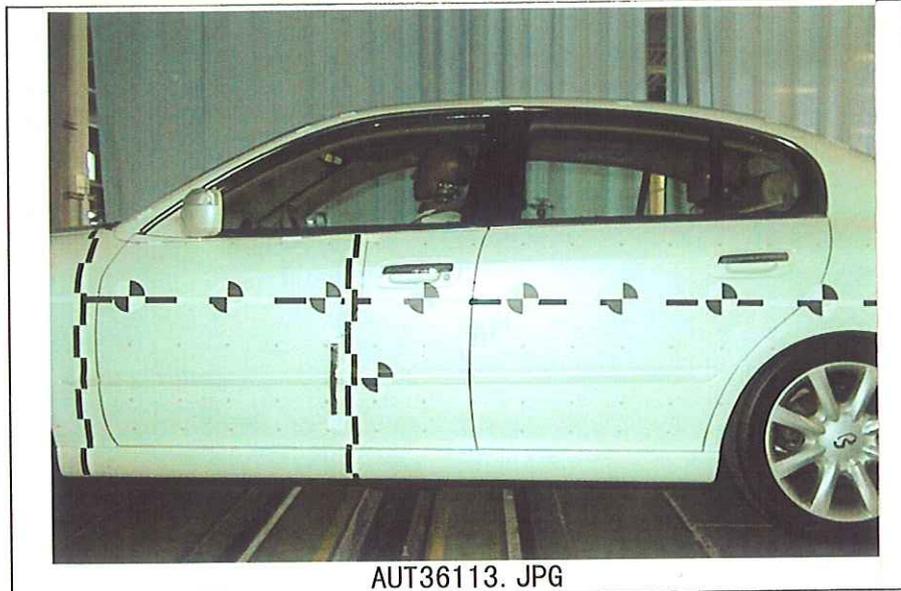
Photo. No.7

SUBJECT : Front dummy, Rear dummy, Position view

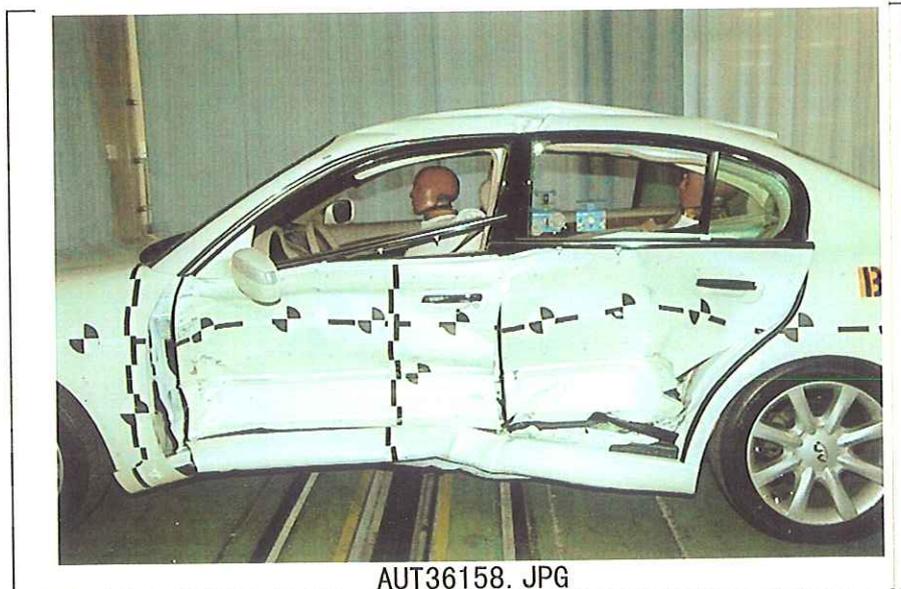
Photo. No.8

SUBJECT : Front dummy, Rear dummy, Position view

Head protection inflatable restraint system is rolled up to take a photograph of post-test Dummy condition.

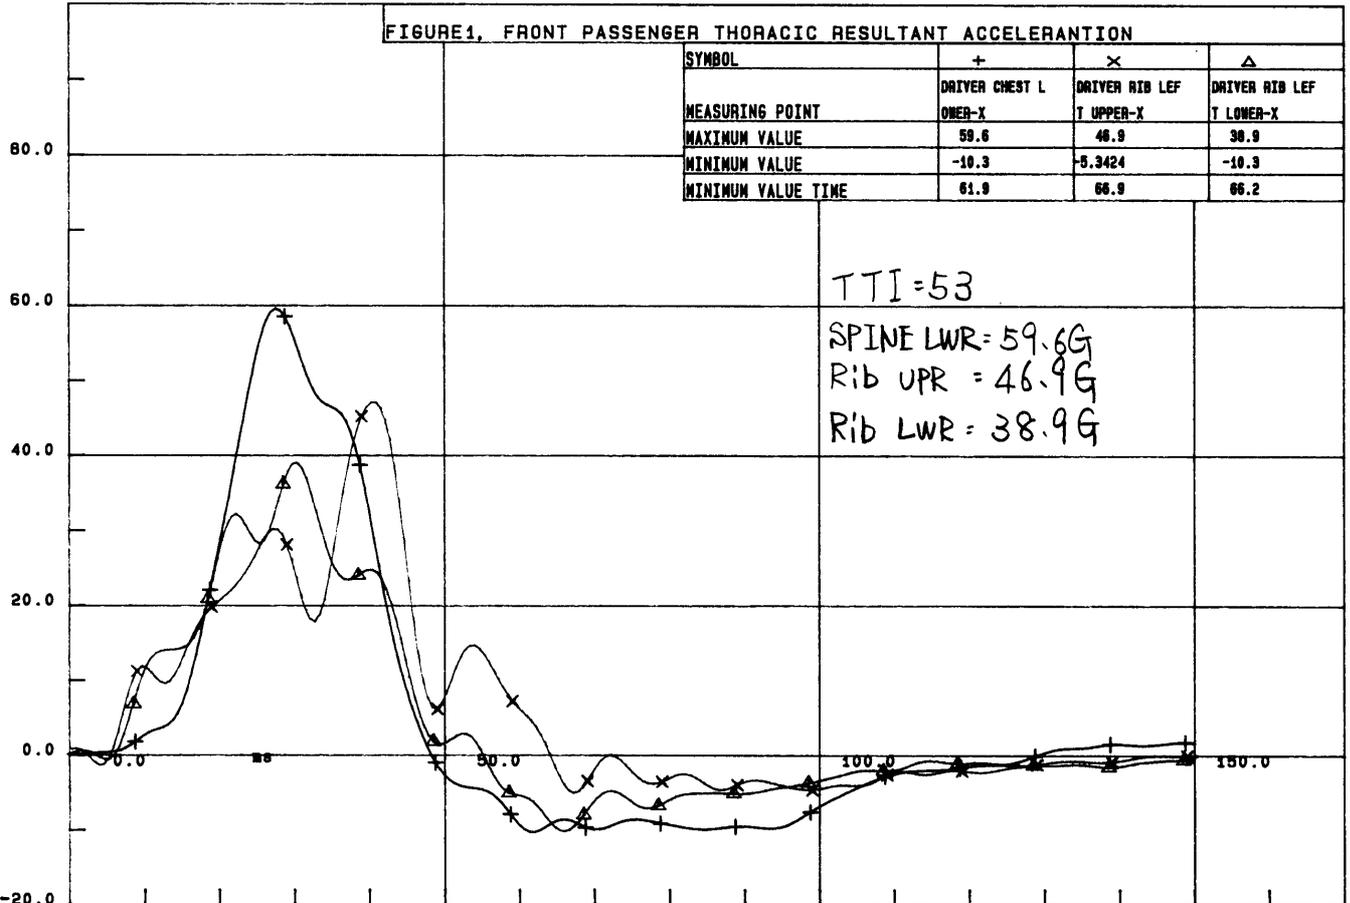
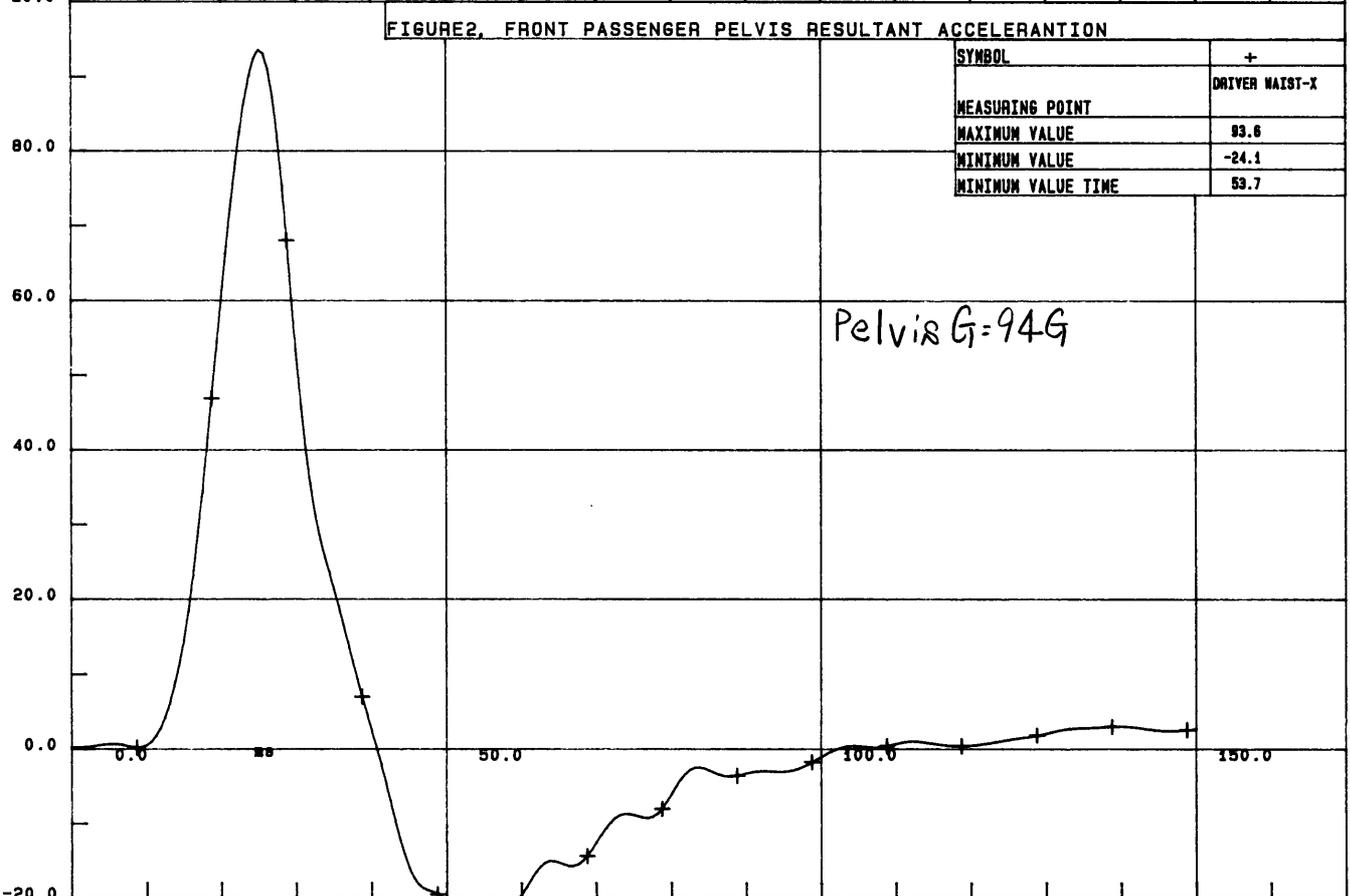
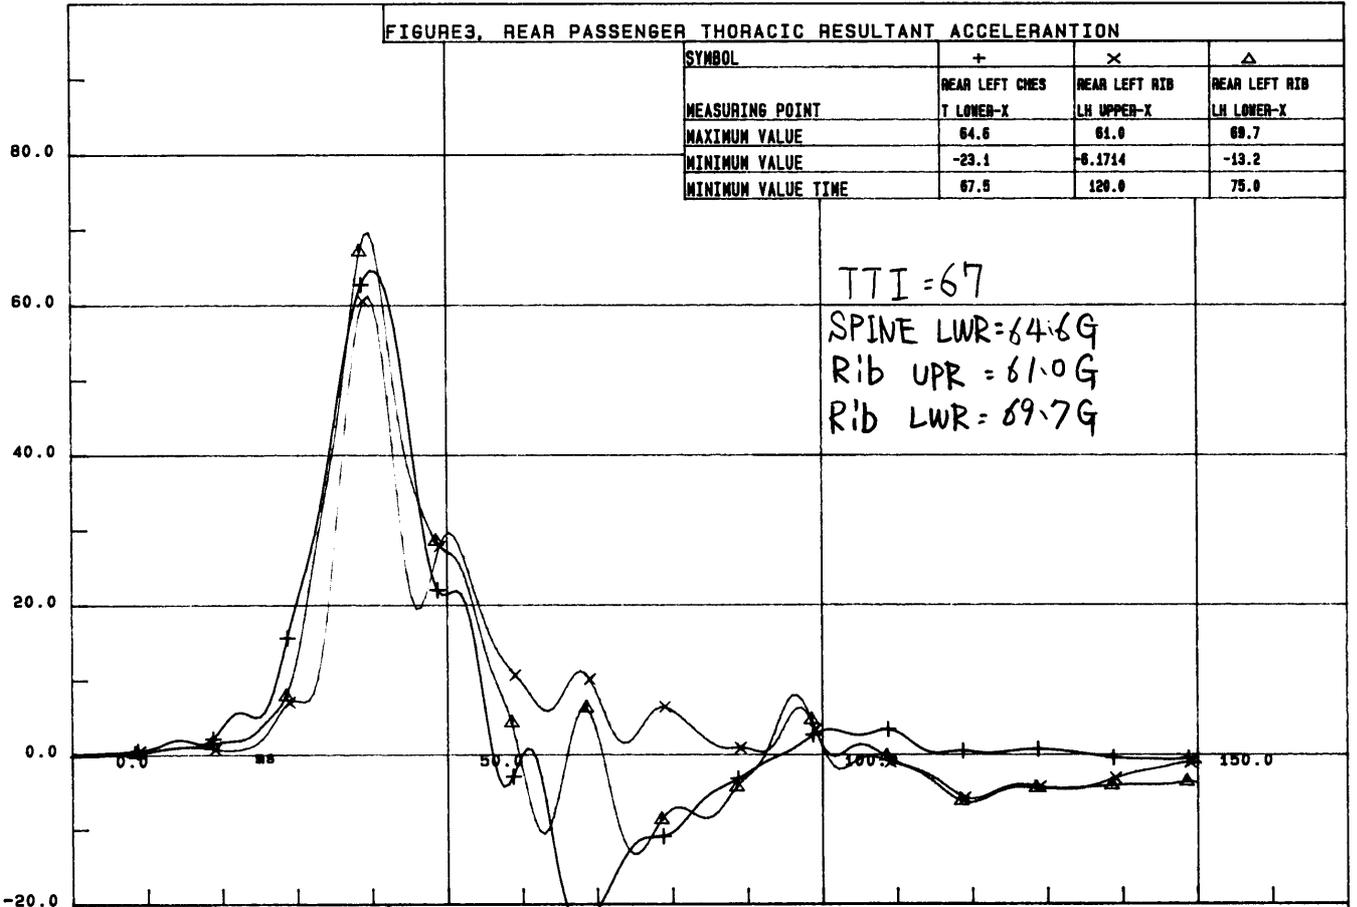
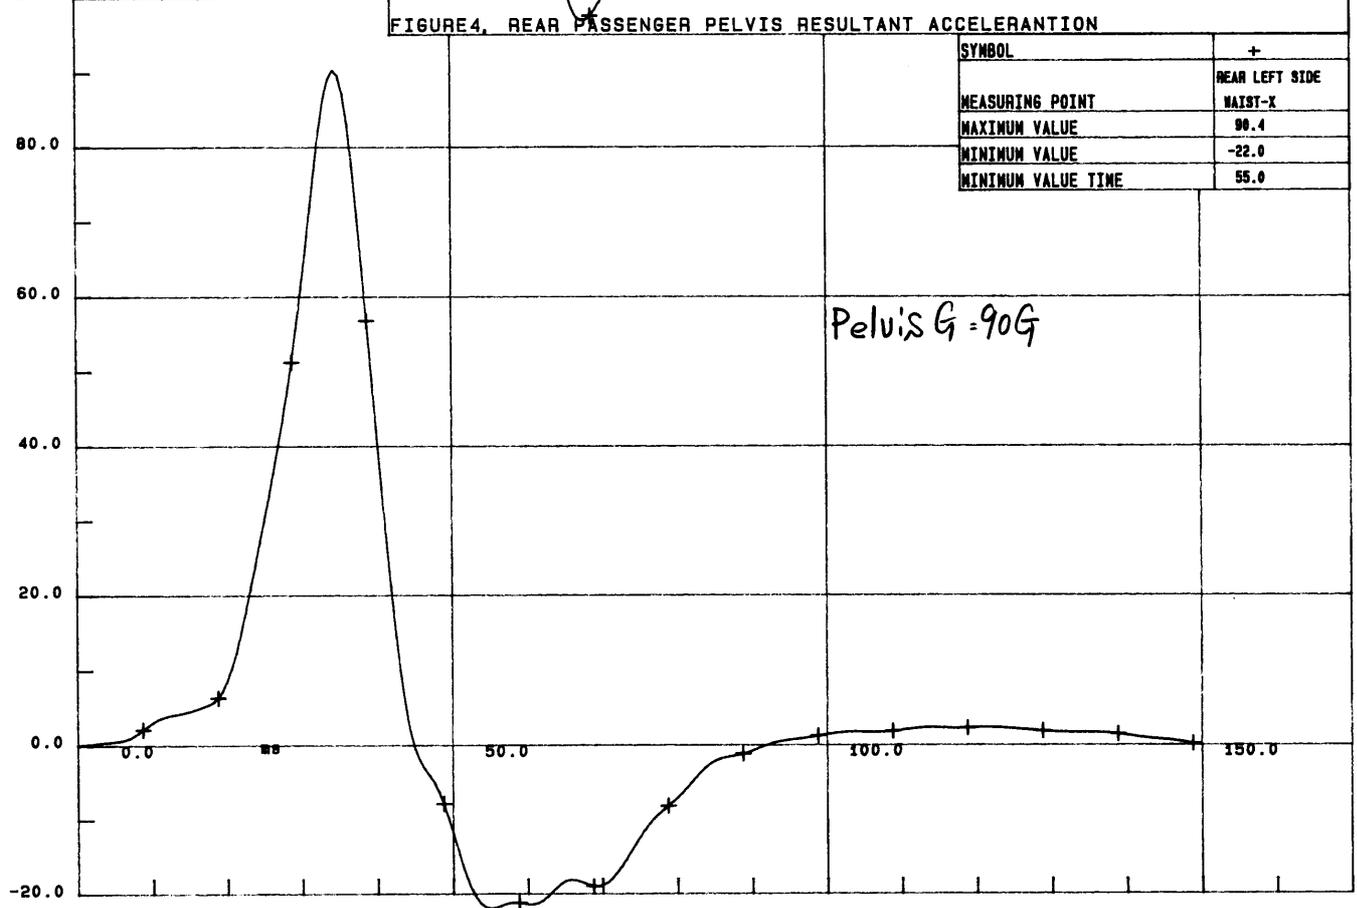
- 4.1 Detailed data of front passenger's injury criteria.  
See Figure 1~2.
- 4.2 Detailed data of Rear Passenger's injury criteria.  
See Figure 3~4.
- 4.3 Photographs of the test vehicle before and after.  
See Photo. 1~8.

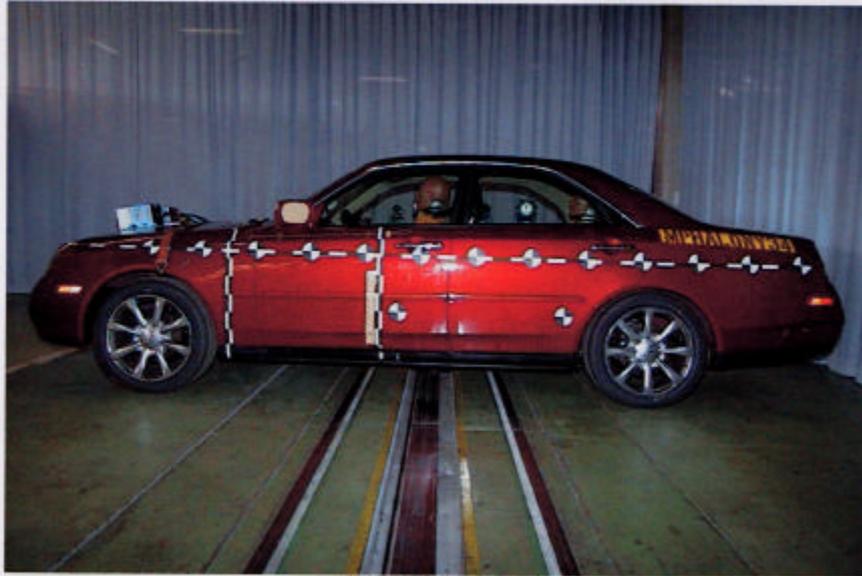
Photo. No.1                      PRETEST

SUBJECT :    Side    view

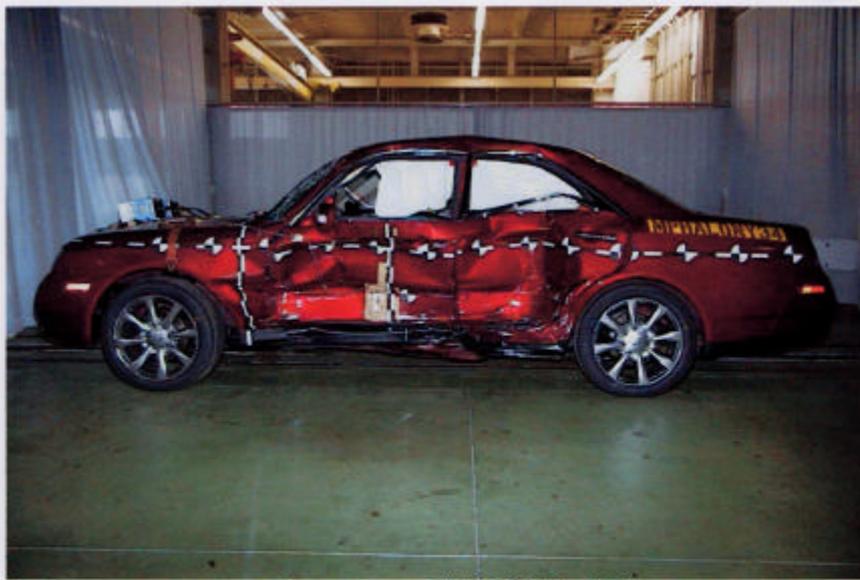
Photo. No.2                      POSTTEST

SUBJECT :    Side    view

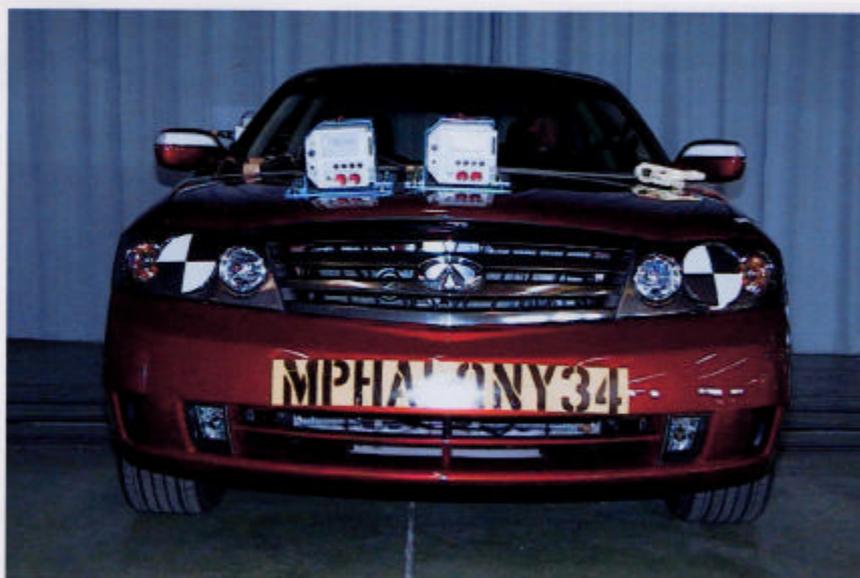
Photo. No.3                      PRETEST

SUBJECT :    Front    view

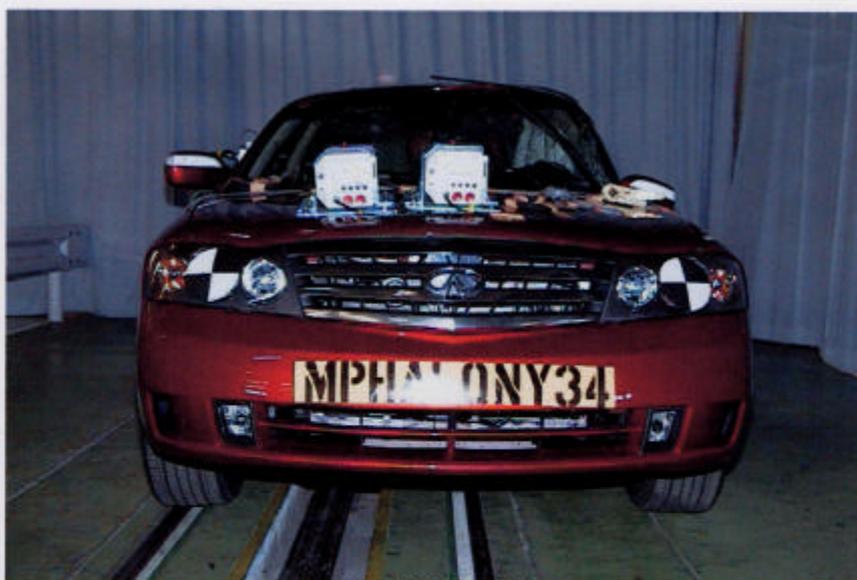
Photo. No.4                      POSTTEST

SUBJECT :    Front    view

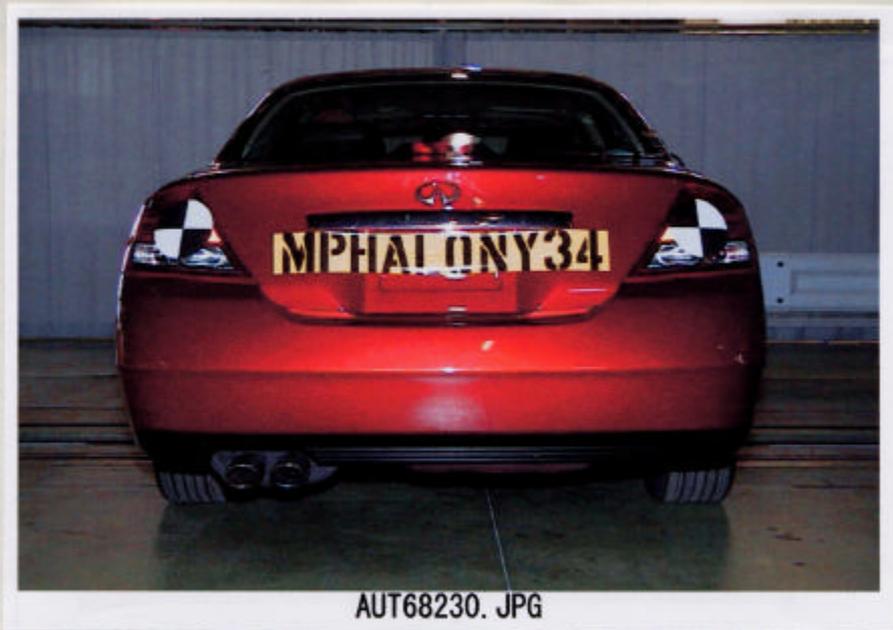
Photo. No.5                      PRETEST  
SUBJECT :    Rear    view

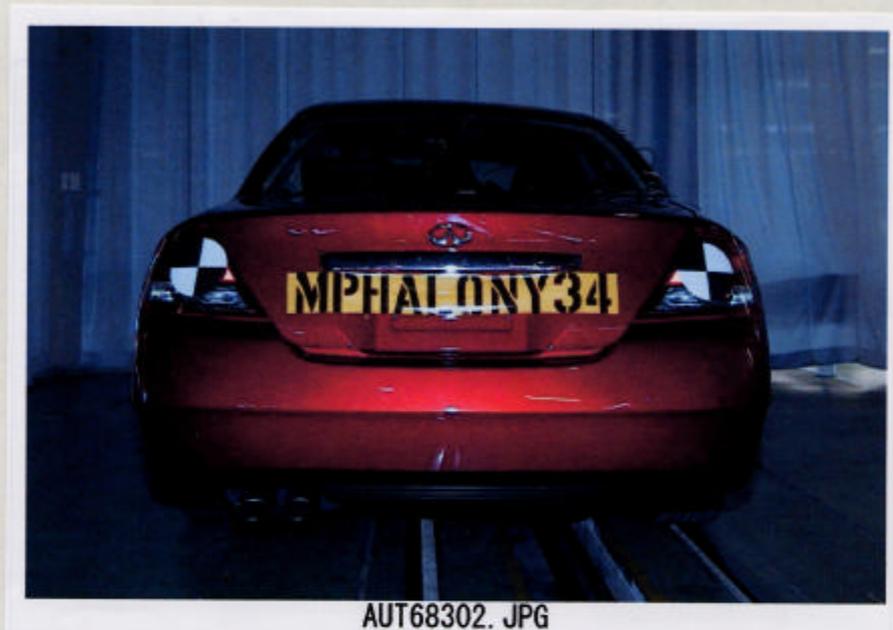
Photo. No.6                      POSTTEST  
SUBJECT :    Rear    view

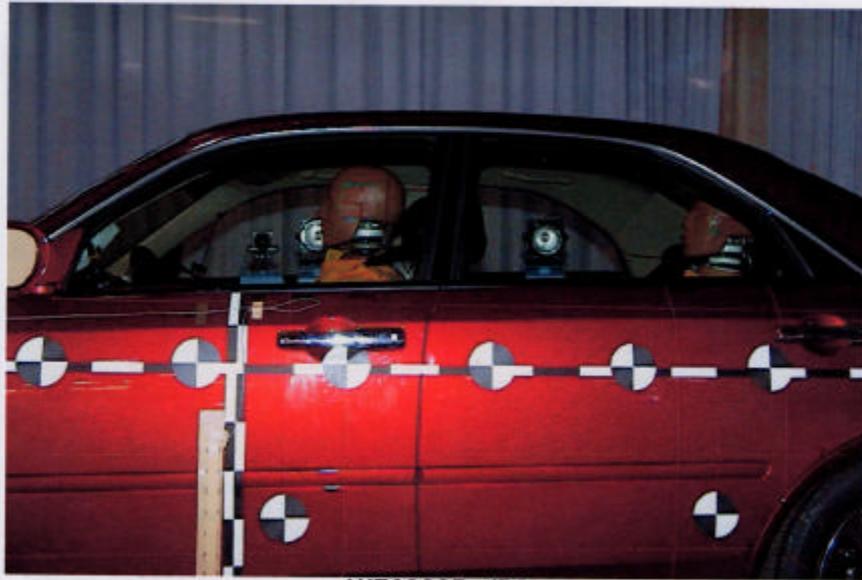
Photo. No.7

SUBJECT : Front dummy, Rear dummy, Position view

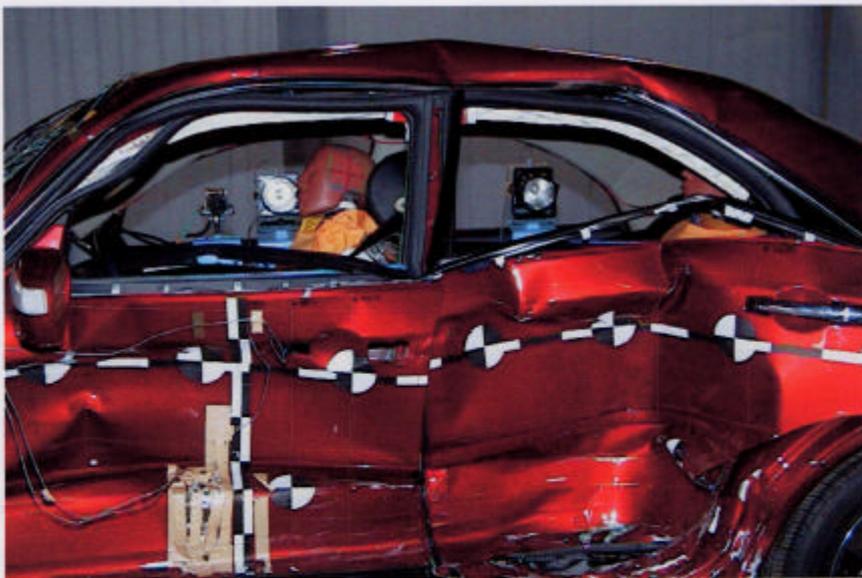
Photo. No.8

SUBJECT : Front dummy, Rear dummy, Position view
