Service Information

Recall Campaign 00V-048 - Brake Lamp Switch Replacement

E38 (7 Series)	produced 9/99 to 10/99
E39 (5 Series)	produced 9/99 to 10/99
E46 (3 Series)	produced 9/99 to 10/99

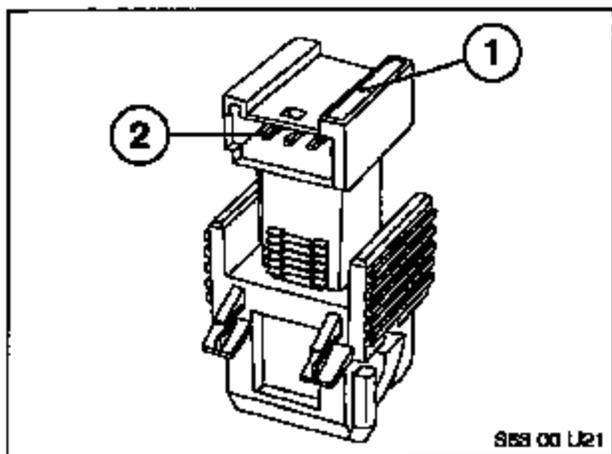
1. Remove the lower footwell trim to expose the brake light switch

2. Check whether the brake light switch is marked with a white bar (1) at the connector end (2)

If the brake light switch is marked with a white bar (1), reinstall the lower footwell trim. No further actions are necessary.

If the brake light switch is not marked with a white bar on the connector side, continue with step 3.

3. Remove and replace the brake light switch (Refer to Repair Instruction 61 31 310)
4. Reinstall the lower footwell trim

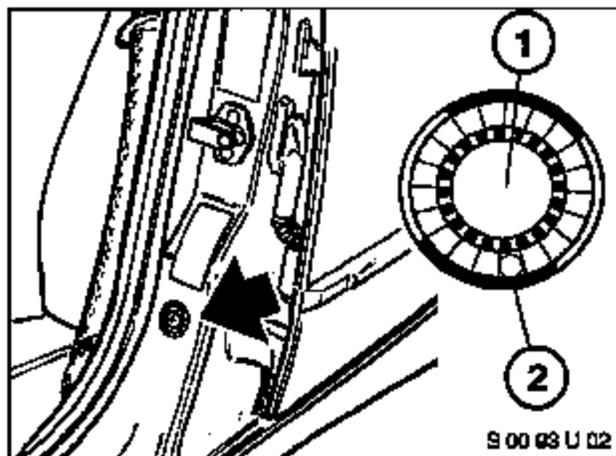
This Recall Campaign has been assigned code number 289. After the vehicle has been checked, and corrected if necessary, obtain a label (SD 92-130) and:

- a. emboss your BMW dealer warranty number in the middle of the label (1);
- b. punch out code number 289 printed on the label and,
- c. affix the label to the B pillar as shown.

If the vehicle already has a label from a previous Service Action/Recall Campaign, affix the new label next to the old one. Do not affix one label on top of another one because a number from an underlying label could appear in the punched-out hole of the new label.
