Service Bulletin

SAFETY RECALL

2010 NT700V Tire Information Label Replacement

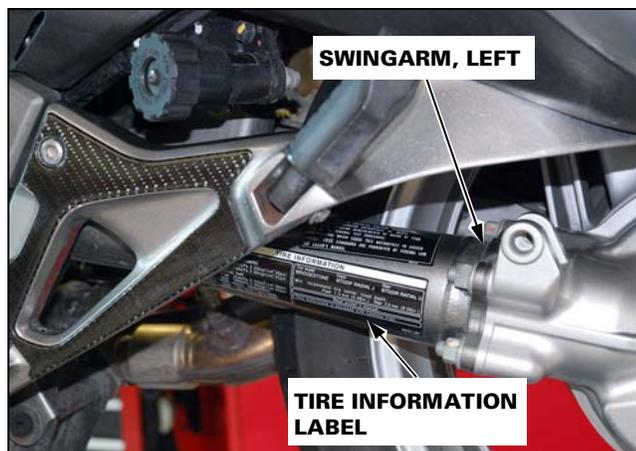
1. Locate the Tire Information Label on the left side of the swingarm.

Examine the tire *model* information on the label and compare it to the correct information shown in the IDENTIFICATION section of this bulletin.

- If the tire *model* information is correct:
 - No further action is necessary.
- If the tire *model* information is incorrect (anything other than shown):
 - Proceed with the remaining steps of the repair procedure.

2. Remove the incorrect tire information label from the swingarm by peeling it up from the corner.

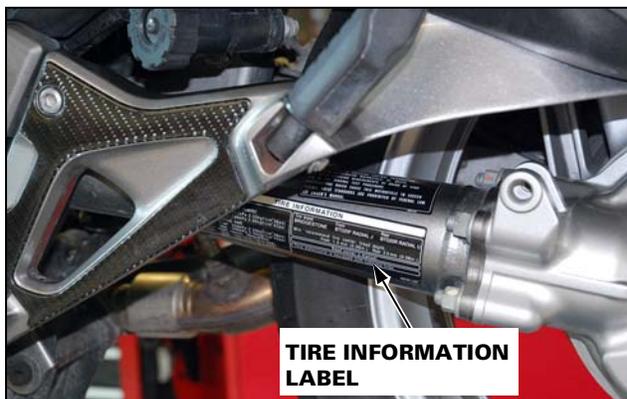
3. Clean any remaining adhesive from the swingarm. Wash the area with soap and water and dry it.
4. Peel the replacement Tire Information Label from its backing sheet and apply it to the clean area as shown.

Once the label is in position, use finger pressure to firmly affix it.
5. Check the tire pressures and, if necessary, adjust them to the specification on the replacement Tire Information Label.
6. File a template warranty claim according to the WARRANTY INFORMATION section of this bulletin.

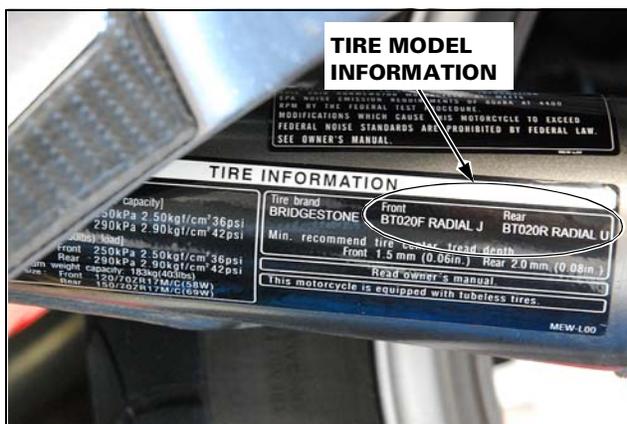
IDENTIFICATION

A correct Tire Information Label can be identified by the *tire model* information on the label. The correct information is:

Front	Rear
BT020F RADIAL J	BT020R RADIAL U
