Technical BULLETIN

RECALL

2001 XV16AN, ANC, ASN, ASNC FACTORY MODIFICATION CAMPAIGN

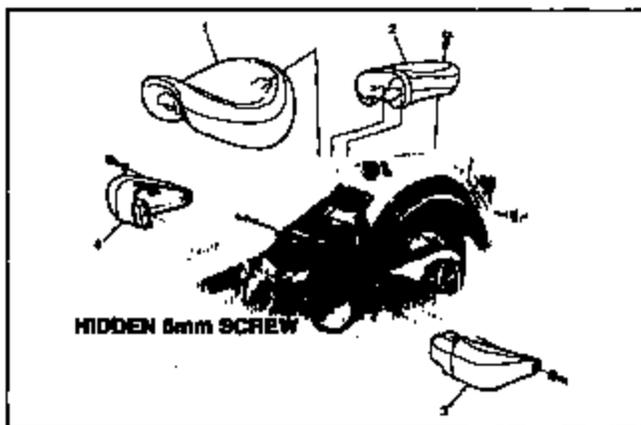
Side Cover Removal:

Before attempting to remove the right side cover, remove the left cover first to access the hidden 6mm bolt.

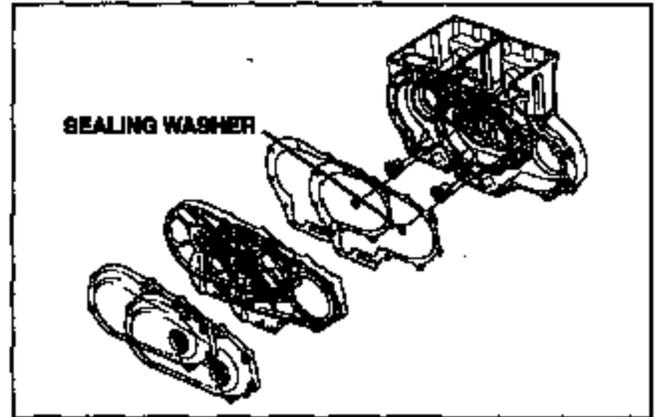
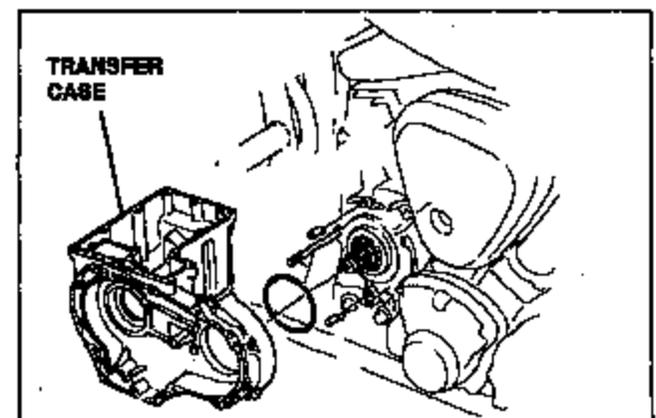
Transfer Case Removal:

- Remove the transfer case bracket first. Then remove the outer chrome cover, inner cover, and drive-sprocket nut.

NOTE: There is a sealing washer between the inner case and the transfer case at the 8mm stud. Be sure to replace it during re-assembly.

- Remove the drive pulley cover and remove the drive pulley nut.
- Loosen the drive belt tension.
- Remove the drive pulley, inner cover, collar, and O-ring.

NOTE: The collar has a bevel on its inside diameter for the O-ring facing inward and a bevel on the outside diameter facing the pulley.

- Remove the drive and driven sprockets with chain as an assembly.
- Remove the collar and O-ring.

NOTE: Collar has a bevel on its inside diameter that faces inward for the O-ring.

- Remove oil tank filler neck.
- Remove the relay bracket on the right-hand side.

NOTE: Leave the relays connected. Simply move them out of the way to allow room for transfer case removal.

- Slide the transfer case out from the right side.

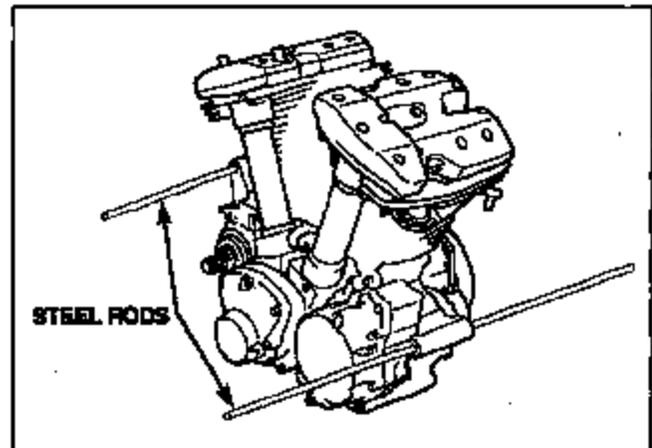
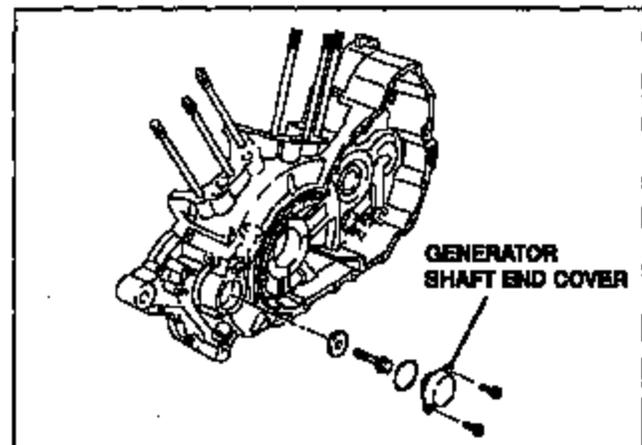
Engine Tear Down:

- Remove the left-hand generator shaft end cover and remove the generator shaft bolt and washer.
- Remove the clutch, primary drive gear, shift shaft, shift detent, oil pump gear and oil crossover pipe.

NOTE: The right side of the crossover pipe has an O-ring. If the O-ring doesn't come out with the crossover pipe, be sure to remove it while the engine is disassembled.

- Remove both top ends

NOTE: Do not remove the push rod tubes from the crankcase. Remove only one circlip from the piston for quicker piston pin removal.

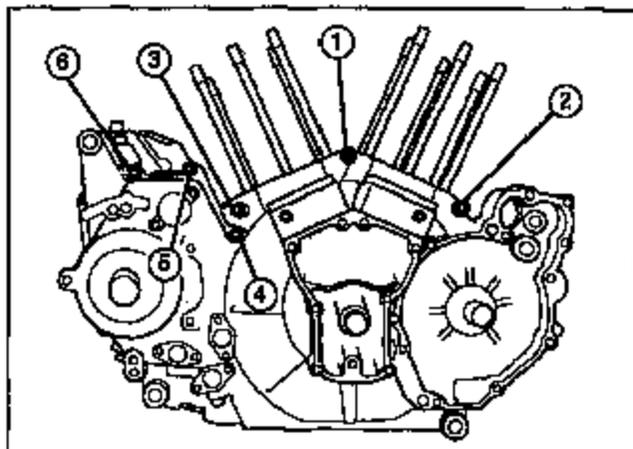
- Remove the right side crankcase bolts (three 8mm and three 6mm) only.

NOTE: Do not remove the cam cover or generator cover.

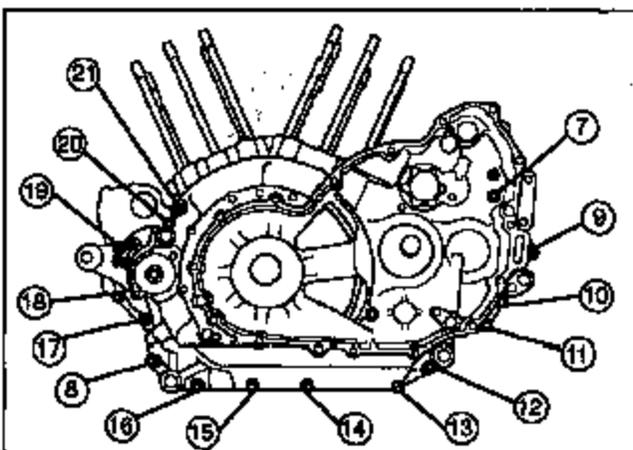
- Tilt the engine to the right and rest the cam cover against a block covered with cardboard or other protective material to protect the engine finish. Remove the left-side crankcase bolts (6mm bolts, quantity 15).

- Align the shift cam segment with the segment-shaped hole in the crankcase.

- While holding the crankshaft against the right crankcase, remove the left crankcase half.

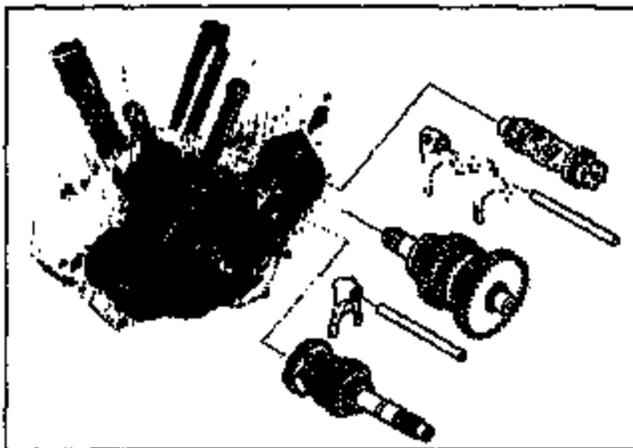
Be sure to hold the crankshaft against the right case half to prevent disengagement of the camshaft drive gear.

- Remove the shift fork shafts, shift forks, and transmission.

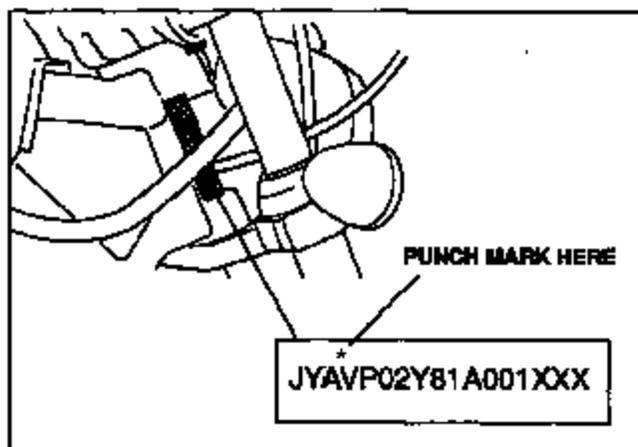
IDENTIFICATION PROCEDURE

After modifying a unit, make a punch mark above the frame number (VIN) on the steering head pipe as shown in the illustration below.
